Runway Collision, United Express Flight 5925 and Beechcraft King Air A90, Quincy Municipal Airport, Quincy, Illinois, November 19, 1996

Investigative Body: National Transportation Safety Board (NTSB), USA

**RUNWAY COLLISION
UNITED EXPRESS FLIGHT 5925
AND BEECHCRAFT KING AIR A90
QUINCY MUNICIPAL AIRPORT
QUINCY, ILLINOIS
NOVEMBER 19,1996**

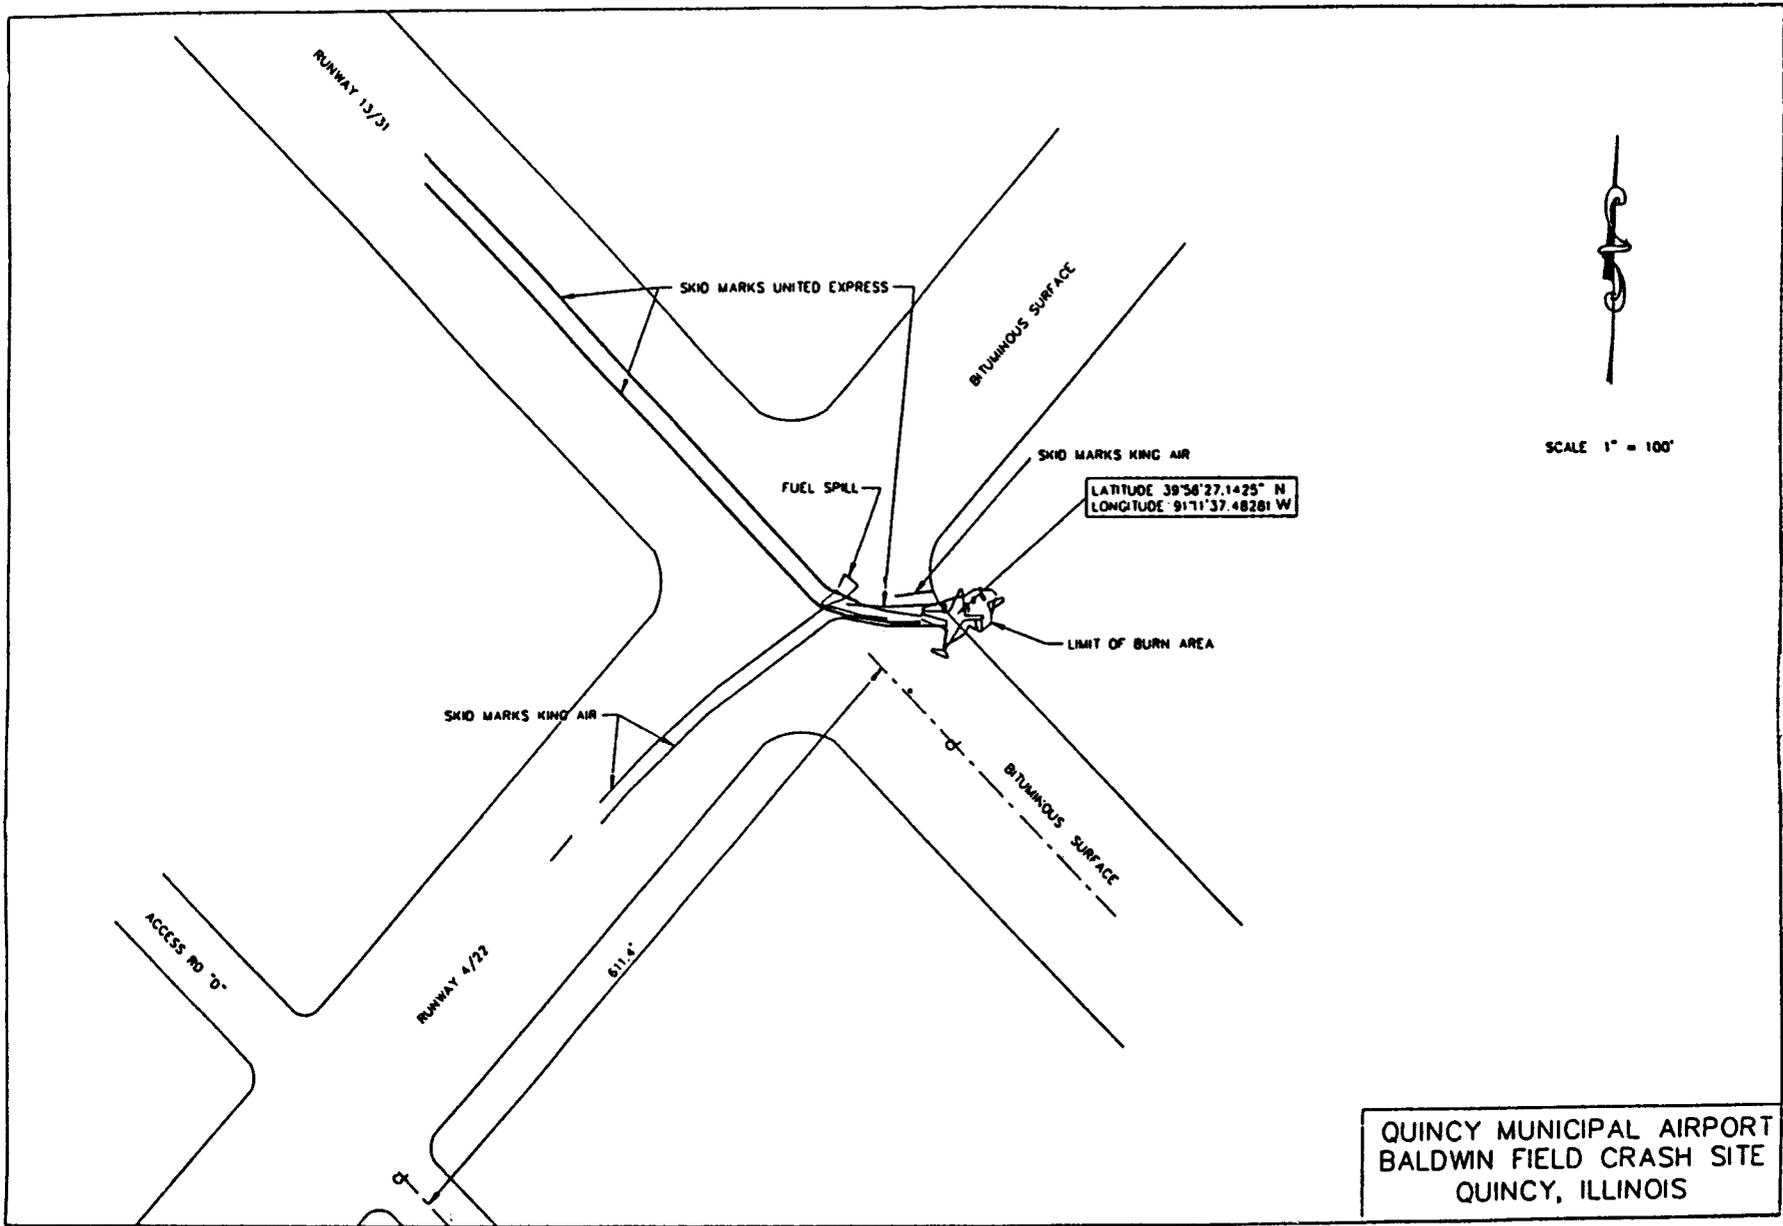
Figure 1.—Diagram of accident site.

The King Air's tire scuff marks veered continually to the right on runway 04 for about 260 feet before they converged with the skid marks from the Beech 1900C. A dark area with an odor consistent with that of jet fuel was found on the runway near the converging skid marks. The grass next to the airplane wreckage was burned and dark and also had an odor consistent with jet fuel.

At the accident site, investigators observed that the grass was burned for approximately 10 feet beyond the perimeter of the wreckage, and that fuel had saturated the grass for about 40 feet beyond the perimeter. A 5- by 8-foot area of fuel residue was observed on the runway area where the aircraft skid marks converged.

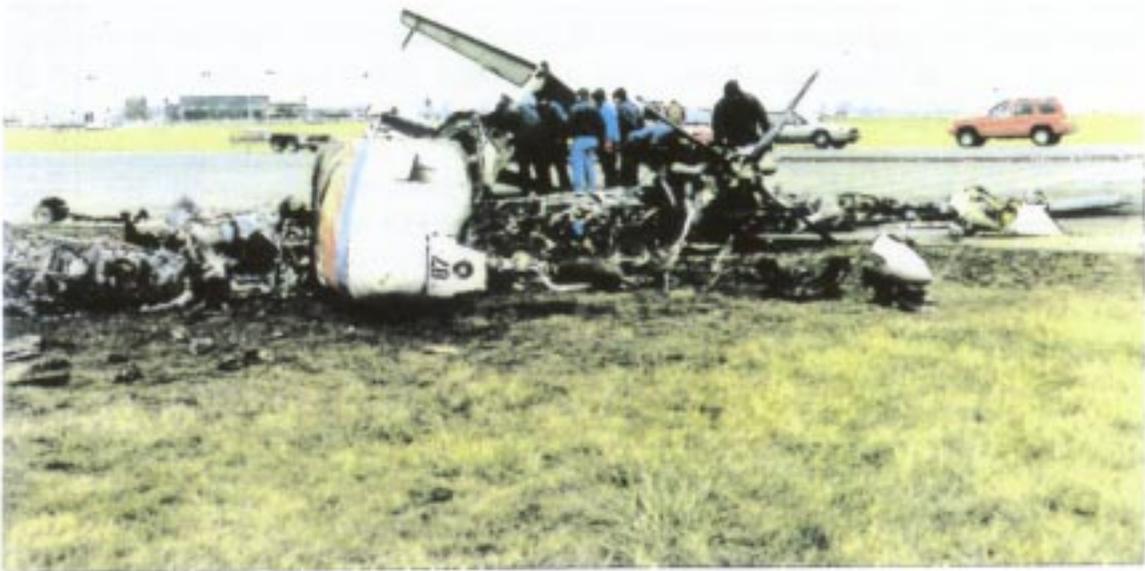
2a. View looking aft of the Beech 1900C

The nose of the fuselage was intact, but it had separated at the forward cockpit area and was resting on its right side with the nose gear extended. The right side of the nose section was compressed inward about 10 inches, and blue paint transfer was found along the right side of the nose assembly that matched the color of the paint trim on the King Air. The tail assembly remained intact and was resting on the left horizontal stabilizer.

The engine and propeller assembly remained attached to the left wing. All four right engine propeller blades had fractured at the blade root and had separated from the hub. One of the propeller blades was found along the east edge of runway 04 at the intersection with runway 13. The blade's leading edge had blue paint transfer that matched the color of the paint trim on the King Air. The leading edge of another torn propeller blade exhibited white paint transfer that matched the color of paint on the King Air's fuselage and wing surface. Examination of the control cables to the fuel controls of both engines revealed positions consistent with normal engine shutdown.

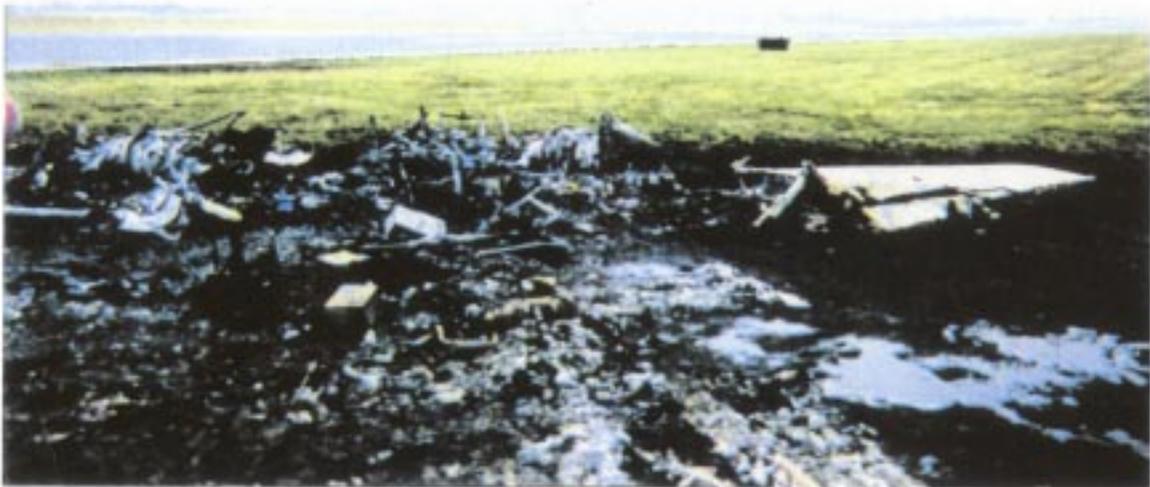
2b. View (looking forward) of the King Air wreckage

Except for the outboard sections of the right wing and the right horizontal stabilizer, the King Air was consumed by the postcrash fire. No evidence of the main cabin door or the emergency exit hatch could be found. The nose gear was folded forward in the down-and-locked position. The radome and a small section of the airplane's left wing leading edge were found on the runway next to the wreckage. The radome was torn and exhibited chipped paint

and abrasive marks on its exterior, and the section of the left wing's leading edge showed black paint transfer that matched the color of paint on the Beech 1900C's propellers. Examination of the control cables to the fuel controls of both engines revealed positions consistent with normal engine shutdown. The cockpit-mounted radio controls were consumed by the postcrash fire. The nose-mounted communication radio units were found crushed and partially burned. No information about the radio's functioning or its settings at the time of the accident could be obtained from the wreckage.

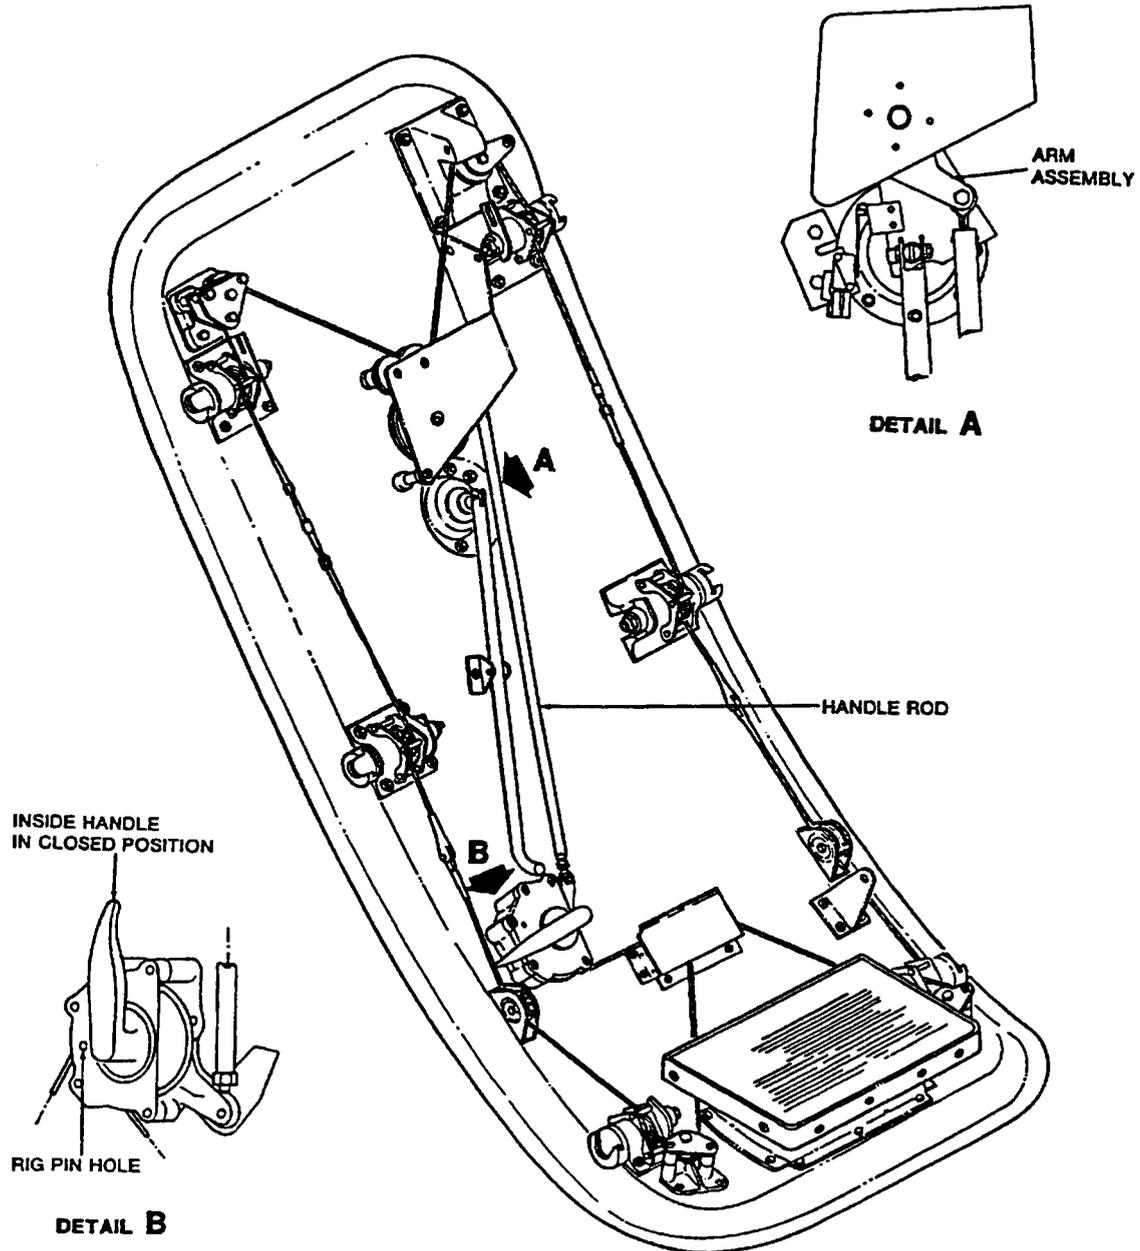
Figure 4.—Beech 1900/1900C air stair door and latching mechanism.

The FBO pilot stated that he found the forward air stair door handle in the 6 o'clock (unlocked) position.²⁹ He said that he attempted unsuccessfully to open the door by moving the handle in all directions and pulling on the door. He said that he did not see any instructions for opening the door, but he was able to rotate the handle upward to the 5 o'clock position but no further. The United Express pilot stated that he then intervened because he believed that the FBO pilot probably did not know how to open the door. The United Express pilot stated that he depressed the button above the handle while rotating the handle from the 3 o'clock position downward to the unlocked position. He stated that the handle felt "normal" as he rotated it. However, he was unable to open the door. The FBO pilot then tried again to open the door by rotating the handle upward, but he was again unsuccessful.

1. All cams were either fully or partially latched;
2. The exterior door handle was frozen in the latched position with aluminum melted around it;
3. The position of the interior door handle assembly could not be determined because there was no frame of reference to compare it to surrounding structure;
4. The door control cable was attached at both handle assemblies and was fractured at both turnbuckles. The metallurgical examination of the turnbuckle fracture surfaces revealed a topography typical of copper alloys subject to static failure influenced by high temperatures and steady state strain rates.

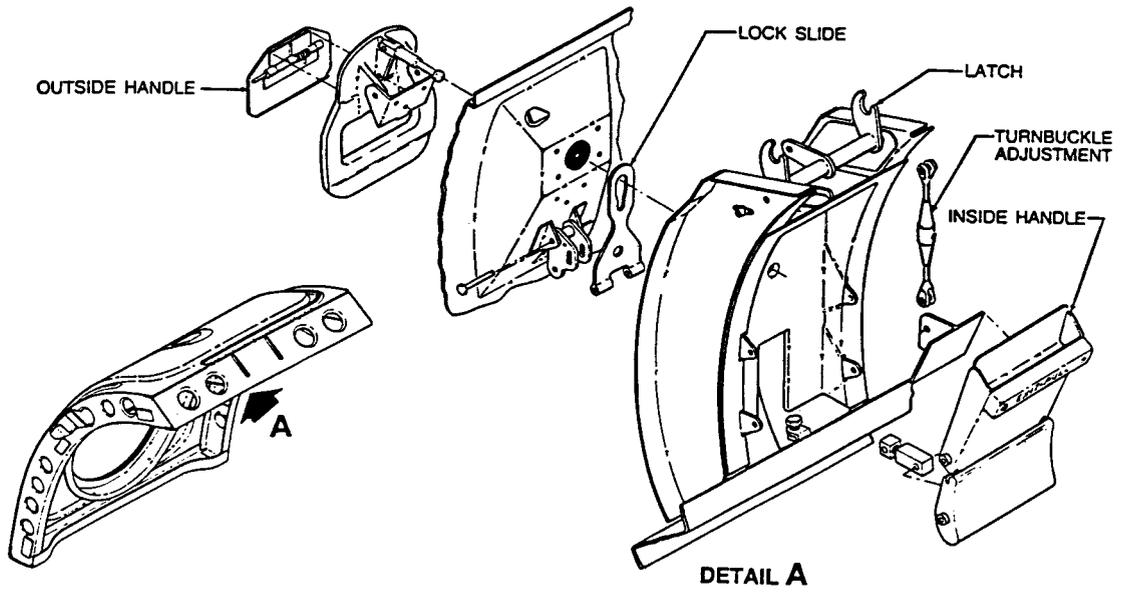
Figure 5.—Diagram of overwing exit hatch.

During wreckage recovery, the overwing exit hatch release latches and turnbuckles were examined. No conclusion could be drawn regarding their positions before the postcrash fire because the release latch secured to the airframe could have fallen from its latched position when the surrounding structure burned away.
