**Aviation Safety Council**

**SQ006 Accident Investigation  
Factual Data Collection  
Group Report**

**Survival Factors Group**

**ASC-FRP-01-01-006**

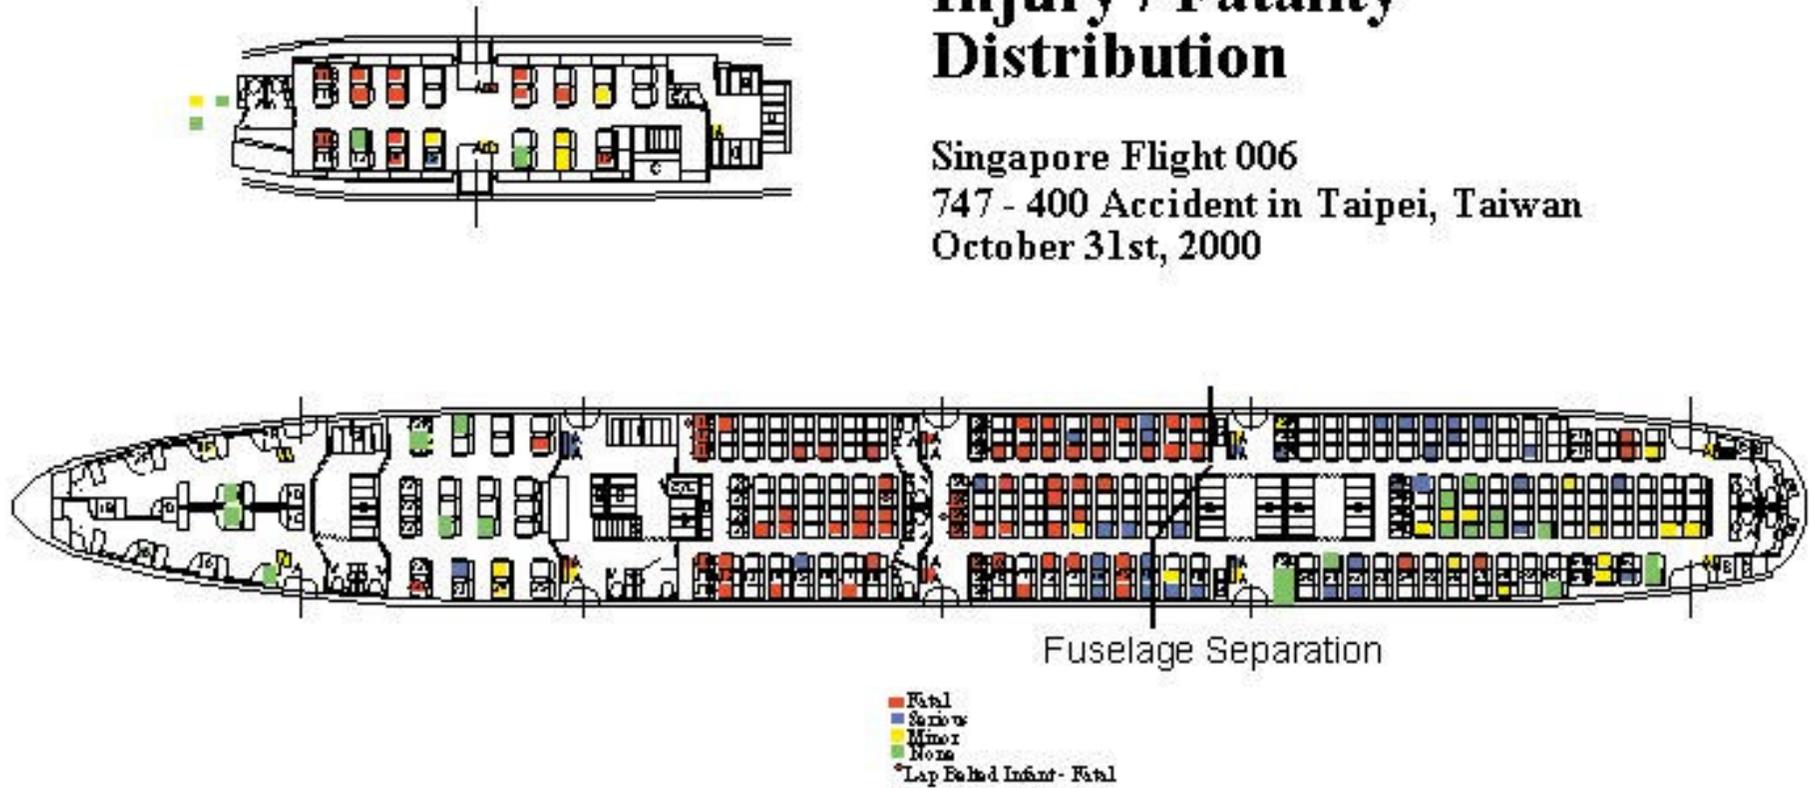
Figure 1.2-1 Injury/Fatal Distribution

The following diagram (Figure 1.2-1) shows the passenger seat positions and the severity of injuries that they sustained. The information on the passenger seat position is from the airline-seating plan and from interviews with passengers.

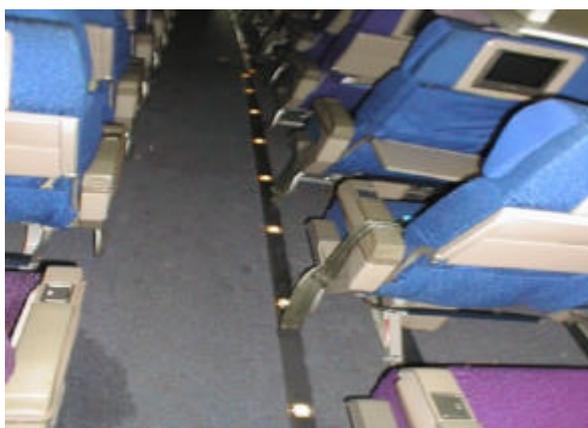
Examination of the emergency lights and floor proximity emergency lighting system positioned between doors 4 and 5 (figure 1.3-1,1.3-2) area revealed that each of the battery packs showed that they were completely discharged. See 1.16.2 for the emergency exit lights examination.

Figure 1.3-1 Illuminated Floor Proximity Lights during Testing

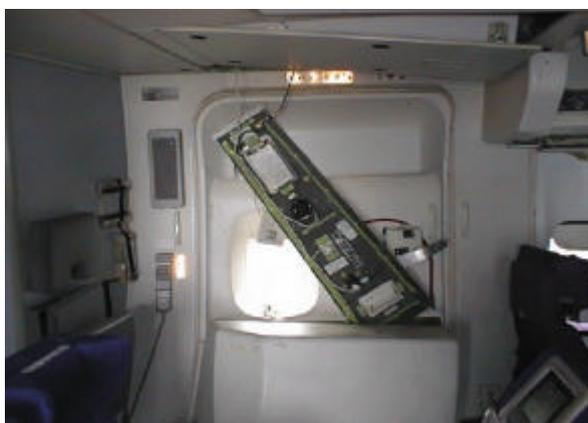
Figure 1.3-2 Illuminated Door 5 Left Emergency Light during testing  
(The over door fairing panel was removed to access the emergency light battery check)

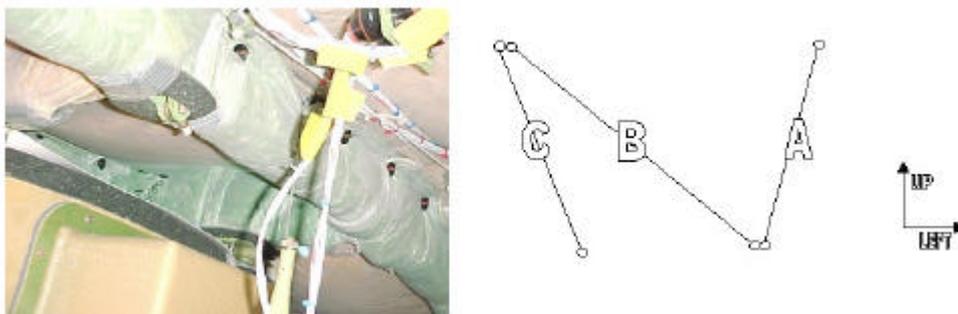
Figure 1.3-3 Tie rod photo

The center overhead bins separated from the upper fuselage frames at the tie rod ends (Figure 1.3-3) in the aft cabin between seats 54 D, F, G & H, and 60 D, F, G & H. Four of the fractured tie rods and one intact tie rod were removed for further metallurgical inspection and testing. The tie rods were removed from left to right and from the rear of the airplane to the front of the aft end of the cabin and were identified with masking tape as follows:

Frames at the following stations ruptured at stringer 1R near the B-Upper, C-Upper Tie rod connections: Station 1900,1960,1980,2000,2020,2040,2060 and 2080.

The fractured tie rods were inspected by the material lab of Chung Shan Institute of Science and Technology. Initial report stated that the main cause of fracture is overstress. (See Appendix 6-1)

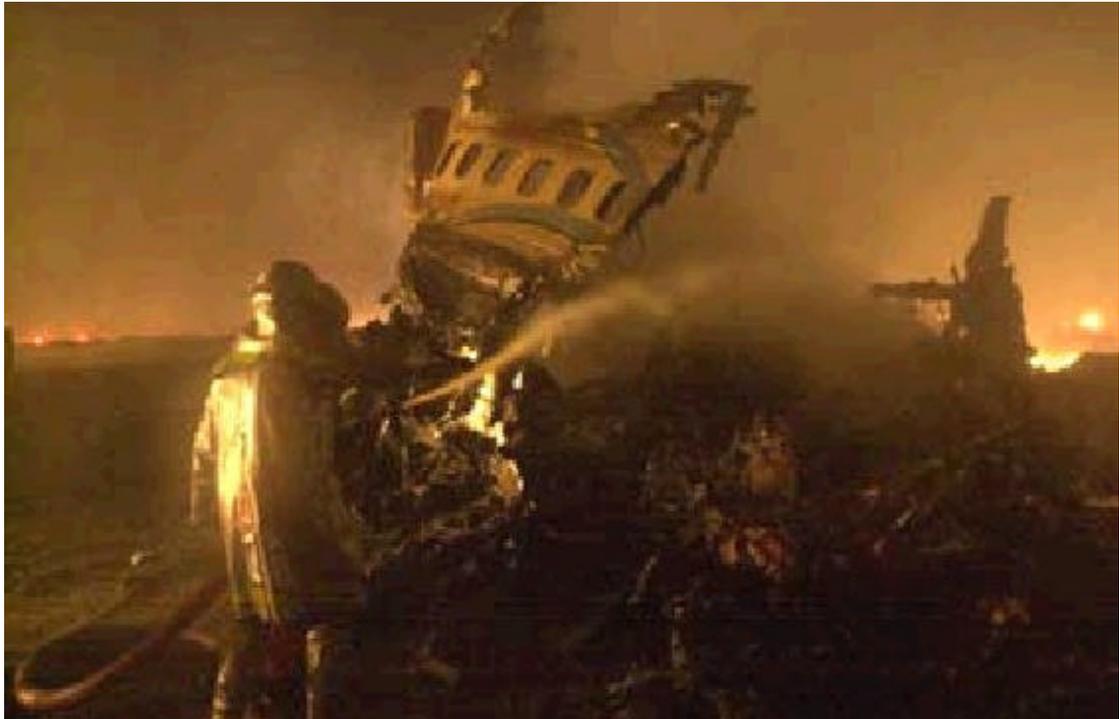
Figure 1.14-1 Fire Fighting Condition

CKS airport fire fighting group (Figure 1.14-1) had used 40,000 gallons of water and 2,300 gallons of chemical in this action.
