**INTERSTATE AVIATION COMMITTEE
AVIATION ACCIDENT INVESTIGATION COMMISSION**

**FINAL REPORT
BASED ON THE RESULTS OF THE INVESTIGATION OF THE AVIATION ACCIDENT**

Type of aviation accident	Catastrophe
Aircraft type	Tu-204-100V
State registration identification mark	RA – 64047
Owner	Ilyushin Finance OJSC
Operator	JSC Aviation Company "Red Wings"
Aviation Administration	Interregional territorial Air Transport Authority Central regions of the Federal Air Transport Agency
Scene of the incident	Russia, Vnukovo Airport, coordinates location of the aviation accident: 55° 35.040 N, 37°15.324 E
Date and time	29.12.2012, 12:32 UTC (16:32 Moscow time) time), day

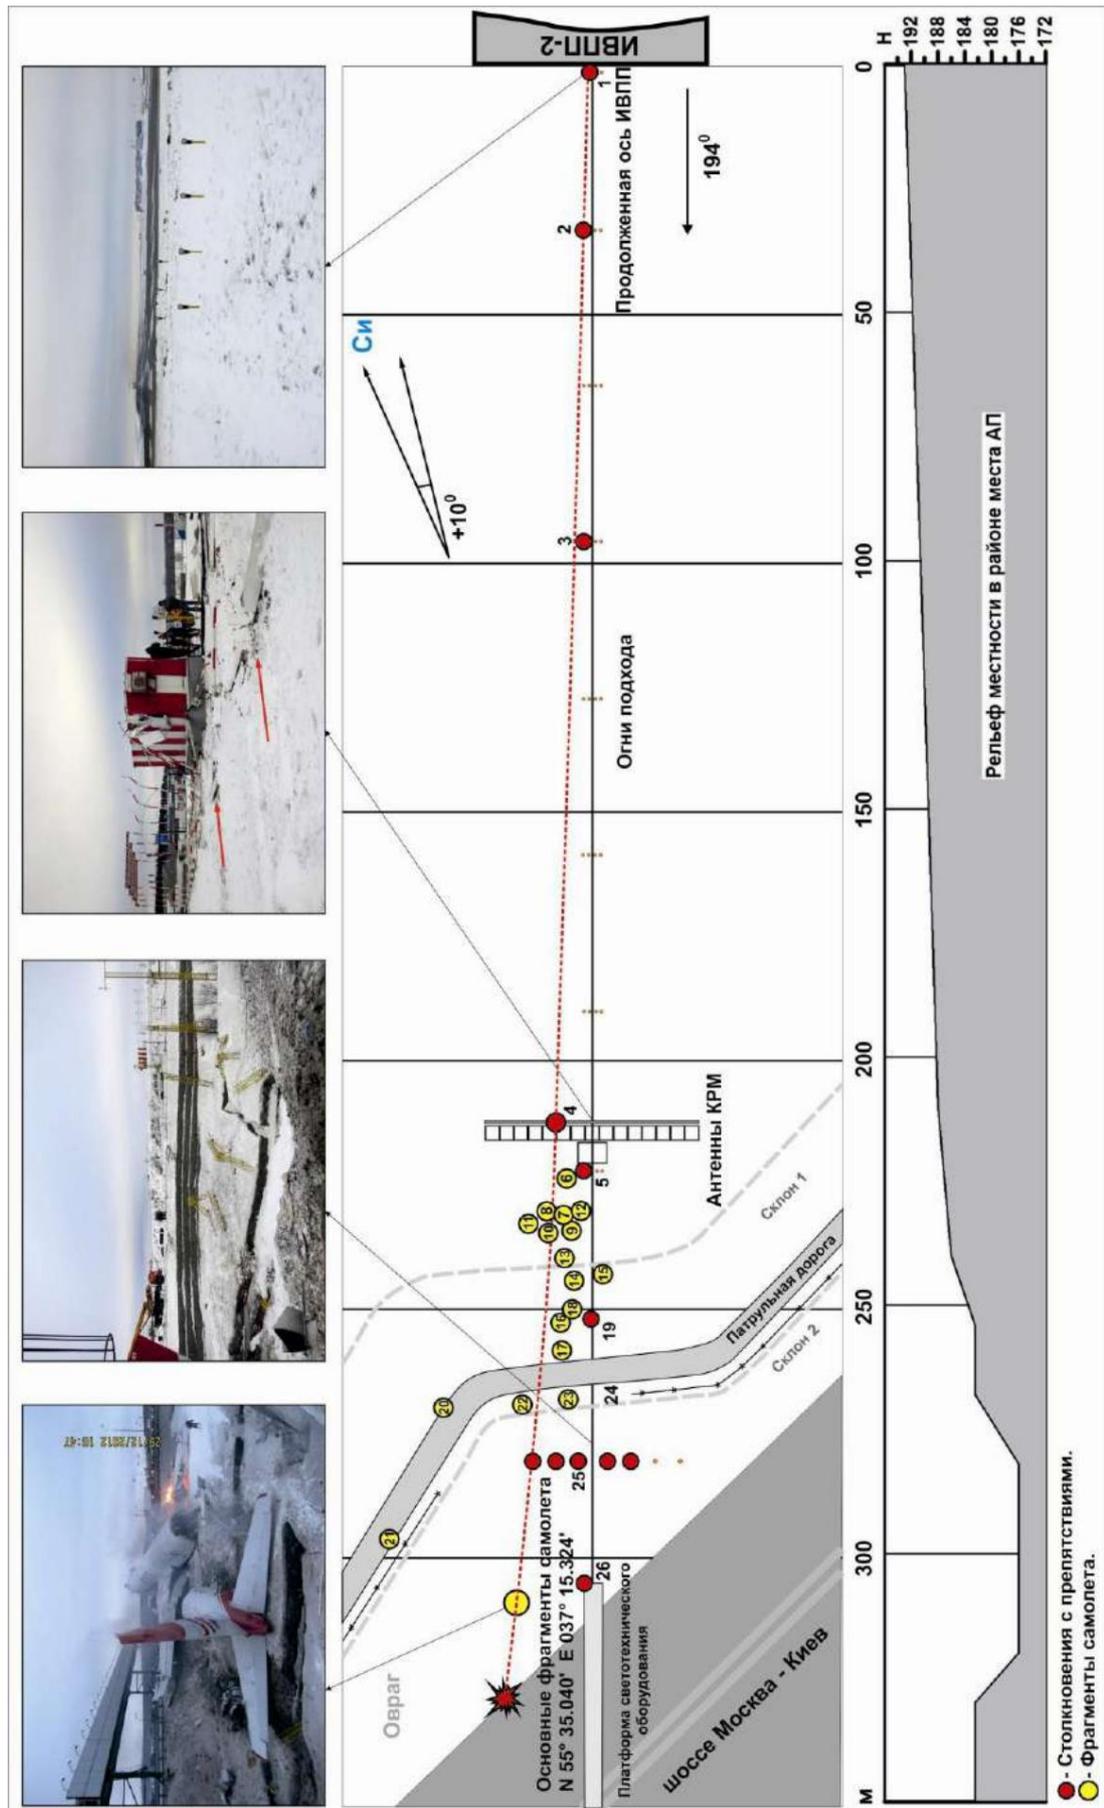
Fig. 4. Sketches of the accident site with the Tu-204-100B RA-64047 aircraft in near Vnukovo Airport (Moscow) on December 29, 2012.

23. Fragment of the brake disc of the main chassis support.
24. Damaged airfield fence.
25. Broken and fallen masts of lighting equipment.
26. Damage to the lighting equipment platform.

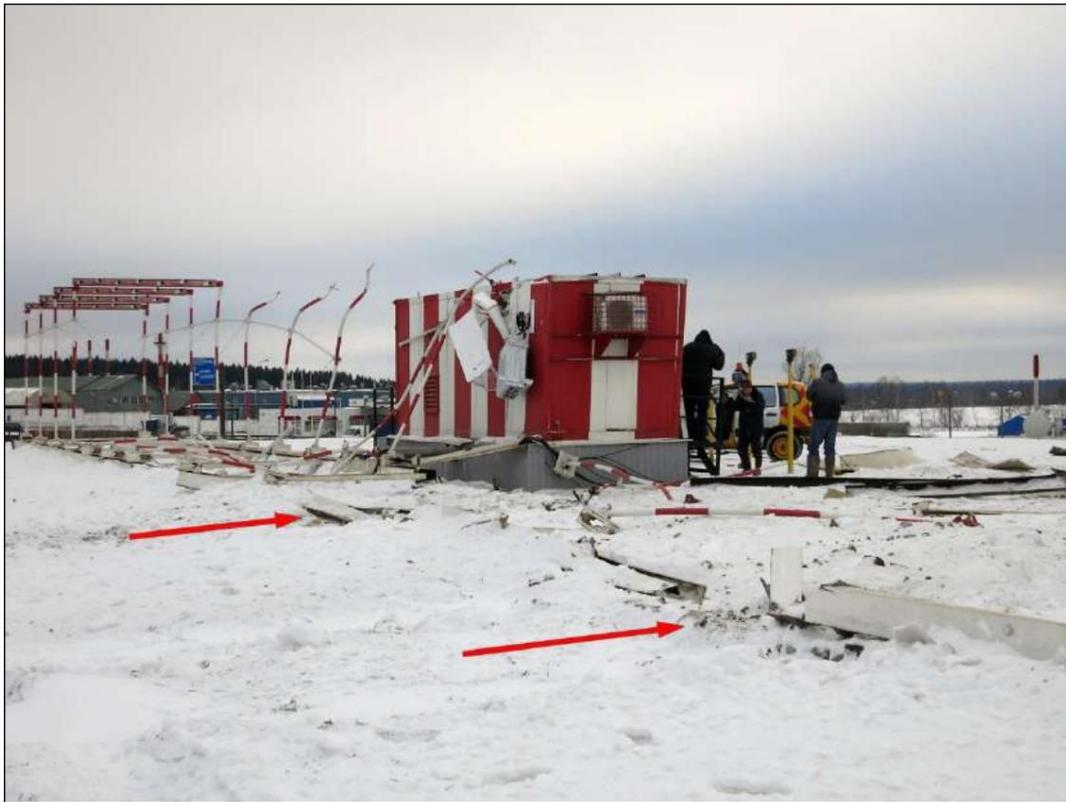
Fig. 5. The location of the aircraft collision with the airfield control center antennas. The arrows indicate places of collision of the wheels of the main landing gear with a concrete parapet (about 25 cm) and the base of the CRM antennas. Damage to the CRM hardware as a result of the impact the left wing of the aircraft.

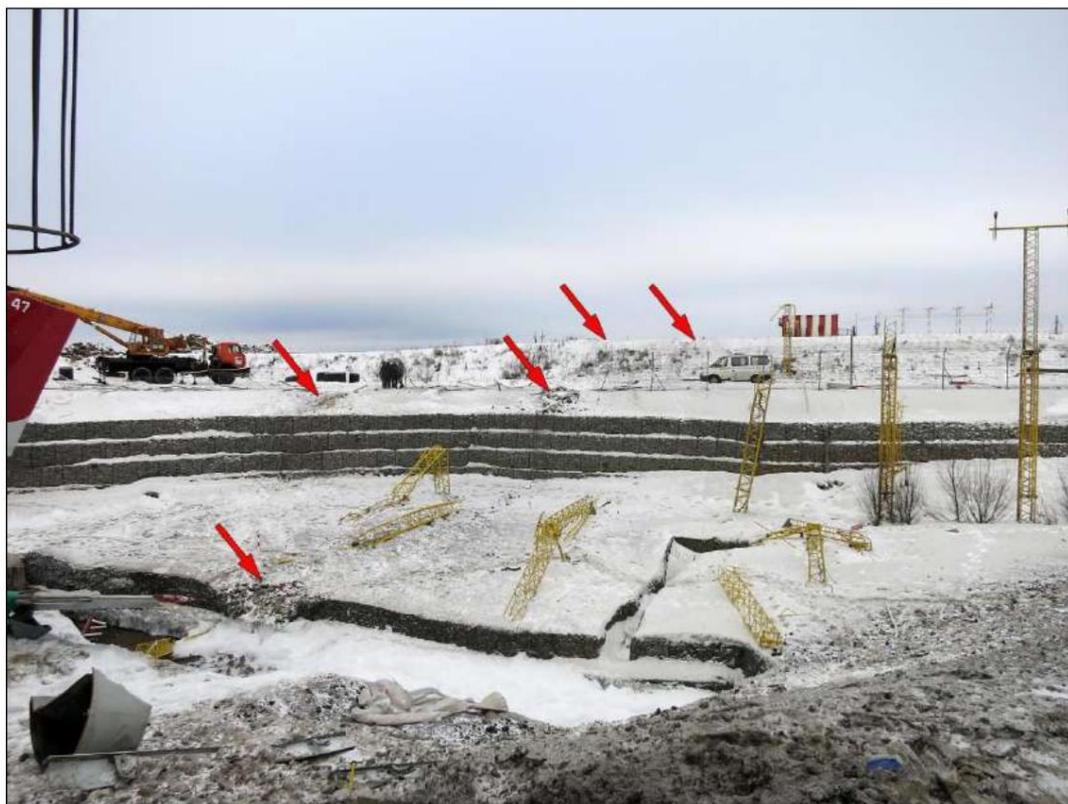
Fig. 6. Traces of the main landing gear touching the ground (marked with arrows). Damaged and fallen masts of lighting equipment.

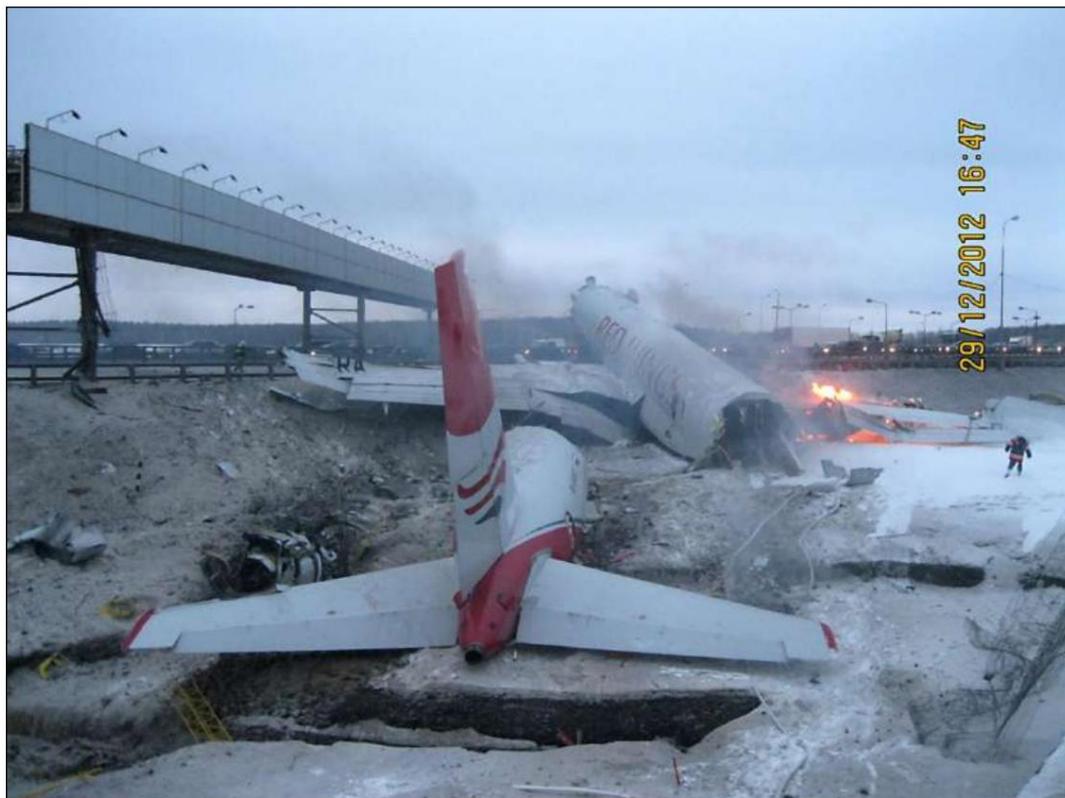
The appearance of the aircraft after the stop is shown in Fig. 7. The aircraft is in normal (not inverted) position, the landing gear is broken. Crew cabin separated from the fuselage, located directly on the road surface of the highway, strongly damaged and deformed. The fuselage is also damaged, the fuselage fracture occurred in the tail section area. The left engine is torn off the pylon and is located near the tail parts of the fuselage. The wing has severe damage and destruction as a result collision with obstacles. The plane stopped at the point with coordinates: N 55°35.040' E 37°15'32.4'. The distance from the end of the concrete pavement of the runway-2 was 330 m, lateral deviation – about 20 m to the right of the extended axis of runway 2.

Fig. 7. Aircraft Tu-204-100B RA-64047 at the scene of the accident.

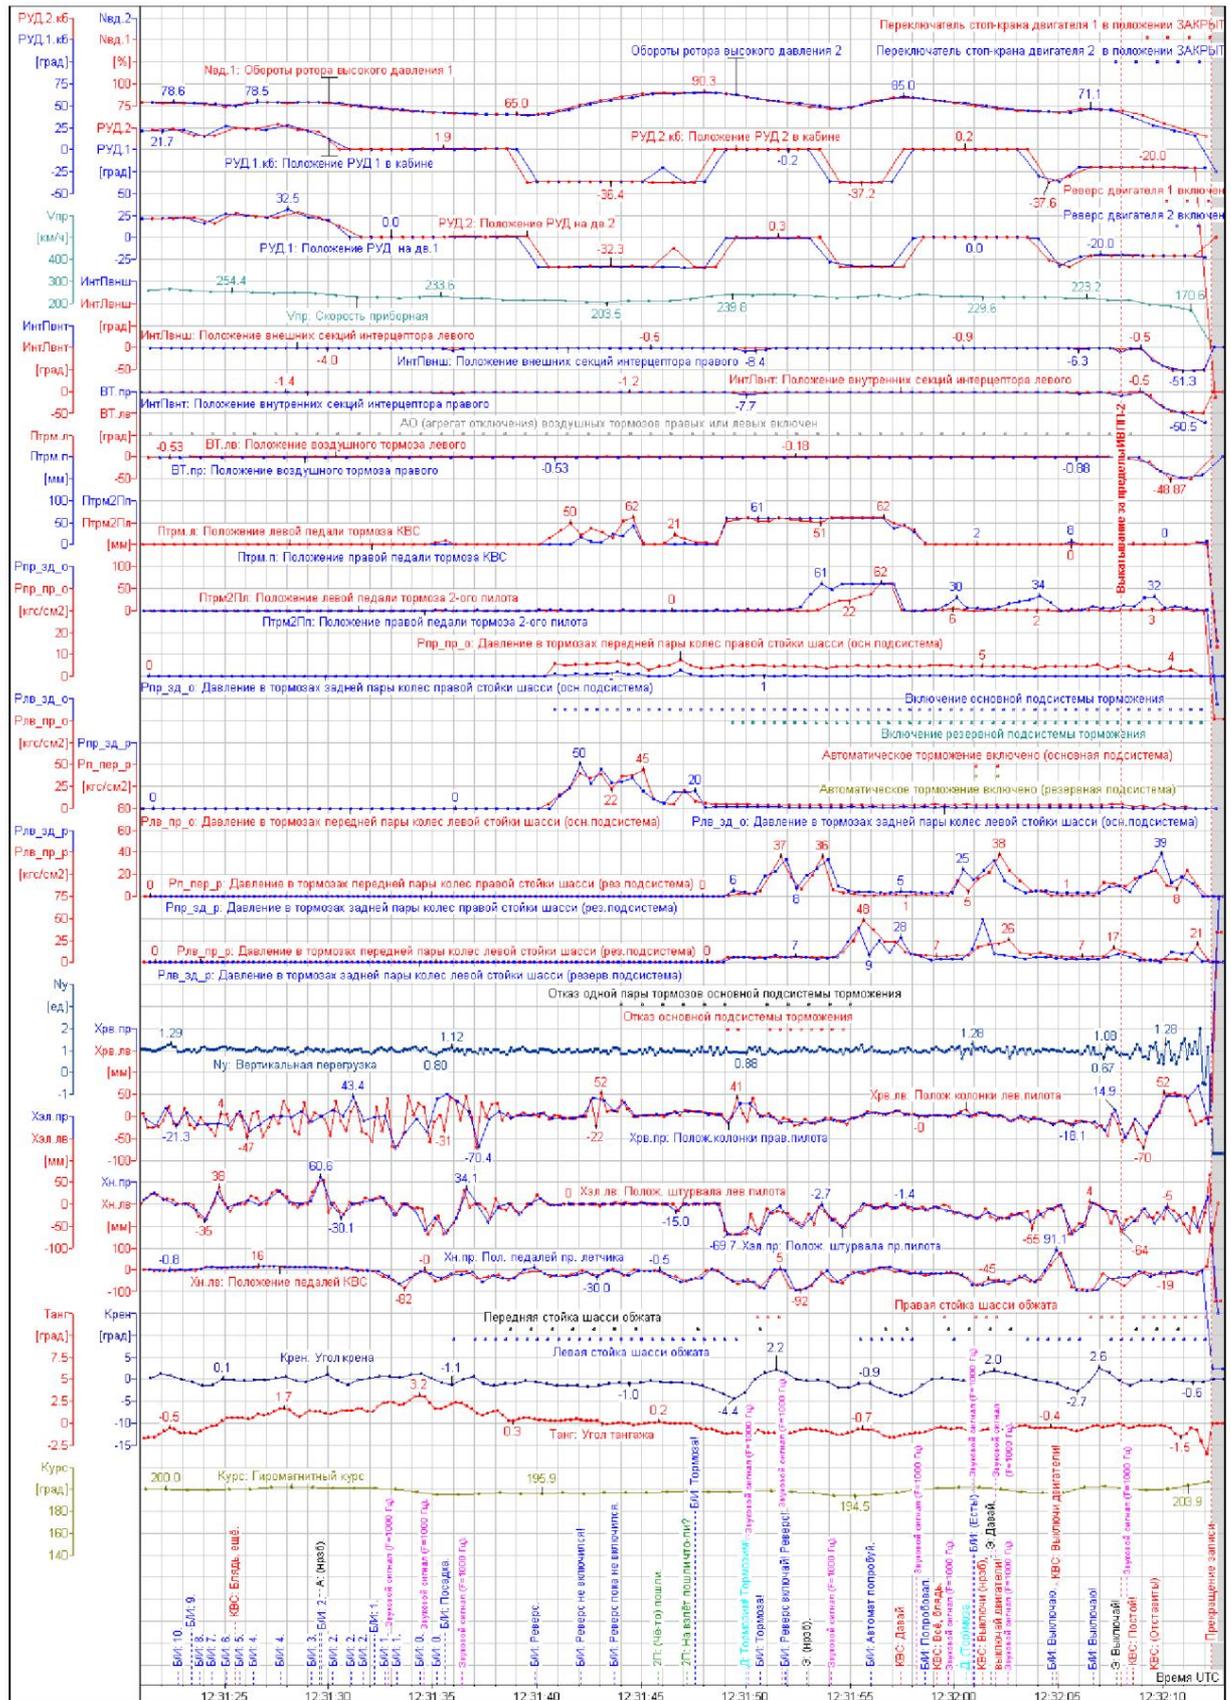
Fig. 12. Flight parameters of the Tu-204-100V RA-64047 aircraft on 12/29/2012 (run, landing in Vnukovo airport).

The plane landed at 12:31:36 at a speed of 230 km/h and a distance 950...1000 m from the input end of runway 19 to the left landing gear support (Fig. 12). Vertical The overload at the moment of landing was ~1.12 units. 3 seconds after landing The nose landing gear lowered. The right landing gear did not compress, the plane was moving with a left bank of -1...-1.5°. most likely due to a crosswind from the right.

After switching the RUR to the off position, at the time 12:31:49 Almost complete compression of the KVS brake pedals to 60 mm was recorded (Fig. 12) At this moment the aircraft was at a distance of approximately 1300 m from the exit end Runway 19 (Fig. 13), the pitch angle decreased to -1.1°, the bank angle, after decreasing to ~ -0.5°, increased to -4.4° (left bank). During the process of squeezing the brake pedals, the feed there was no pressure applied to the brakes of the main landing gear, and when the pedals were fully depressed The occurrence of a one-time command "Failure of the main braking subsystem" was registered and almost immediately - "Enabling the backup braking subsystem".

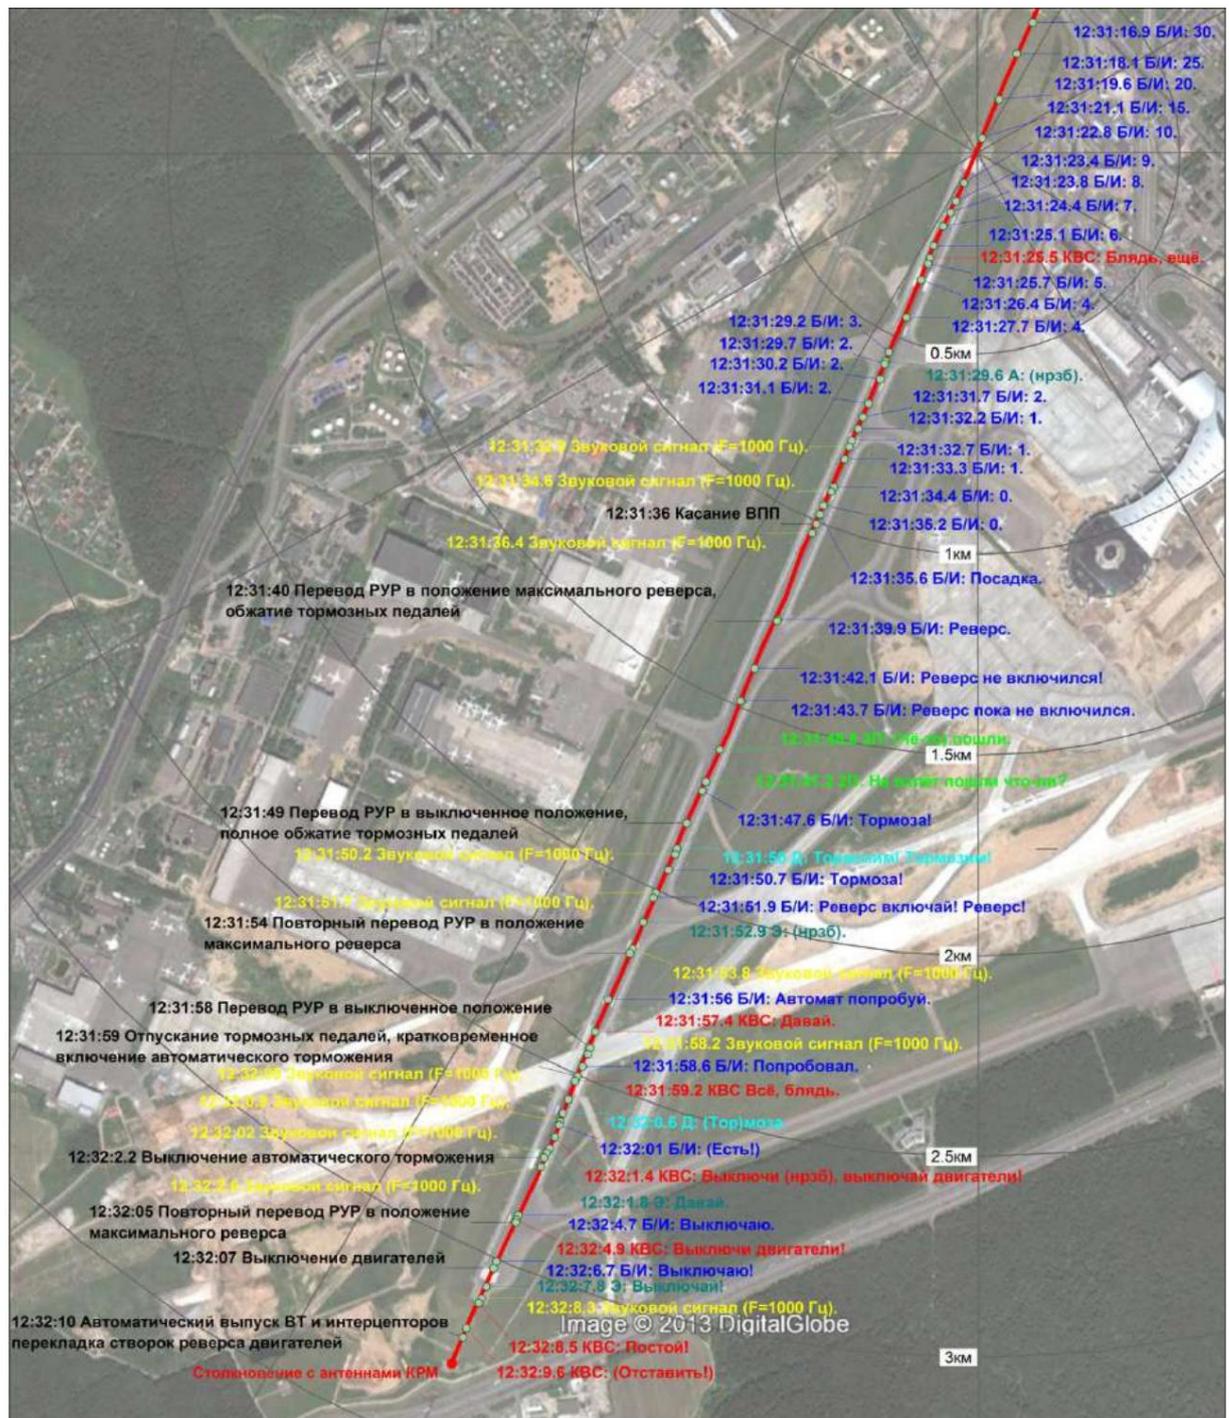
Fig. 13. Trajectory of the Tu-204-100B RA-64047 aircraft on runway 19 at Vnukovo Airport 29.12.2012.

As a result of the engines operating on direct thrust, by the time the RUR is transferred to off position, the airspeed increased to 240 km/h. Up to this point the plane was moving along the runway on the left and front landing gear. Increase in instrument speed, as well as the control actions of the crew to maintain direction movements, led to additional "unloading" of the chassis supports. In the process of further movements with oscillations in the roll from -4.4° to $+2.5^{\circ}$ there was a compression of the left, then right landing gear, in some areas the aircraft was almost completely separated from

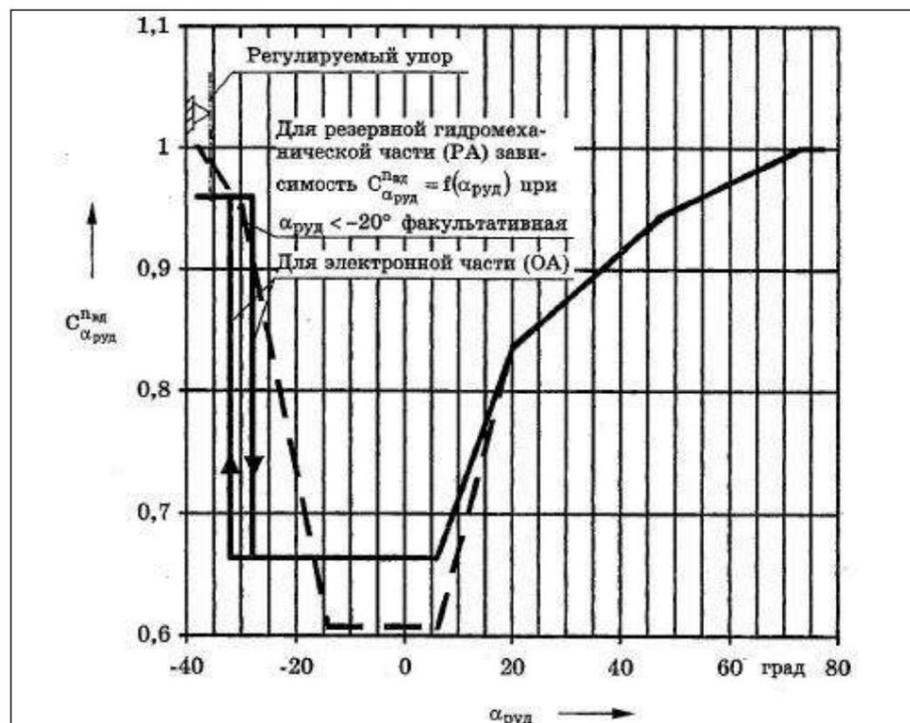
Fig. 17.

At the same time, in case of failure of the electronic control system and switching to the backup automatic change of engine operating mode when controlled from The RUR will occur proportionally to the deviation of the pointer on limb of the regulator pump, starting from the support platform (Fig. 17).

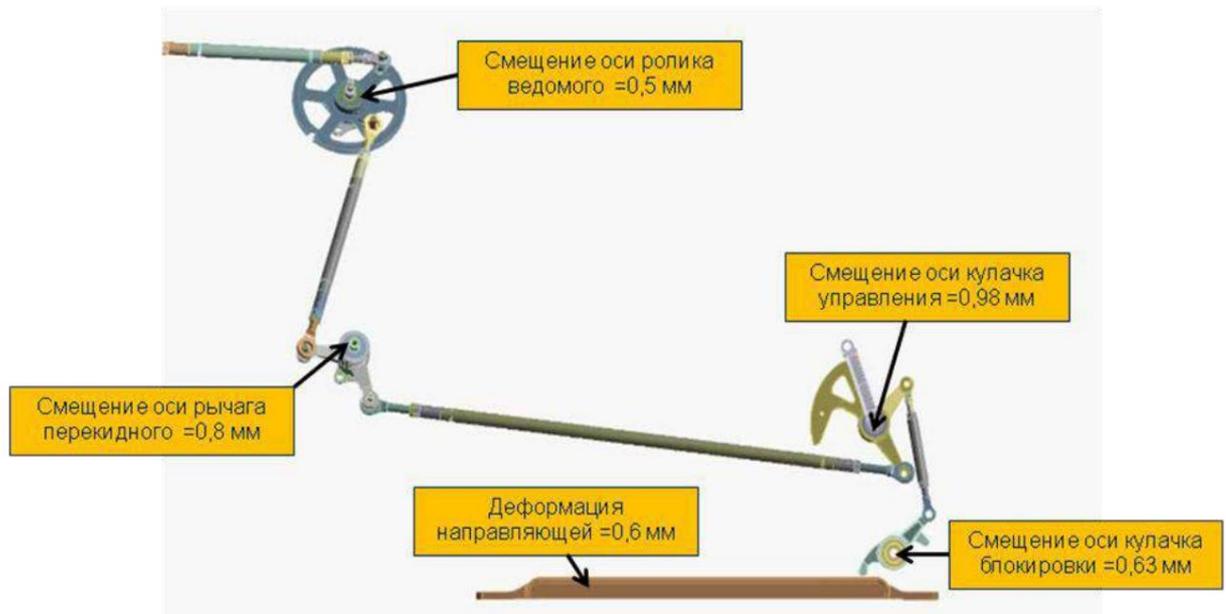
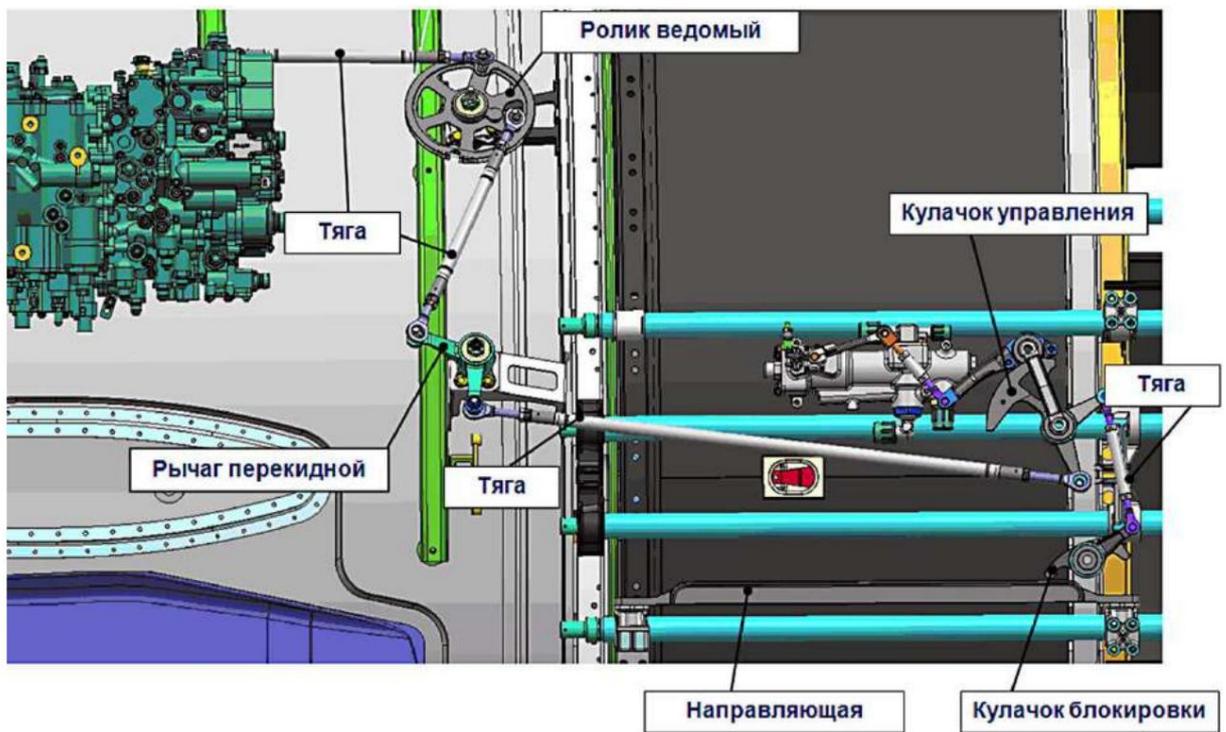
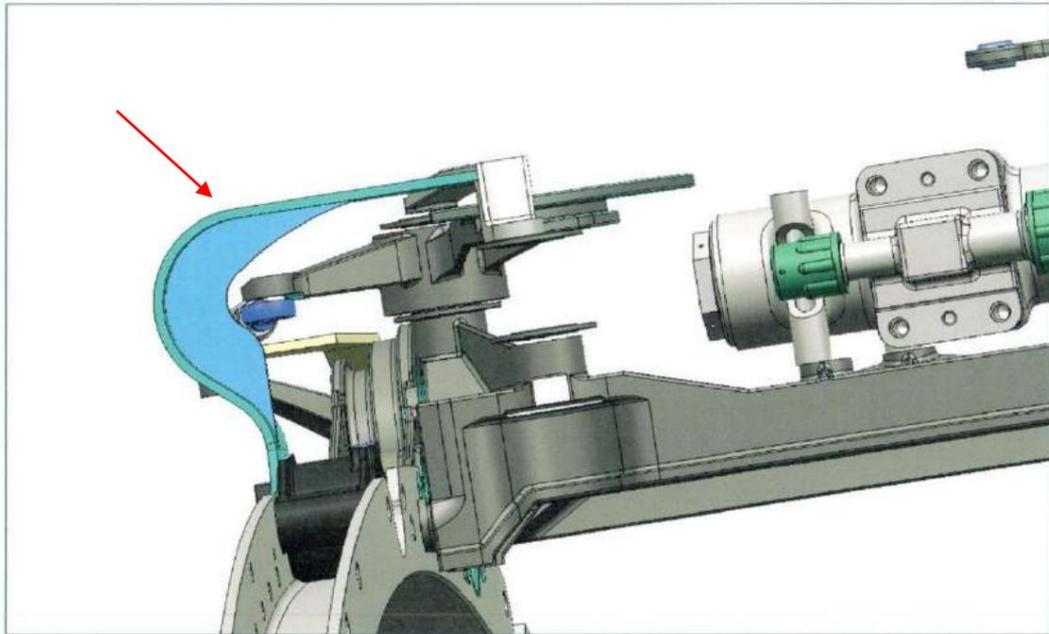
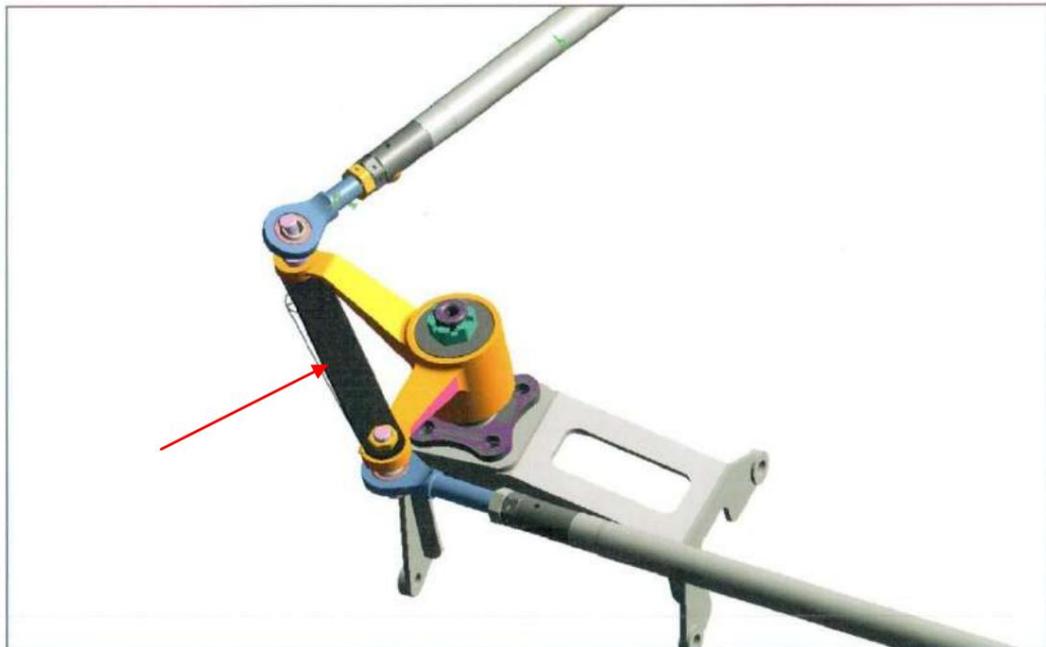
However, the work carried out by the Commission, as well as the analysis of the results of the work on engine adjustments carried out after the accident with the Tu-204-100V RA-64047 aircraft in within the framework of the implementation of airworthiness directives and ETU, showed that when applied to the reverse control lever has a force of about 15 kg, it is possible to shift the pointer to the limb of the pump-regulator (when the locking cam rests against the guide) up to values $\sim 10^\circ$ (the exact values depend on the state of the control wiring of each specific engine, with an increase in engine operating time after repair data values are likely to increase). The shift becomes possible due to deformations and displacements of a number of structural elements of the propulsion part of the system engine control, including control and locking mechanism elements (Fig. 18 and Fig. 19). It should be noted that, according to the engine manual, the total wiring play control from the drive roller to the control cam should not exceed 0.7 mm, in this case, the total play of the rest of the MUB, including the locking cam and guide, not standardized. After the accident with the Tu-204-100V aircraft RA-64047 the rigidity of the structure was increased by installing a number of additional elements (Fig. 20 and Fig. 21, additional elements are shown with red arrows).

Additional movement of the pointer on the dial of the pump regulator is possible also if there is a gap between the locking cam and the guide when in position RUR on the intermediate stop. In addition to the rigidity characteristics of the control cable a specific engine, the amount of force that must be applied to the RUR for them movement until the engine thrust increases with the doors not repositioned reverse, depends significantly on the amount of adjustment of the gap between the cam locking and guide. The larger this gap, the easier it is for the pilot to apply
