NATIONAL TRANSPORTATION SAFETY BOARD

AIRCRAFT ACCIDENT REPORT

**AIR CANADA FLIGHT 797
McDONNELL DOUGLAS DC-9-32, C-FTLL
GREATER CINCINNATI
INTERNATIONAL AIRPORT
COVINGTON, KENTUCKY
JUNE 2, 1983**

**NTSB/AAR-86/02
(SUPERSEDES - - NTSB/AAR-84/09)**

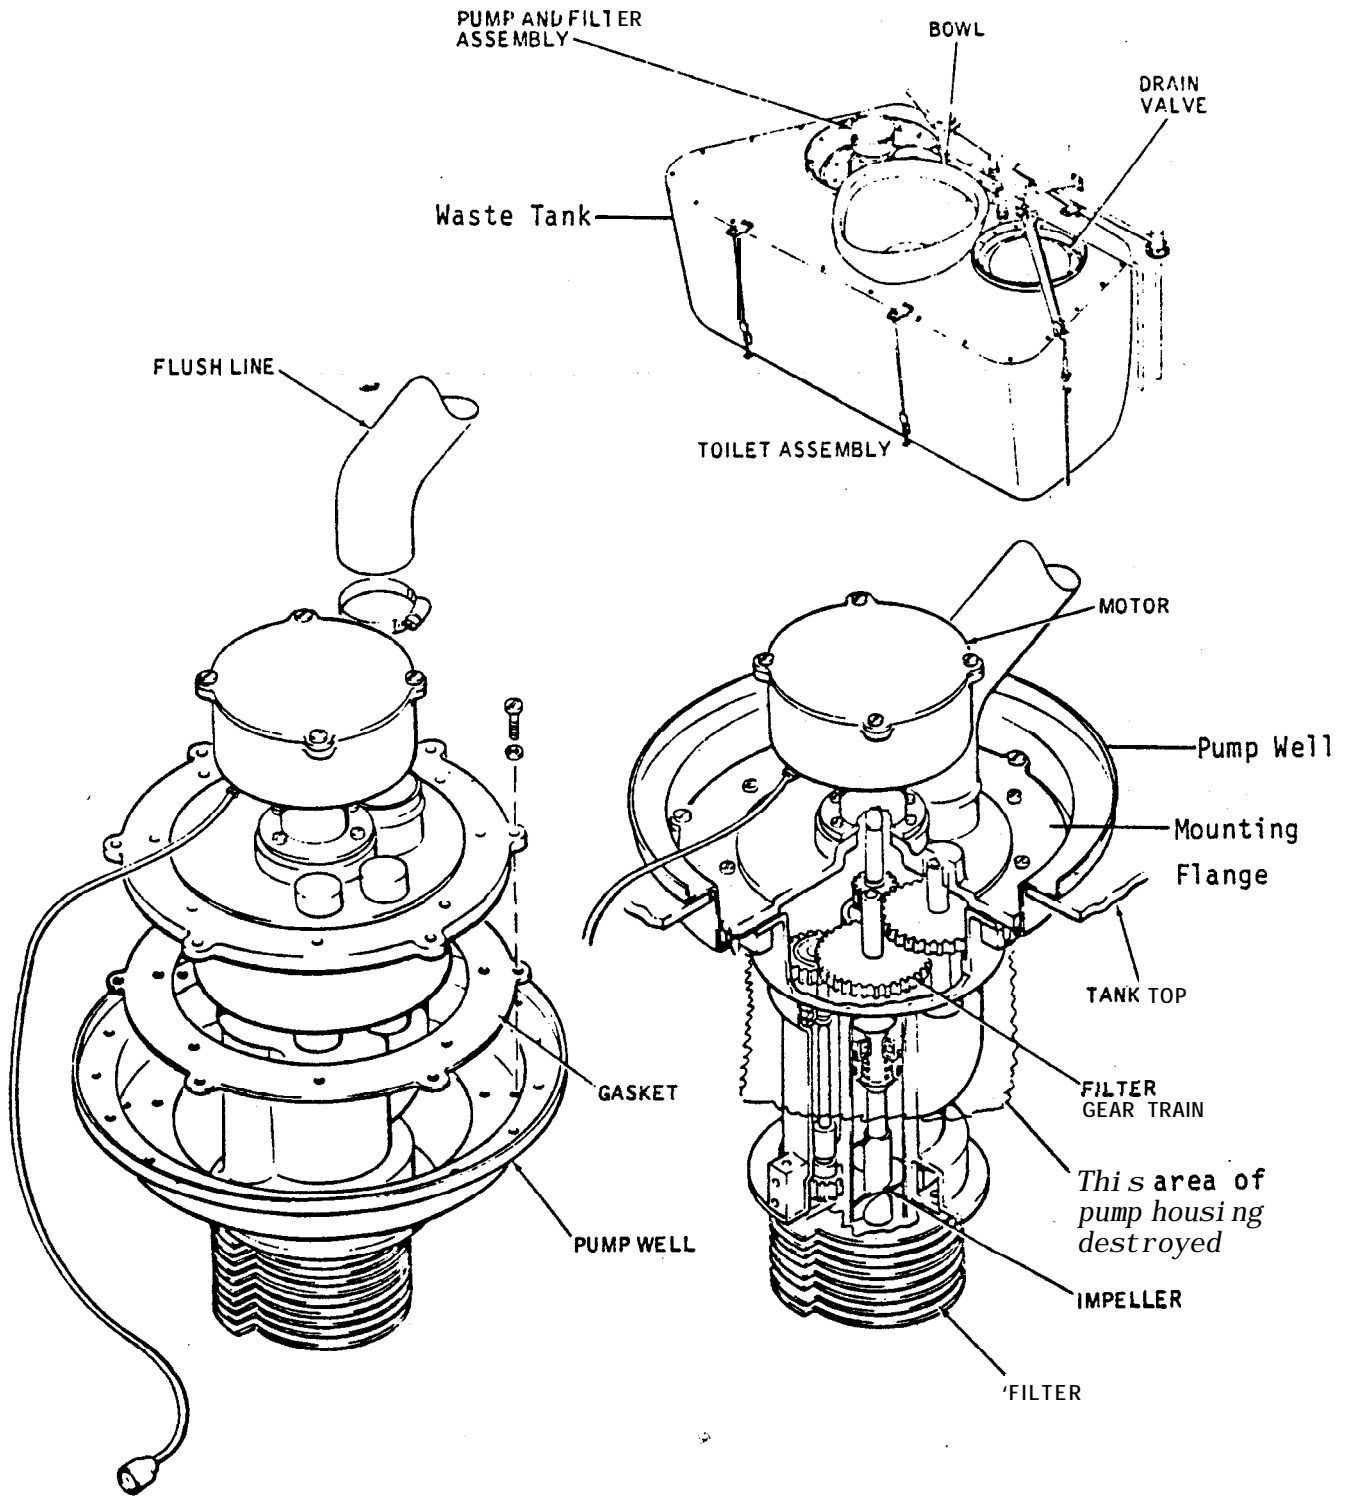
Figure 11.—Lavatory pump and filter system.

The flush motor was found attached to its mounting flange which was attached to the pump well. The flush motor assembly was found in approximately its normal position in the waste tank next to, but detached from, the flush pump and filter assembly. The motor housing was completely melted. Large concentrations of molten metal were found on the forward side of the mounting flange facing the toilet bowl, and on the aft side where the **3-phase** electrical leads enter the motor housing. A portion of the wiring harness which supplies **a.c.** power to the flush timer, flush motor, and flush button was encased in the molten metal on the aft side of the motor. The rotor section of the flush motor was encased in molten metal above the field windings; however, the rotor did not appear to have been damaged extensively by heat. (See figure 11.)

The flush pump and filter assembly found in the waste tank was partially intact. The filter and pump mechanisms, which apparently had been located below the water line in the waste tank, were in good condition. Above the water line, the plastic housing for the pump and filter was melted away. This housing also encloses the filter gear train and is part of the assembly used to mount the pump and filter to the pump well. The exposed shaft and gears showed heat damage. The gears, which make up the filter gear train that connects the motor to the pump and filter, were found lying in the waste tank. The plastic mounting ring, which mates the pump and filter housing to the pump well, was found intact among the debris in the waste tank. There was some slight melting of the top surface of the mounting ring. All of the components of the flush motor and pump assembly were removed for further examination.
