MINISTRY OF JUSTICE OF THE REPUBLIC OF LITHUANIA  
TRANSPORT ACCIDENT AND INCIDENT INVESTIGATION DIVISION

Accident to cargo aircraft  
Boeing 737-400SF, registered EC-MFE,  
operated by Swiftair,  
that occurred on 25 November 2024  
near Vilnius International Airport,  
in Vilnius, the Republic of Lithuania

## **INTERIM REPORT**

No. (A-24/23) 1A-242  
20 December 2024

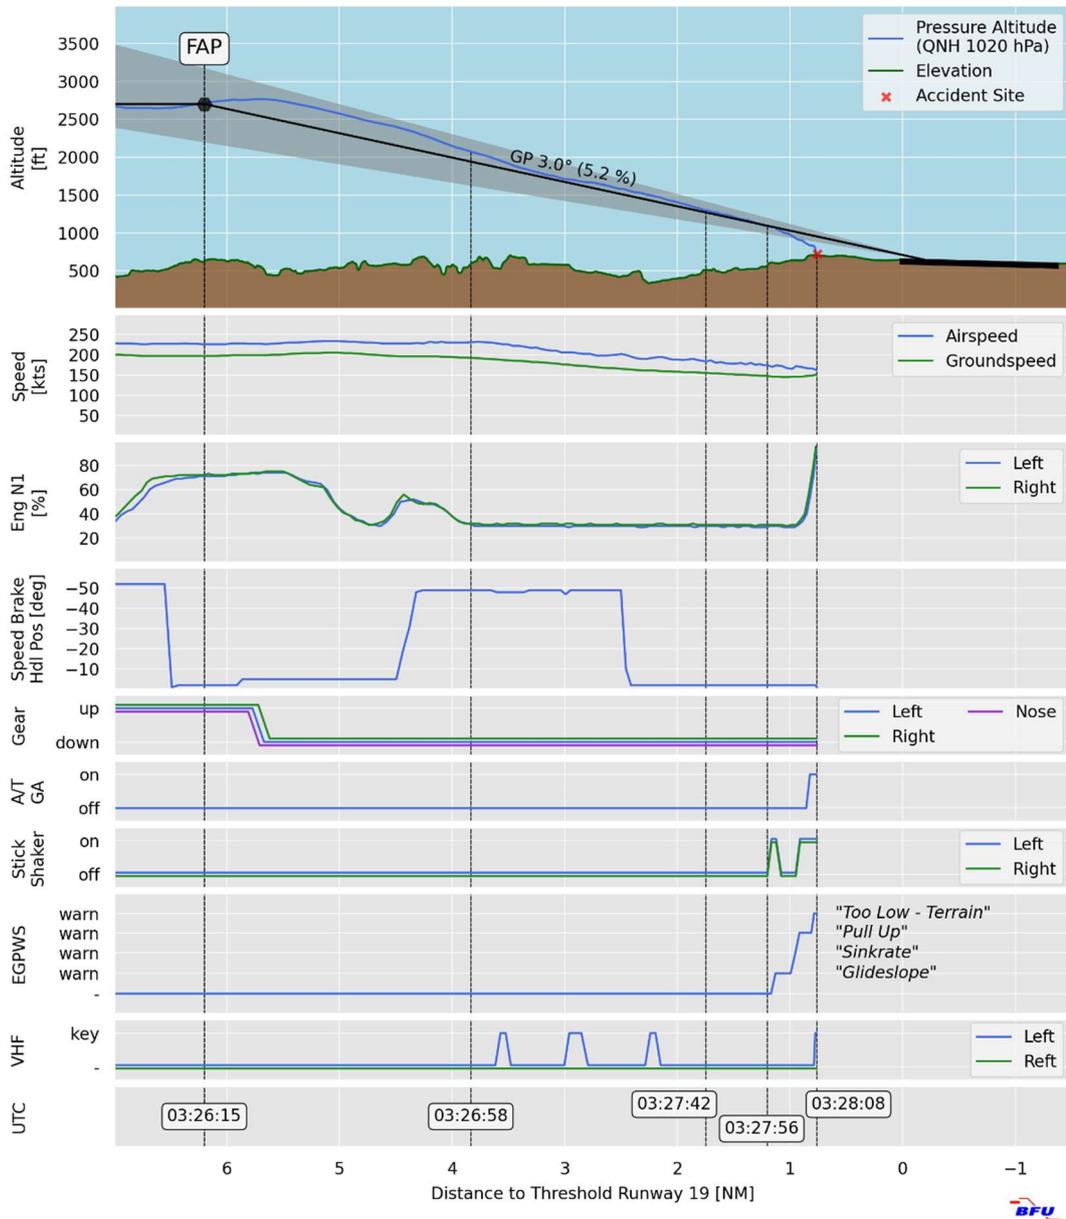
Figure 2. FDR overview plot of the final approach phase of the flight

At 03:26:15 hrs the aircraft reached the final approach phase (Figure 2). At the same time the co-pilot asked the captain for gear down and flaps 15. The captain stated that there were still very fast and that the co-pilot has to reduce speed first.

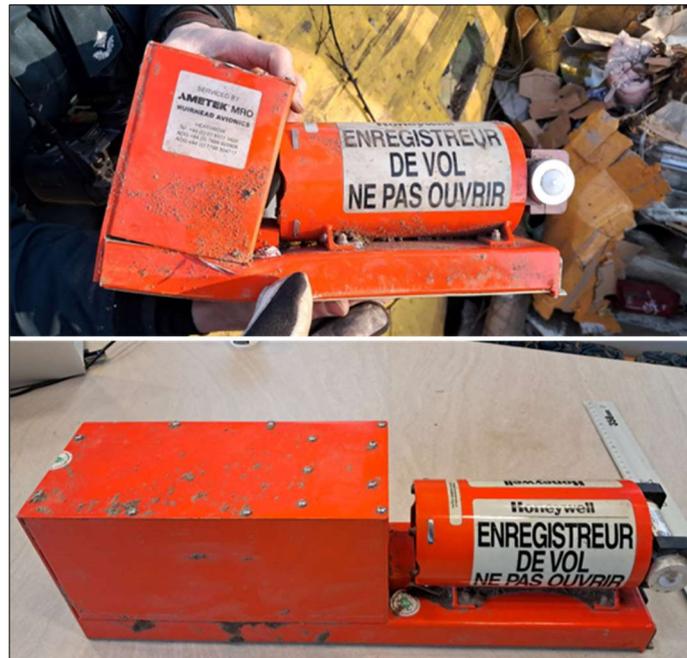
Figure 7. Recorders after recovery from the accident site, CVR shown at the top and FDR shown at the bottom (source and copyright TAIID).

The recorders (Figure 7) were found at the accident site at the expected positions within the airframe (see chapter 1.12.1 for details).

The recorders were sealed and transported to the German Federal Bureau of Aircraft Accident Investigation (BFU) flight recorders laboratory in Brunswick, Germany for inspection, repair, download and further analysis. The damaged chassis of both recorders were removed from the CSMU and the connectors to the memory boards were checked visually and electrically. No damages were found, and all electrical tests met the target values.

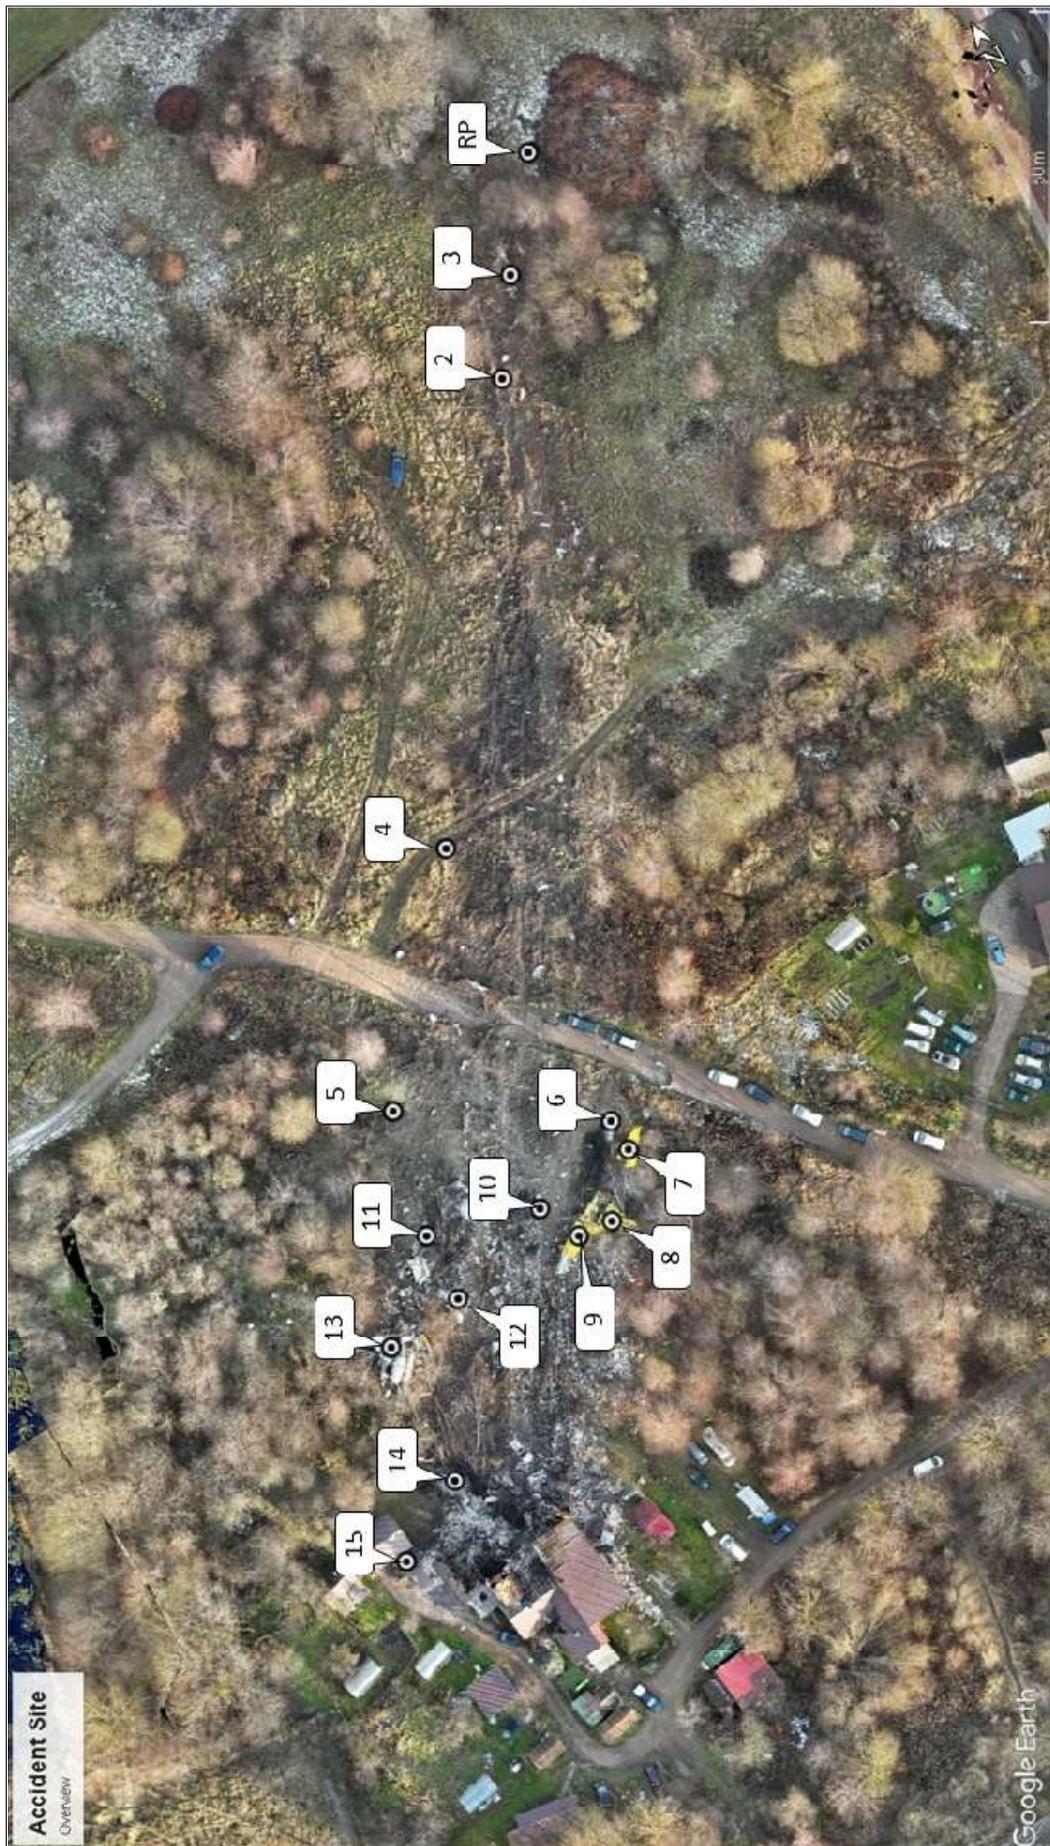
Figure 8. Accident site overview (source BFU/TAIID)

When approaching the accident site from the northeast, the first impact mark on the top of a tree was found at 54°39'28.19"N 025°18'7.81"E (used as reference point - RP, Figure 8). The RP was 1575 m from the threshold of Runway 19 of Vilnius Airport. The bearing from the RP to the threshold was 201.5°.

From the RP, the accident site extended in the direction of 210° for about 235 m to the southernmost aircraft part, which was the LH Engine (point 15, Figure 8). A house was located next to the LH Engine. This house was severely damaged from both the impact and subsequent fire. The fragments of the aircraft and cargo were spread over a corridor with a width of approximately 50 m.

The first impact mark on the ground was found at 54°39'27.86"N 025°18'7.31"E (point 2, Figure 8). It had a length of approximately 45 m and was oriented at approximately 200°. Within this mark, the first identifiable fragments from the aircraft structure were found (RH wingtip and RH horizontal stabilizer tip and one flap actuator).

A part representing approximately two-thirds of the RH Engine inlet cowling (point 4, Figure 8) was found 112 m, 218° from the RP. The RH Engine (point 5, Figure 8) was found separated from the Pylon at the northern section of the accident site without its cowling 155 m, 219° from the RP.

The LH tip of the Horizontal Stabilizer (point 6, Figure 8) was found 156 m, 206° from the RP. The Vertical Fin with the Rudder attached (point 7, Figure 8) was found next to the Horizontal Stabilizer.

The aft part of the fuselage (point 8, Figure 8) from the very end to STA 900 including door 2L was found 172 m, 207° from the RP. A large section of the crown area (9 x 3 m) forward of STA 900 was found next to it.

The FDR (point 8, Figure 8) was found within the aft fuselage section, still installed in its rack. The CVR (point 9, Figure 8) was found in the adjacent part of crown area, still installed in its rack. The rack and chassis of the CVR were bent, while the FDR showed no obvious damage.

The RH Main Landing Gear (point 10, Figure 8) was found 168 m, 210° from the RP.

Door 2R (point 11, Figure 8) was found 175 m, 216° from the RP.

A large (5 x 2 m) fragment from the RH skin of the fuselage including the two RH overwing emergency exit frames (point 12, Figure 8) and adjacent crown area was found 184 m, 215° from the RP.

The front of the fuselage (point 13, Figure 8) was found 194 m, 217° from the RP resting on its left side. This included the Flight Deck, E&E Bay, and Nose Landing Gear from the forward pressure bulkhead to approximately STA 360. The section of fuselage containing the Main Cargo Door and terminating just forward of the Wing Box was lying next to the Flight Deck.

The LH Wing Root (point 14, Figure 8) including the center Wing Box were found 214 m, 214° from the RP. The LH Main Landing Gear was found within this section. Additionally, out-board portions of the LH Wing were buried beneath rubble from northern wall of the house.

The LH Engine (point 15, Figure 8) was found with its Pylon still attached 226 m, 216° from the RP at the southern end of the accident site leaning against the garage with an attached carport. Metal columns supporting the roof of the carport remained undisturbed.

More than one third of the residential buildings were damaged by impact of wreckage parts and fire (Figure 8).

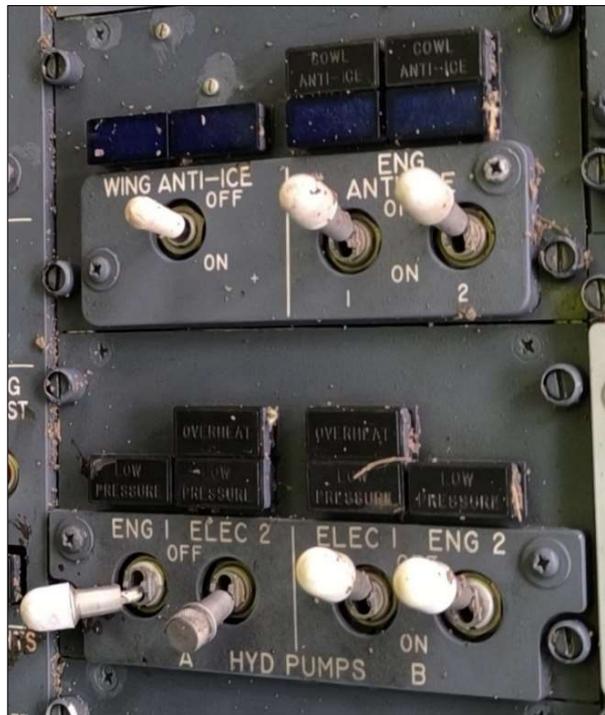
Figure 9. Position of the hydraulic pump select and anti-ice switches on the P5 (source TAIID).

Both the gated switches for the Engine-Driven and Electric Motor-Driven Hydraulic Pumps for System B on the overhead Panel P5 were found OFF; however, the switches for System A were ON (Figure 9). The switch for the Engine-Driven Hydraulic Pump for System A was deformed to the left.

The Wing Anti-Icing Switch and both Engine Anti-Icing Switches were found in the OFF position (Figure 9).

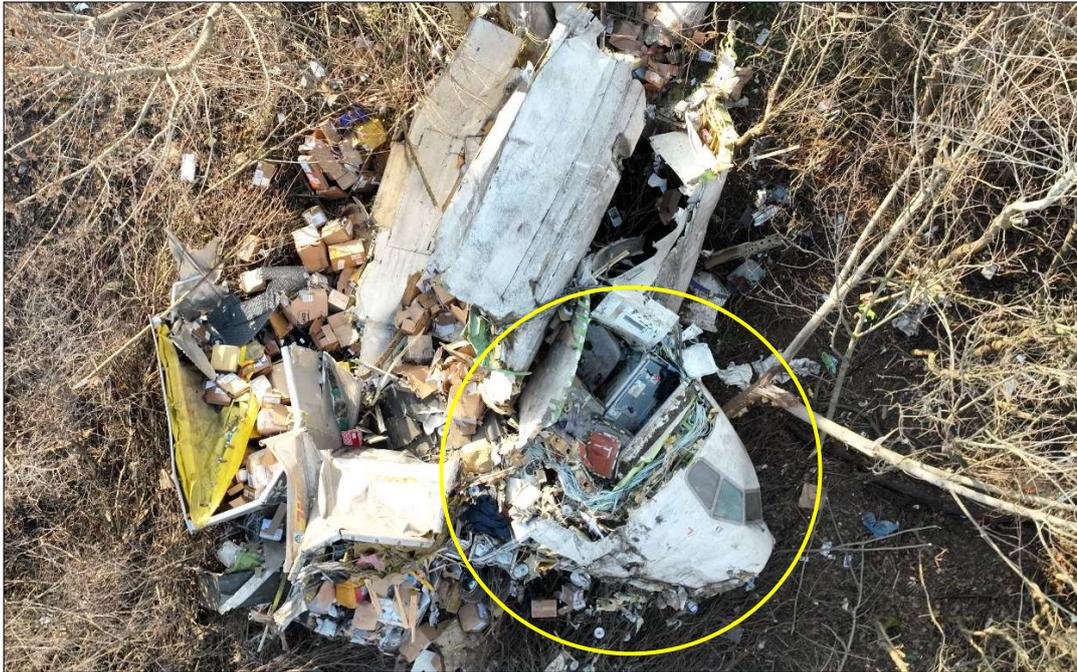
Figure 10. Aerial view of the front part of the fuselage including flight deck (source TAID)

The forward fuselage including the flight deck and the area behind flight deck and lavatory was damaged but did not show evidence of fire (Figure 10).

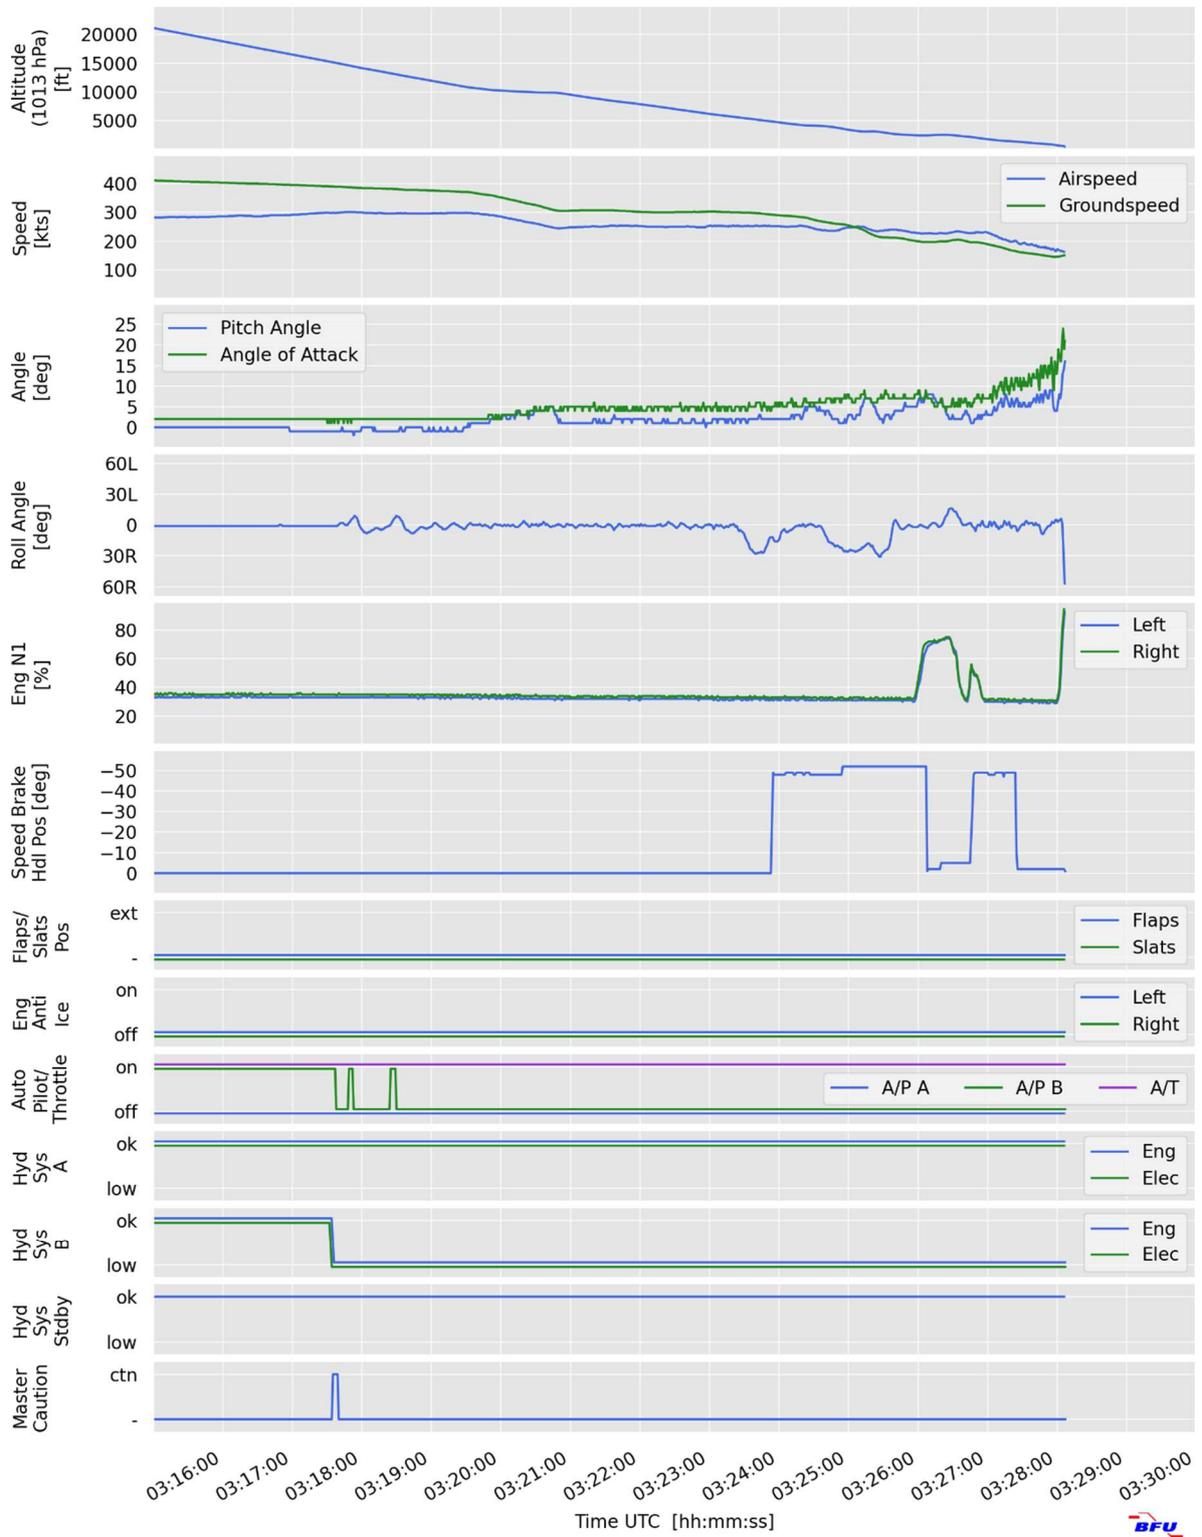
#### FDR overview plot of the last minutes of the flight

At 03:24:29 hrs the captain stated for flaps 5. The CVR recorder an audible several clicks, which were most likely coming from a flap handle movement. FDR data show that the actual flap position remained at flaps zero (flaps up) (Appendix B).
