AIRCRAFT ACCIDENT REPORT

AMERICAN AIRLINES, INC.
McDONNELL DOUGLAS DC-10-10, N103AA

NEAR WINDSOR, ONTARIO, CANADA

JUNE 12, 1972

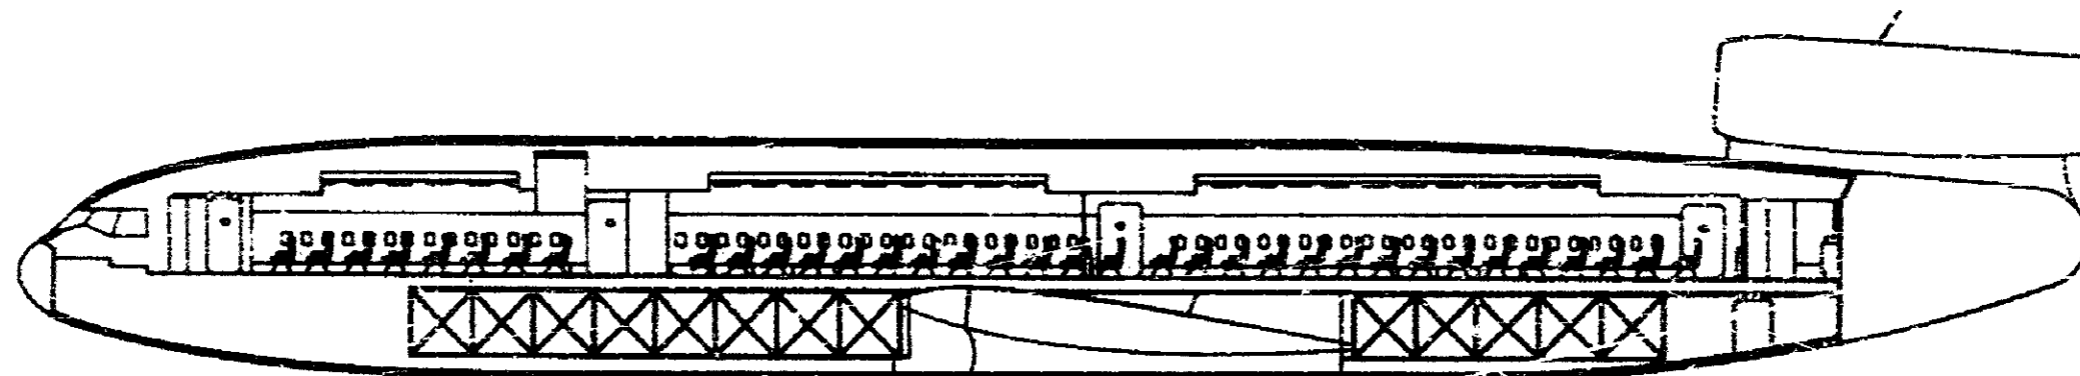
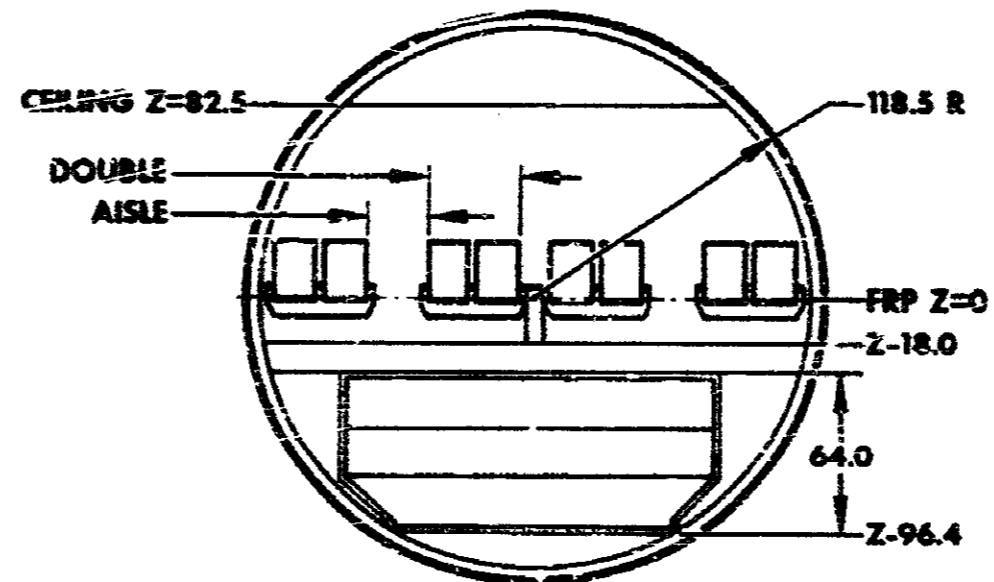
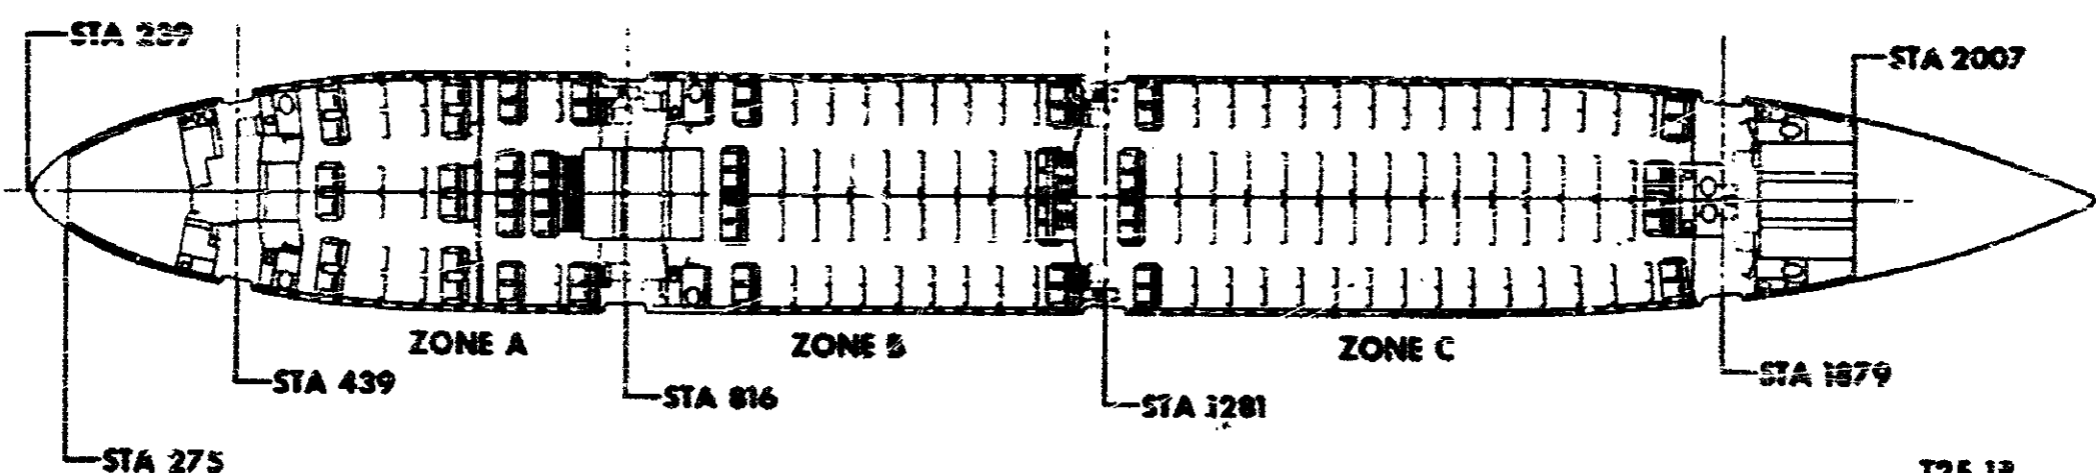
FLOOR PLAN

The cabin floor in the aft lounge area sustained major damage. The first nine transverse floor beams in the lounge area were fractured approximately 6 inches from the vertical struts near the left side of the compartment. These beams also failed in bending near the right side of the airplane, and allowed the floor to settle partially into the cargo compartment. There were no seats attached to this floor section; however, a

The loss of the aft cargo compartment door resulted in a rapid loss of pressurization in that compartment. This particular cargo compartment was not equipped with pressure relief vents to the passenger cabin above it, as were other cargo compartments on the airplane. Thus, the loss of the door caused the full differential pressure between the pressurized passenger cabin and the atmosphere to be exerted on the cabin floor over the compartment. This loading failed the floor support structure, and the cabin floor collapsed downward into the cargo compartment.

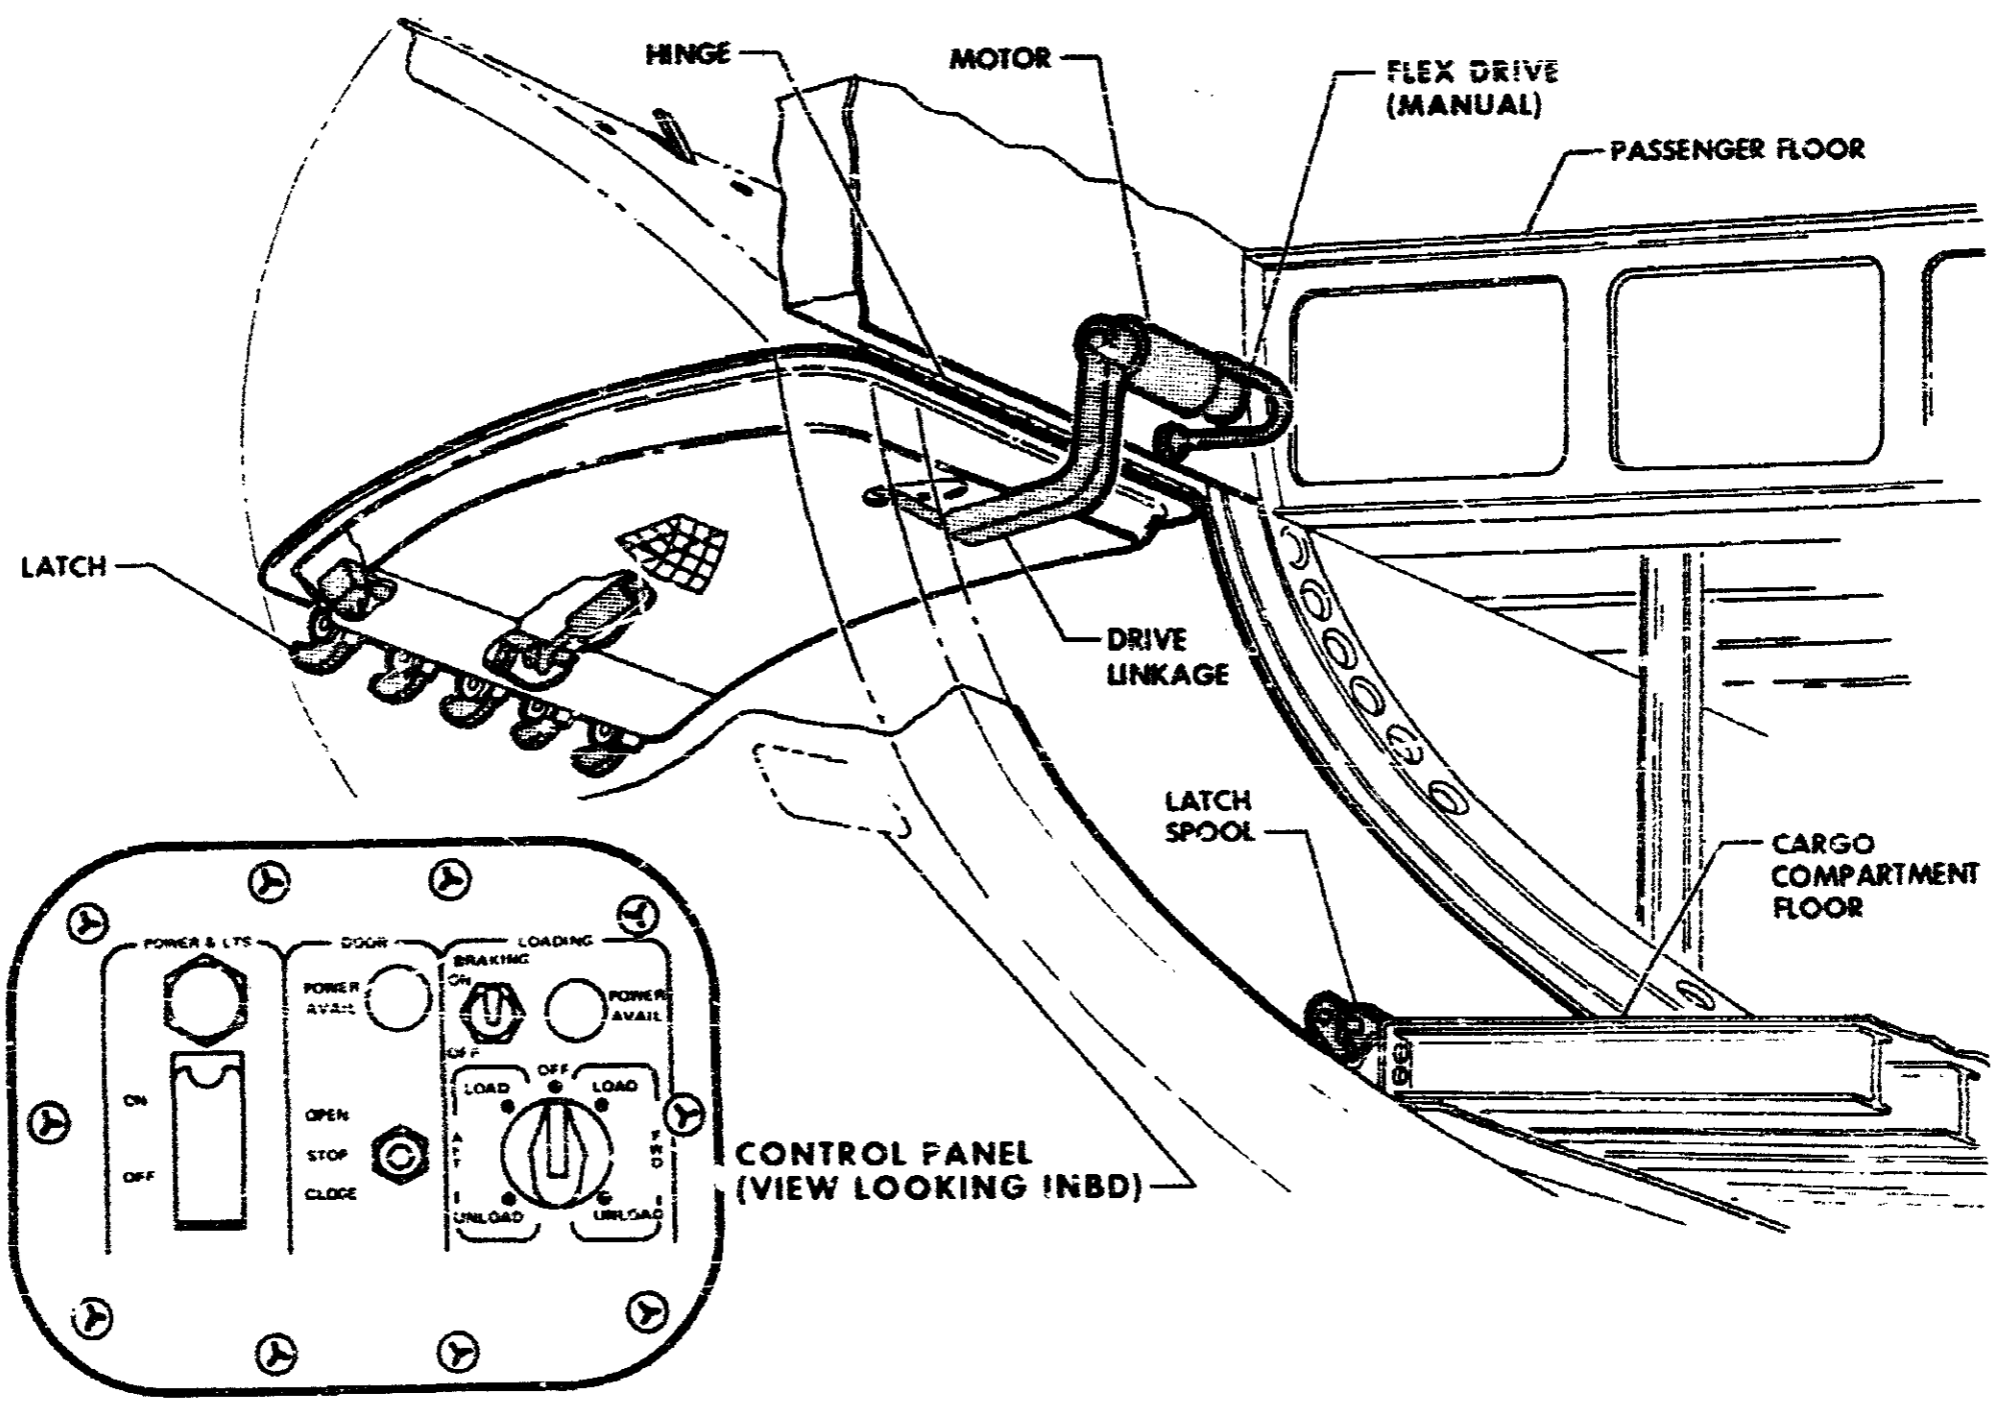
CARGO DOOR
36

The door was found with the four latches nearly closed, with the lockpins not engaged, with the vent door overtraveled beyond the open position and with the door handle in the stowed position. The latches, which were filled with

Structural damage to the door verified that the latches were not overcenter when the door opened in flight. The two fasteners which attached the door latch actuator to the door had both failed in shear. Part of one of the bolts was found in the piece of door skin which remained on the airplane—an indication that this failure occurred in the air, and not when the main portion of the door impacted the ground.

actuator linkages are not overcenter. Thus, the evidence indicates that the latch actuator did not extend far enough to drive the latches beyond the overcenter position, and that pressurization forces on the door were transmitted back through the latch linkage to the actuator support bracket. According to the manufacturer, the dimension between the latch crank and the overcenter stop should have been 0.47 inch for this particular actuator extension. With a 0.47 inch displacement, a 4.5 p.s.i. pressurization differential across the door would have been sufficient to fail the two fasteners which had an ultimate shear strength of 6,600 pounds. The manufacturer noted that the 4.5 p.s.i. figure was an approximation, since redundancy of the system, tolerances, deflections, and variances in rigging can all affect the load transmitted through the mechanism.

the latches, which eventually caused failure of the fasteners which secured the actuator support bracket to the door structure. The latches were then sprung open, which permitted the door to blow open. The combination of airloads and impact of the door with the aircraft fuselage caused the door structure to fail, and most of the door separated from the airplane.
