**AIRCRAFT ACCIDENT REPORT. TRANS WORLD
AIRLINES, INC. B707, N742TW, THE GREATER
CINCINNATI AIRPORT, ERLANGER, KENTUCKY
NOVEMBER 6, 1967**

**NATIONAL TRANSPORTATION SAFETY BOARD,
WASHINGTON, D. C.**

**Doc
NTSB
AAR
68
AK**

AIRCRAFT ACCIDENT REPORT

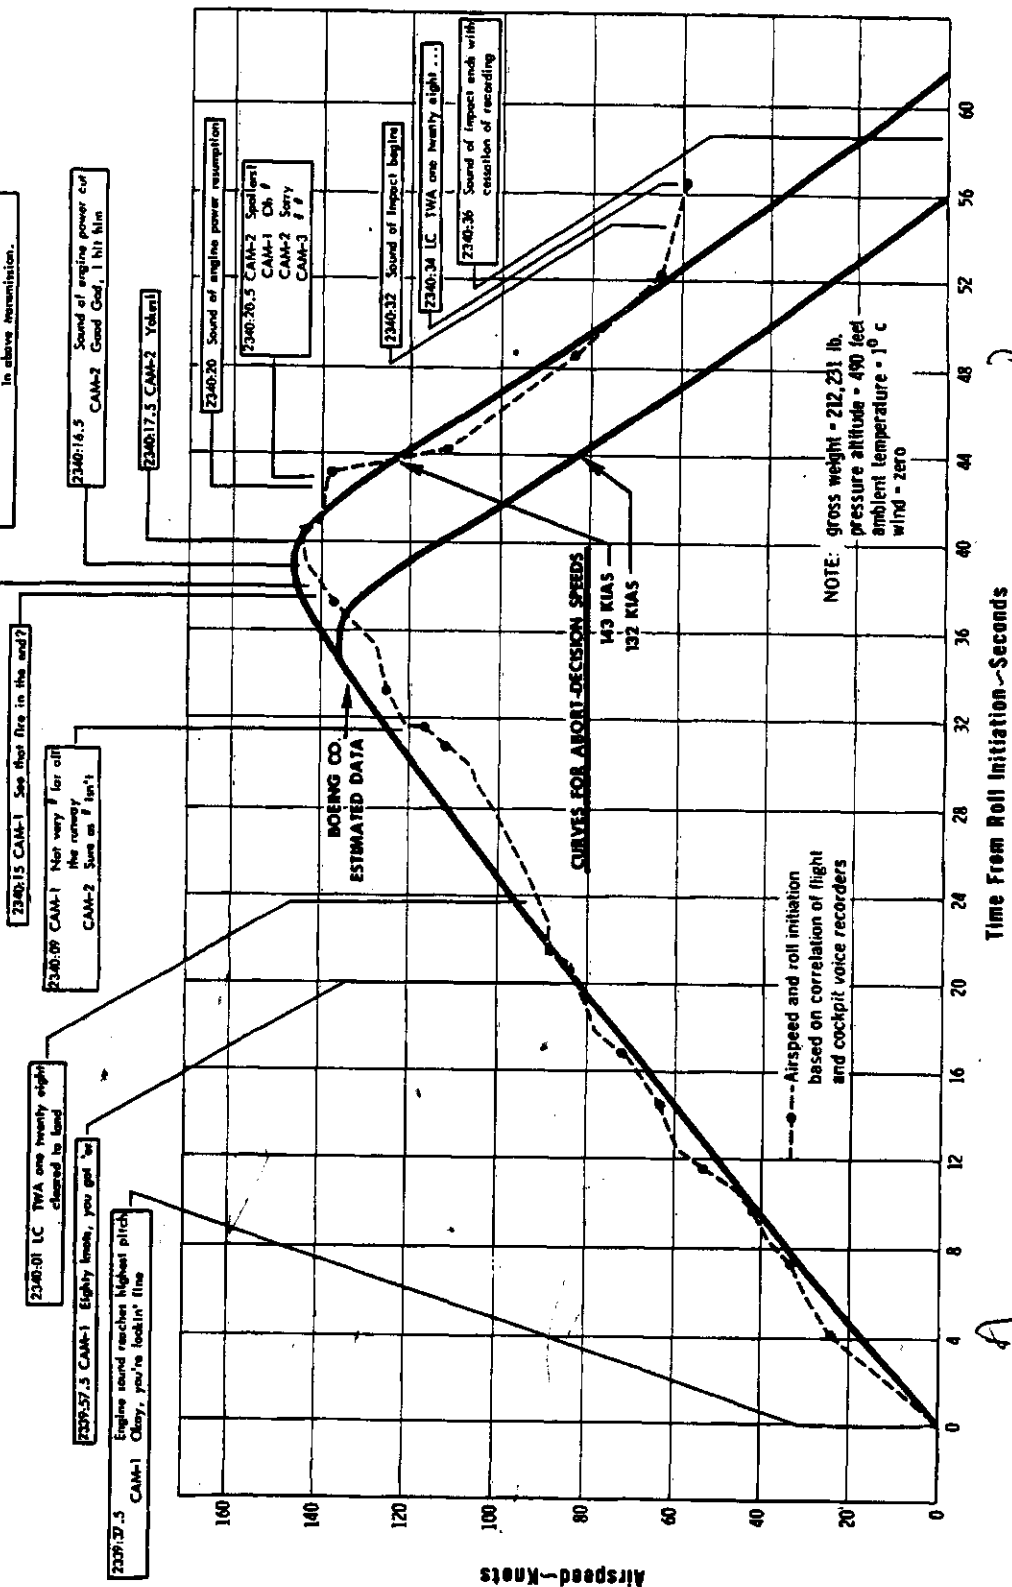
TRANS WORLD AIRLINES INC.
B-707 N742TW
THE GREATER CINCINNATI AIRPORT
ERLANGER, KENTUCKY
NOVEMBER 6, 1967
Velocity vs Distance

The CVR-flight recorder airspeed curve was then compared with a predicted performance curve provided by Boeing. (See Attachments 1 and 2). This comparison, utilizing the takeoff clearance as a time reference, revealed an apparent disparity between the predicted and recorded performance of the aircraft in both the acceleration and deceleration phases of the takeoff. Further study of the evidence prompted selection of the engine noise reaching its highest peak as the time reference for the takeoff roll initiation point. This resulted in closer comparison of the two airspeed traces at the higher, more accurately recorded values, and still provided exceptional correlation with the physical evidence. In addition to the time base reference point, there were three other factors affecting the compatibility of the predicted and recorded performance. First, the airspeed values during deceleration are apparently depressed due to static

The final CVR-flight recorder correlation indicates that the first reference of the crew to the position of DAL 379 occurred at approximately 115 knots. At this point, TWA 159 had progressed about 3,350 feet along the runway in 31.5 seconds. Five seconds later, at 4,400 feet (200 feet prior to passing DAL 379), the flight reached V_1 . Acceleration continued as TWA 159 passed DAL 379 at approximately 135 knots, the sound of a "pop" was recorded at 139 knots, the sound of the engine power cut was at 143 knots, and finally the airspeed peaked at 145 knots. During this time interval, between 36.5 seconds and 40.5 seconds, the flight traveled approximately 950 feet to 5,350 feet from the takeoff roll initiation point. The airspeed then dropped in the next second to 140 knots. At 42.5 seconds the sound of engine power resumed, followed at 43 seconds by the command of the first officer for spoilers. At this point, the aircraft was approximately 5,900 feet down the runway and a marked increase in the deceleration began. The sound of impact began at 7,575 feet.
