*Accident  
which occurred  
on 30 January 2000  
in the sea near Abidjan Airport  
to the Airbus 310-304  
registered 5Y-BEN  
operated by Kenya Airways*

**REPORT**

**5y-n000130**

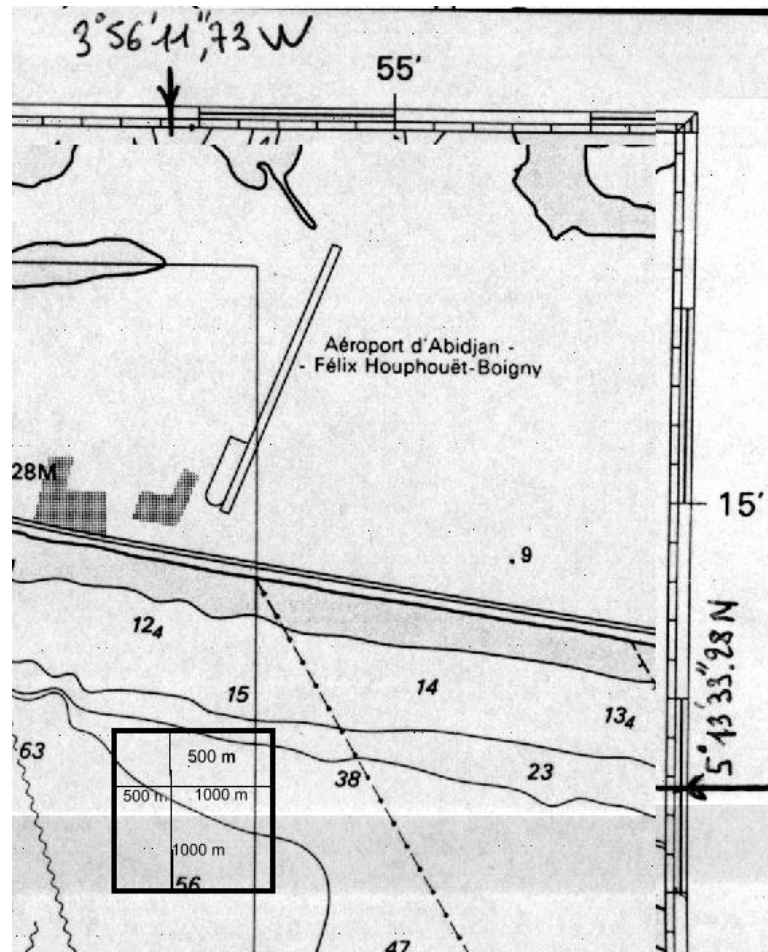
The impact occurred 1.5 NM from the Abidjan runway on the Atlantic Ocean. Debris from the wreckage was spread over an area 150 meters wide (east to west) by 450 meters long (north to south), at depths between 40 and 50 meters. The wreckage came to rest on the sandy seabed and was subject to a sea current from west to east.

The 1.5 square on the site plan above corresponds to the wreckage search area. The inner rectangle delineates the area where most of the debris was found.

The detail on the wreckage distribution map, within the rectangle, gives the dimensions of the debris as identified during the sonar location phase (appendix 8).

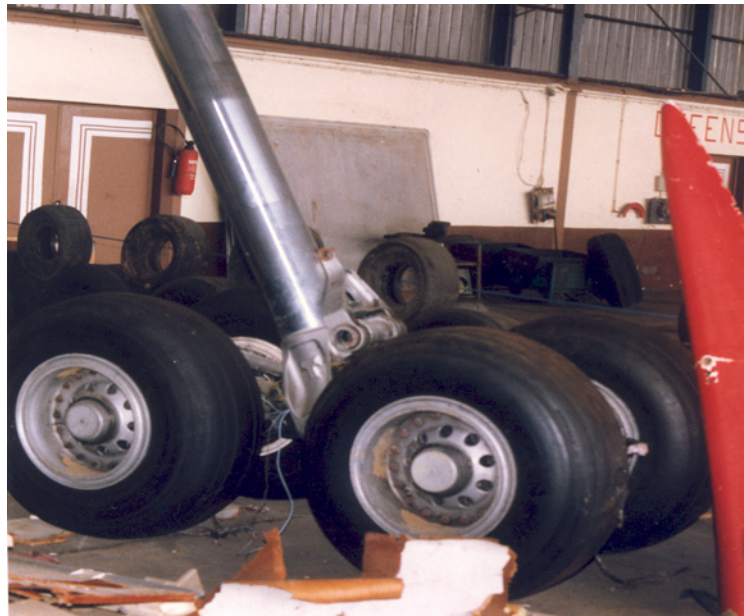
Train d'atterrissage repêché

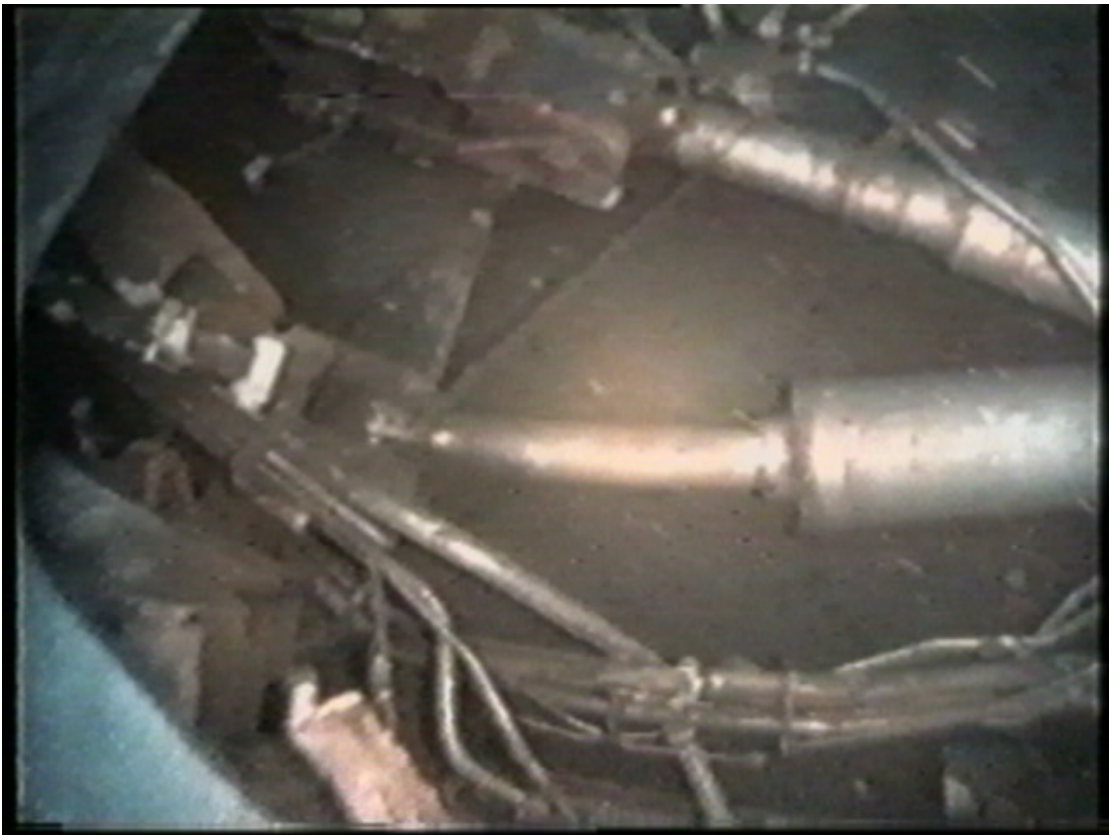
- the landing gear shock absorber that was twisted and in extended position;
- the flap actuator screw jack in the 15° position;
- a slat guide rail broken on the side where it was connected to the wing;
- the elevator actuator screw jack in a 1.2° nose up trim position;
- the fan blades on one engine severely damaged ;
- the second engine observed in two parts;
- on the cockpit center console, spoiler levers in the armed position (raised and locked).

Amortisseur du train d'atterrissage

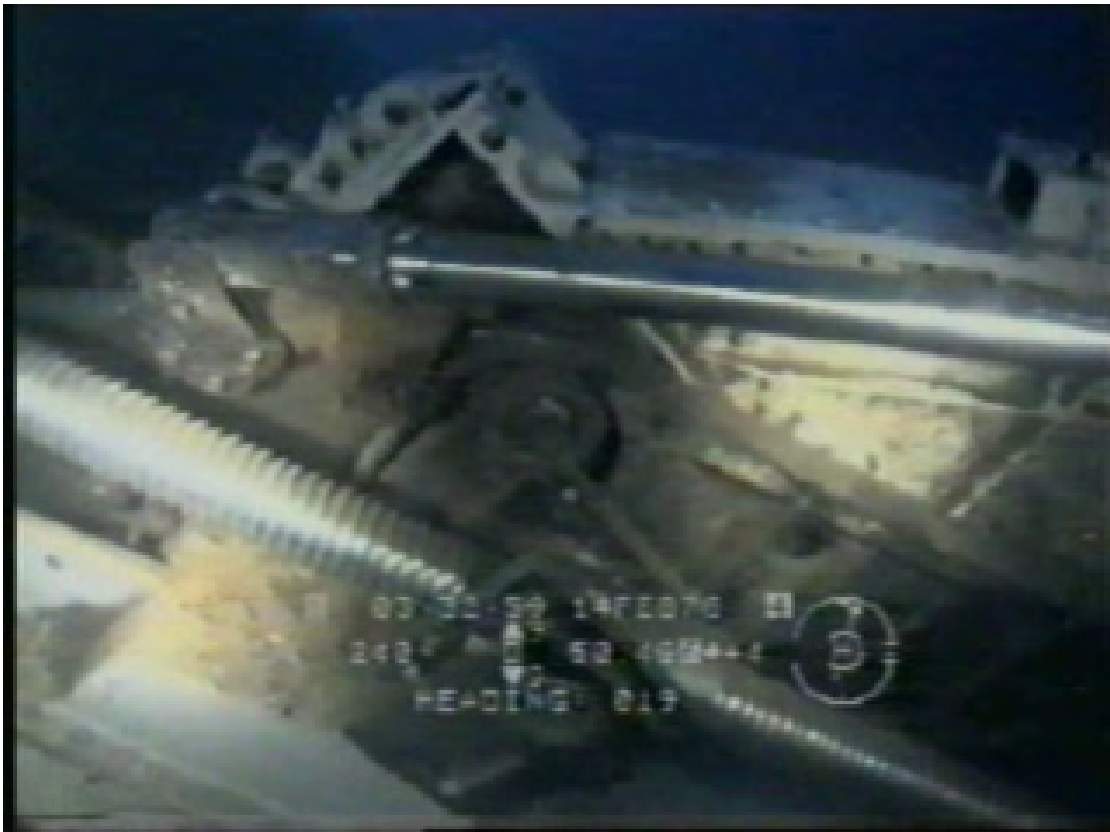
Vis de vérin de volets

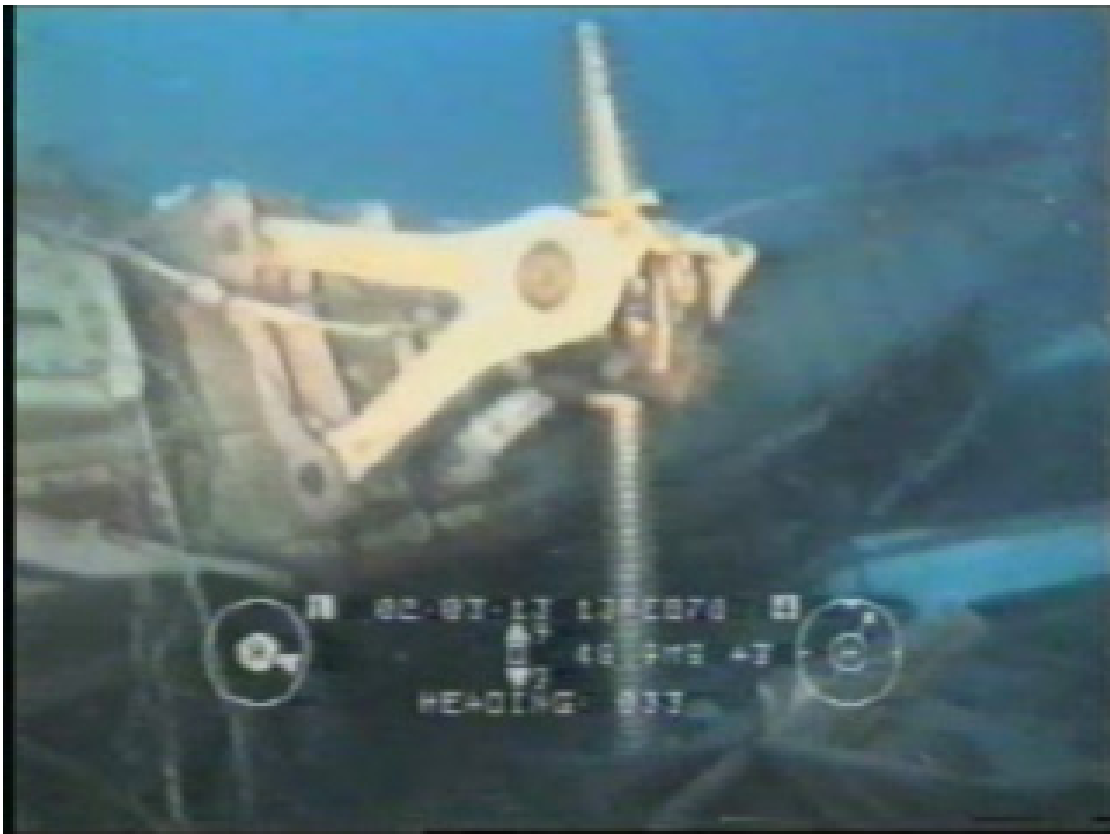
Vis de vérin du plan horizontal réglable

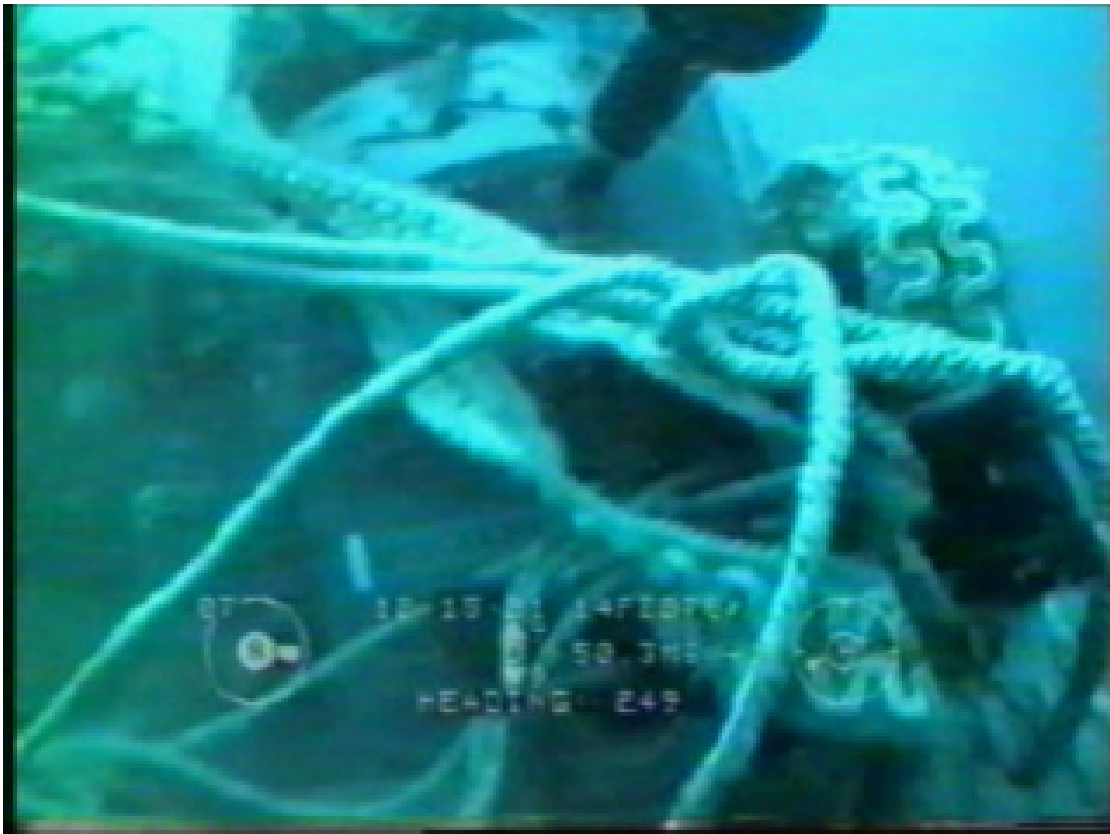
Console centrale du cockpit

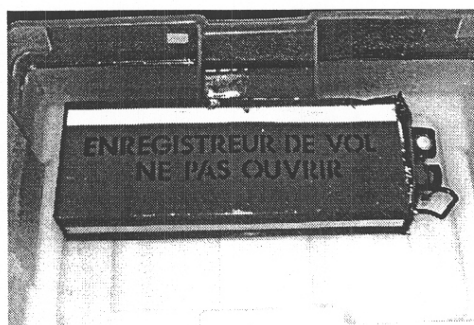
*Figure 1: FDR as received*

The recorder was transported in water to minimize oxidation. It was found to exhibit slight impact damage to the outer casing and face plate (Figure 1). The recorder was rinsed with fresh water and disassembled in order to remove the tape medium. The internal crash protected memory module and the tape medium were found to be in pristine condition (Figures 2 and 3). There was no corrosion damage to the recording.

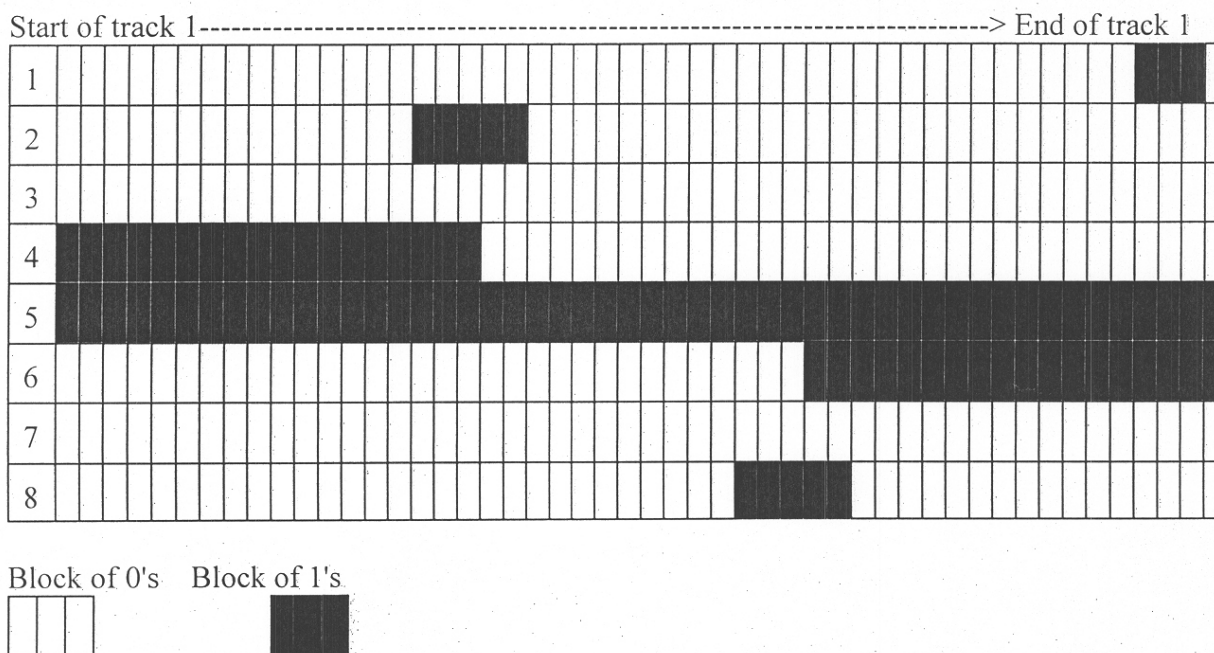
Figure 4 depicts the relative percentage of blocks of 'ones' and/or 'zeros' on each of the eight tape tracks. It should be noted that for odd tracks (1, 3, 5, 7), the recording proceeds from left to right (i.e. forward). For even tracks (2, 4, 6, 8), the recording proceeds from right to left (i.e. reverse). Data is recorded onto each track in sequence, starting on track 1 in the forward direction. At the end of track 1, the recording switches to track 2 and records in the reverse direction. At the end of track 8, after approximately 25 hours of data is recorded, the recording switches back to track 1 and the process repeats, overwriting the previous data. A large section of 'ones' was found, starting near the 2/3 point of reverse track 4, continuing for the entire forward track 5, and then changing to 'zeros' about 1/3 into reverse track 6.

*Figure 4: Percentage of tape that contained blocks of ‘ones’ and/or ‘zeros’*

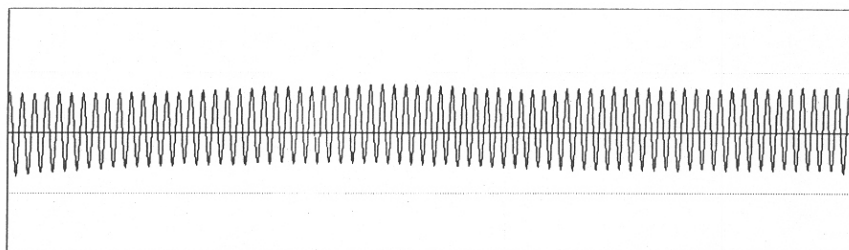
*Figure 5: Sample pattern of 'ones' from accident FDR*

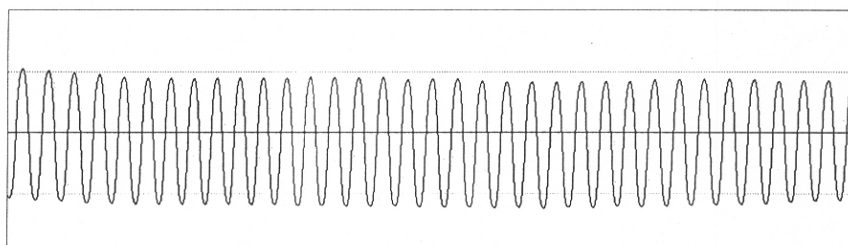
*Figure 6: Sample pattern of 'zeros' from accident FDR*

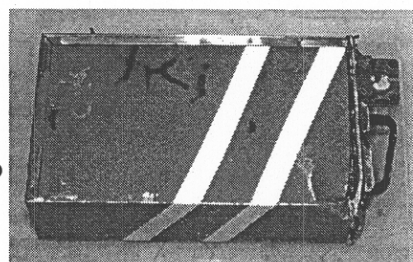
*Figure 7: CVR as received*

The recorder was transported in water to minimize oxidation. Some impact damage was observed to the outer casing and face plate (Figure 7). The recorder was rinsed with fresh water and disassembled in order to remove the CVR tape. The tape medium was found to be in pristine condition with no corrosion damage. The tape was originally played back on an open reel tape deck at the normal speed of 1 7/8 inches per second using 400 hz AC power. A comparison of the CVR communications with the identical communications recorded on the ATS tape indicated that the original playback speed was too slow, requiring a 1.23% increase in speed. This was considered due to a slight difference between the playback speed
