FLIGHT SAFETY FOUNDATION

After Smoke Detected in Cargo Compartment Crew Lands DC-10, Then Fire Destroys Aircraft

Although there were only minor injuries in the evacuation, the evacuation was delayed by the flight crew's failure to depressurize the aircraft. Investigators were unable to determine the fire's ignition source but found evidence of undeclared hazardous cargo.

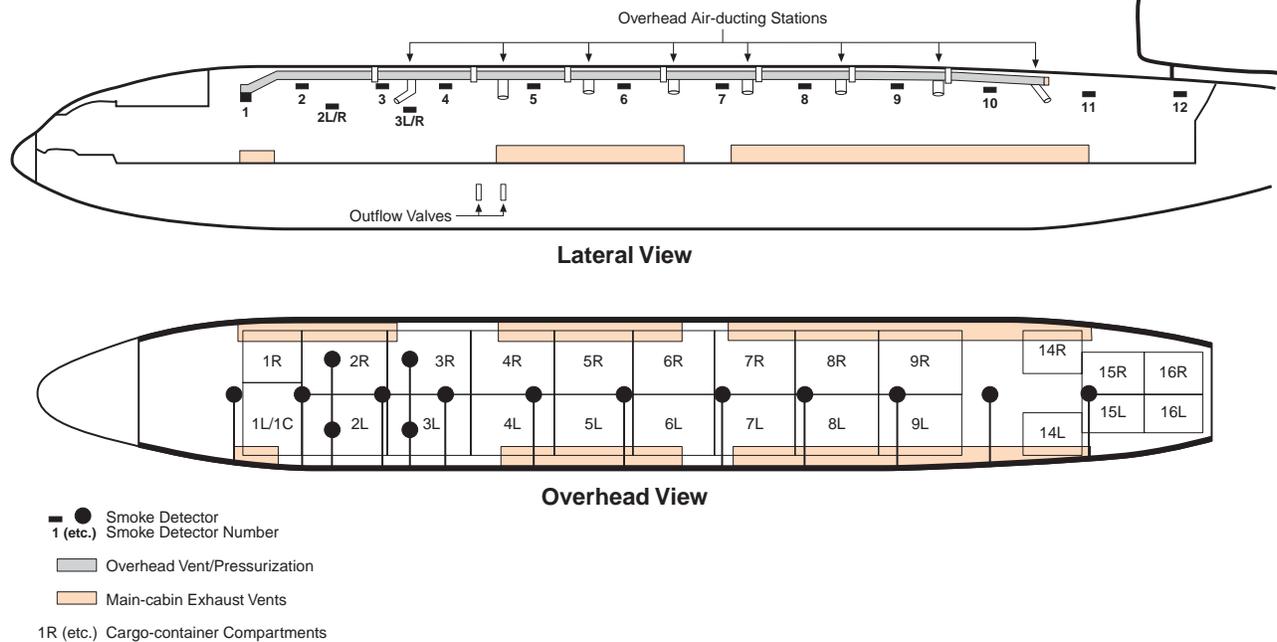
Figure 1

Systems and Cargo-container Compartments of DC-10-10CF, FedEx Flight 1406, Sept. 5, 1996

"The cargo containers that had been in the main cabin were removed from the airplane and arranged in the same order in which they had been in the airplane," said the report. "A conical 'V' burn pattern was observed from right to left and from forward to rear with the lowest (deepest-burned) area centered over container 6R. It was observed that the cargo in containers surrounding 6R (position 6L, 7R and 5R) was burned to a greater depth along the sides next to container 6R than in the other areas of those containers."

The container in cargo position 6R evidenced the most severe heat and fire damage, and was the only container to show heat damage on its bottom. Nevertheless, NTSB could not confirm that the fire originated in that container.

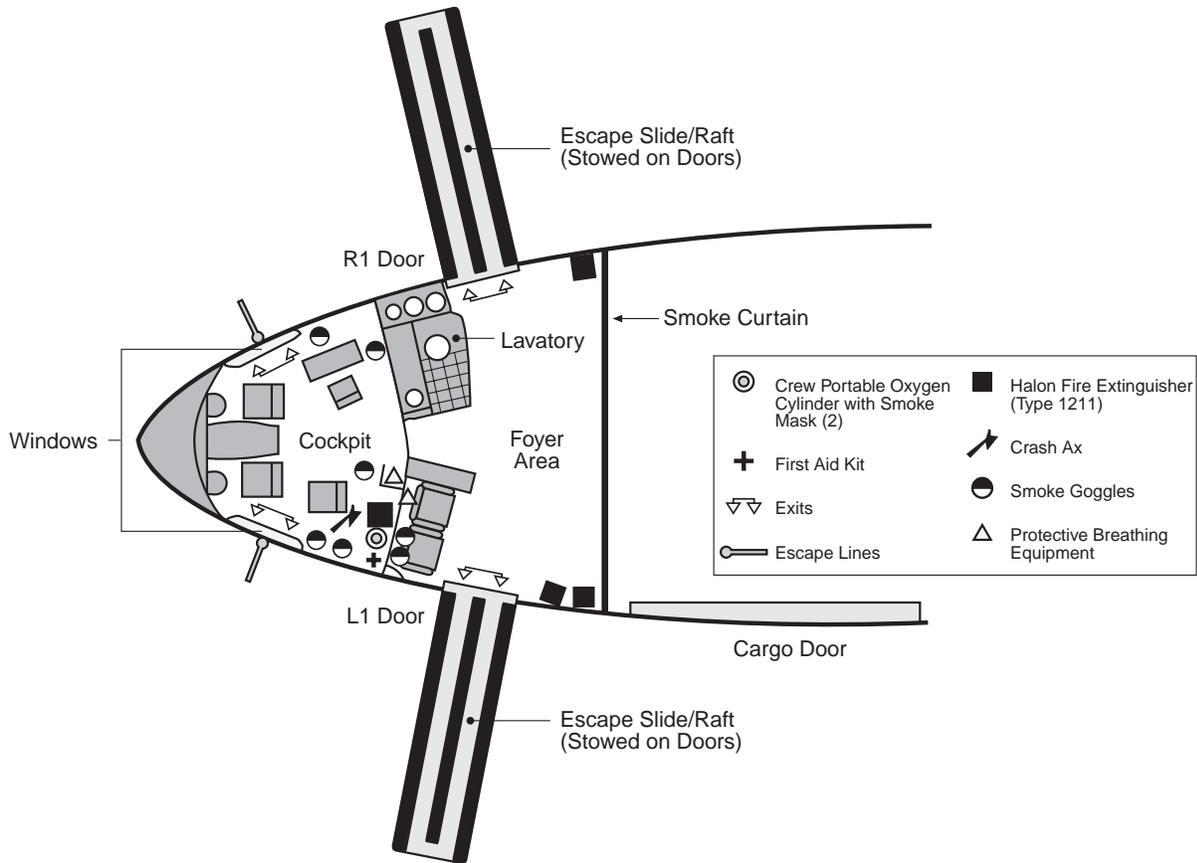
Figure 2

Forward Area of DC-10-10CF, FedEx Flight 1406, Sept. 5, 1996

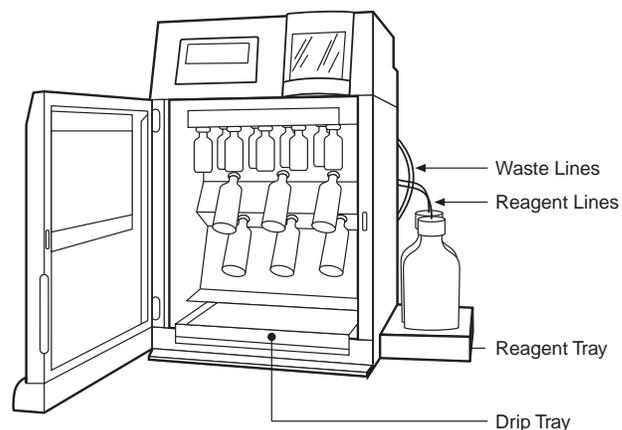
Figure 3

The report said, “The [DNA synthesizer] unit contained several bottles with labels that included flammability symbols, and some of the bottles contained liquid. One large bottle in the aft row had a very strong odor when it was removed from the unit. Because this unit was found at the lowest point of the ‘V’ burn pattern, the [NTSB] investigation evaluated and analyzed the liquids contained in this unit.

Expedite Model 8909 DNA Synthesizer

NTSB said that the evidence indicated that the DNA synthesizer had not been completely purged of hazardous chemicals before being placed on the accident aircraft.

The report said, “Tests of the liquids from the accident synthesizer showed that flammable chemicals (THF and acetonitrile) were still present in the bottles on the machine after the fire. The quantity of chemicals remaining in the synthesizer's bottles after the fire was insufficient to have caused the external fire damage to the synthesizer and the cargo container. However, it is likely that significant amounts of the chemicals were consumed in the prolonged and intense fire, and thus the synthesizer probably contained much larger quantities of these flammable chemicals before the fire.
