NATIONAL TRANSPORTATION SAFETY BOARD

AIRCRAFT ACCIDENT REPORT

**COLLISION OF
AERONAVES DE MEXICO, S.A.
McDONNELL DOUGLAS DC-9-32, XA-JED
AND PIPER PA-28-181, N4891F
CERRITOS, CALIFORNIA
AUGUST 31, 1986**

NTSB/AAR-87/07

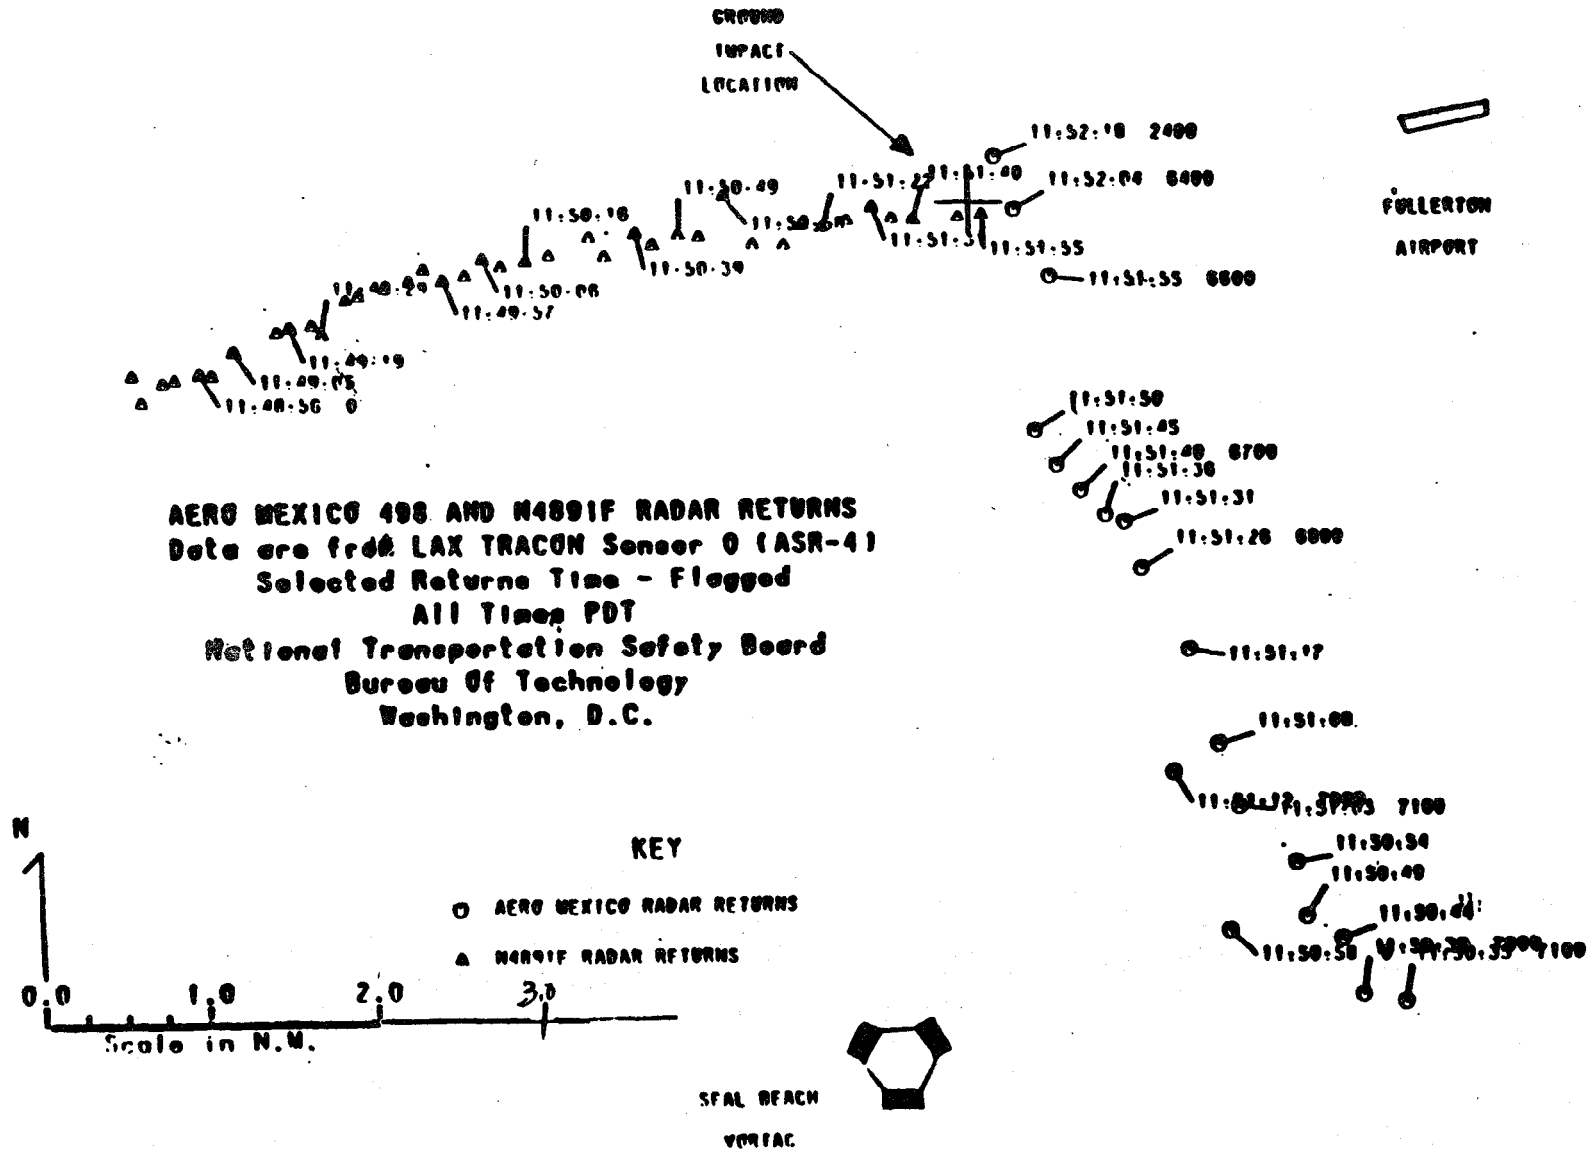
Figure 5.--Beacon targets of DC-9 and Piper during last 3 minutes of flight.

The recorded radar data also indicated that the Piper passed the TCA's lateral boundary about 1149:47 and that the collision occurred about 3 nmi west of that boundary. The manufacturer's climb performance chart was based on a 76-KIAS climb speed. Between 5,000 feet and 7,000 feet, based on the airplane's estimated gross weight and the existing weather conditions, the Piper could have climbed at a rate of about 300 fpm to 350 fpm. Since the collision occurred about 1152:09 at about 6,560 feet, the Piper probably climbed through 6,000 feet-the base altitude of this segment of the TCA-about the same time it crossed the TCA's lateral boundary,

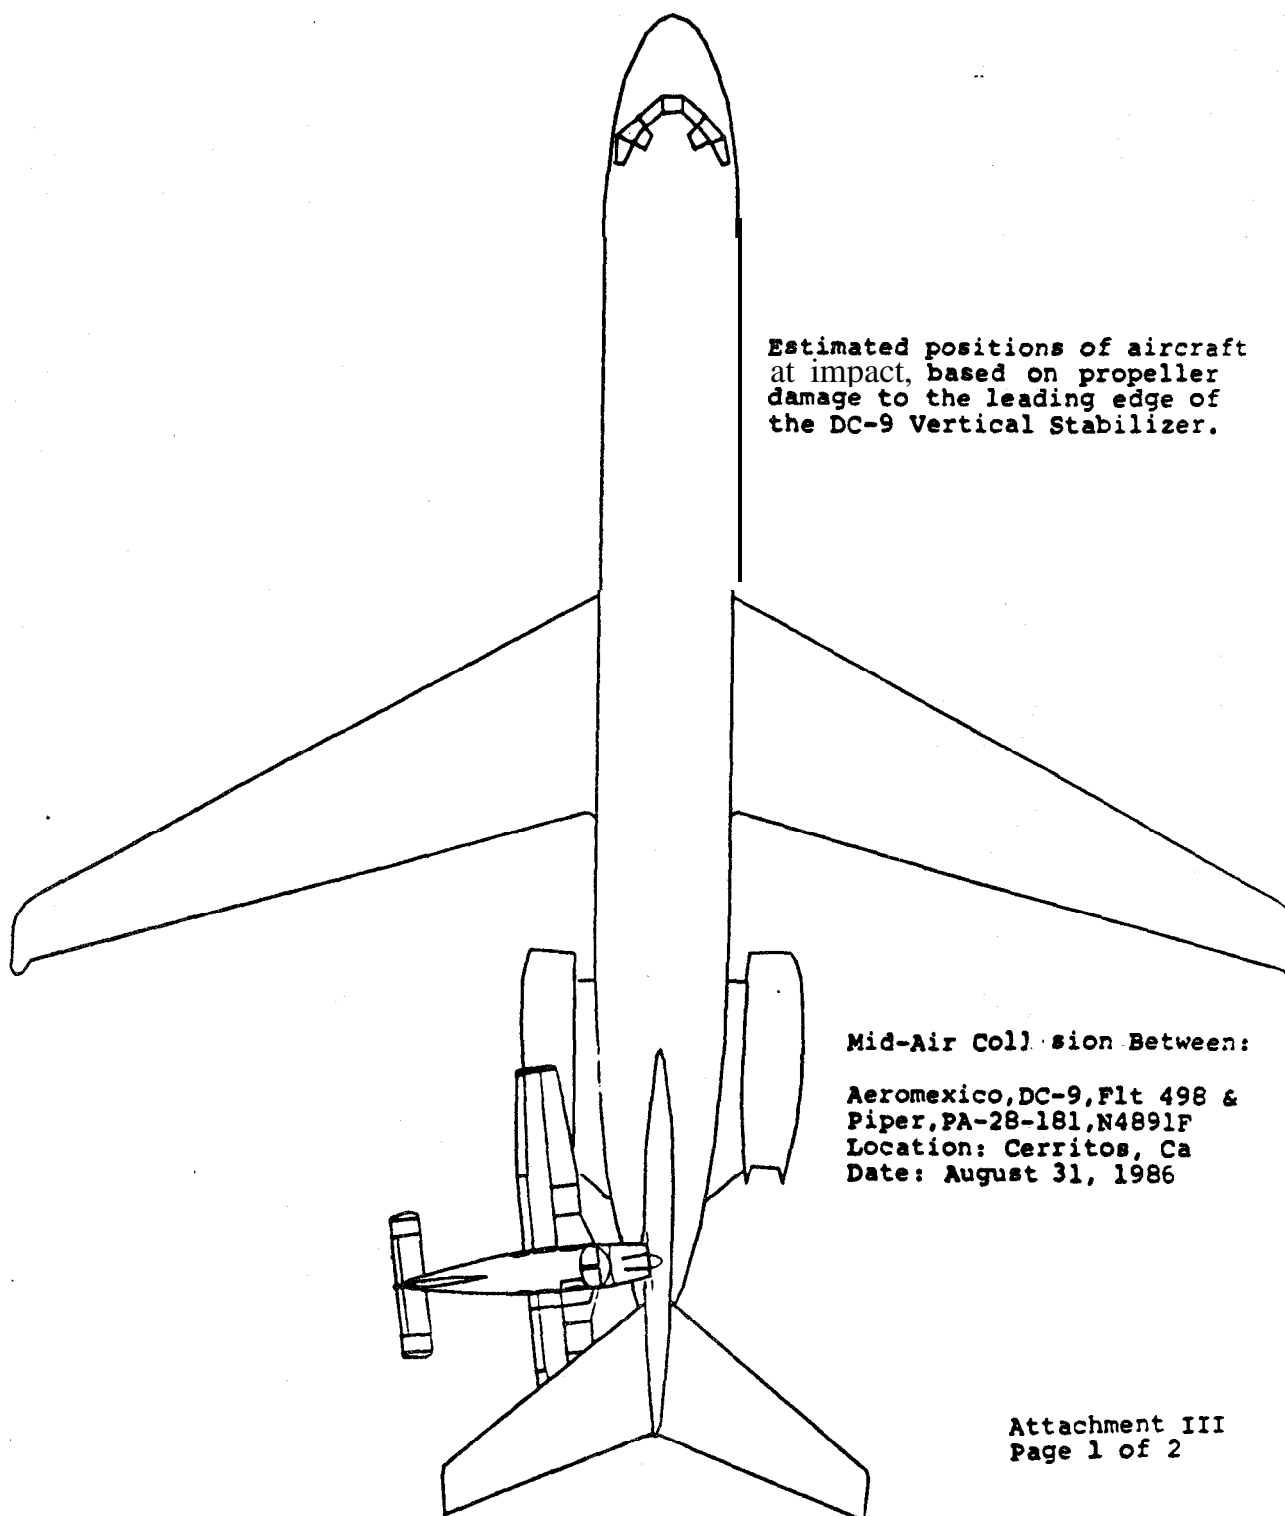
Figure 6.--Collision geometry as viewed from above the DC-9.

The damaged areas on the DC-9 vertical and horizontal stabilizers contained propeller slice marks, paint transfer marks Rom the nose wheel area and vertical stabilizer of the Piper, and embedded pieces from the cabin roof area of the Piper. **The** location and angles of these marks and damage on the **DC-9**, when matched to their respective locations on an intact Piper PA-28, showed that the front of the Piper had struck the left side of the DC-9 vertical stabilizer and that the impact angle was perpendicular to the longitudinal axis of each airplane. (See figure 6.) The impact angle was generally consistent with the flight tracks of the airplanes shown on the radar data plots.

The absence of any impact marks or damage on those portions of the DC-9 left wing and fuselage forward of the empennage that had not been consumed by fire and the damage to the DC-9 vertical and horizontal stabilizers, showed that the PA-28 airplane was about 8 to 10 feet above the top of the **DC-9's** fuselage and about 15 to 17 feet above its wings when the collision occurred. **The** damage also indicated that the longitudinal axis of the Piper was almost level at impact and that the initial impact was -with the DC-9 vertical and horizontal stabilizers. **The** debris **from** the Piper cabin roof, embedded in the leading edge of the DC-9 **horizontal stabilizer**, and the fact that the roof of the Piper was sheared off at about the same height on both sides of its fuselage, confirmed the fact that the **DC-9's** horizontal stabilizer struck the top of the **Piper's** fuselage and that the Piper was in the almost wings-level attitude at impact. (See figure 7.)

Estimated positions of aircraft at impact, based on the propeller damage and scratch marks on the DC-9 Vertical and Horizontal Stabilizers.
