AIRCRAFT ACCIDENT REPORT

EASTERN AIR LINES, INC.

L-1011, N310EA

DECEMBER 29, 1972

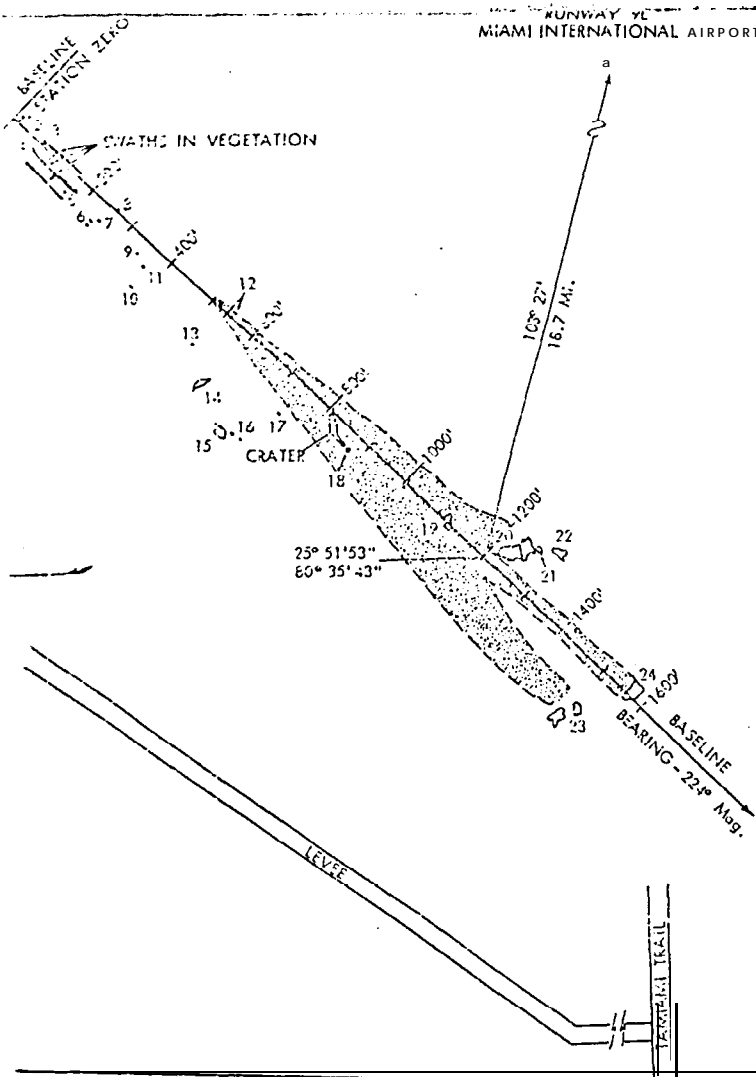
APPENDIX D

- 1-4. Small pieces of left-hand wing, outer structure.
5. Small engine parts - fan blades, Oil cooler.
6. Engine mount frame, part of No. 1 fan case, oil scavenge filter.
