REPORT

on the accident
on 6 March 2003
at Tamanrasset
to the Boeing 737-200
registered 7T-VEZ
operated by Air Algérie

7t-z030306a

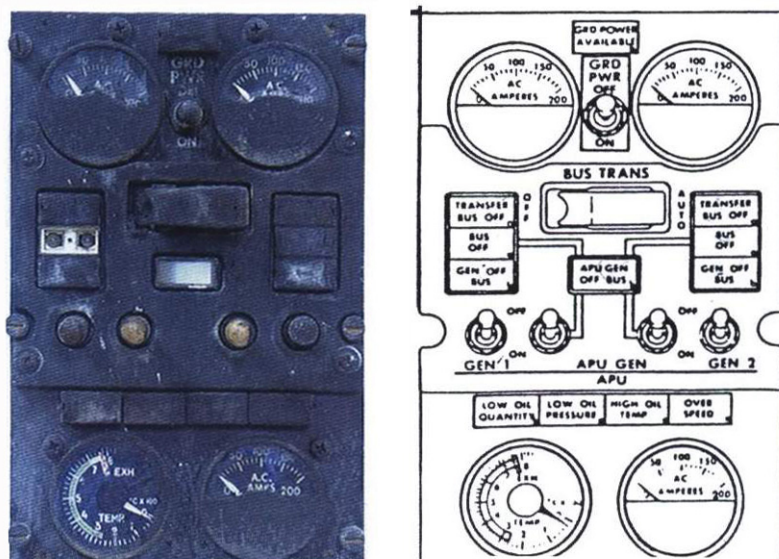
Examination of the electrical power system did not bring to light any malfunction. The photo below, accompanied by the graphic from the airplane manual, shows the module related to electrical power generating systems linked to the two generators and to the APU.

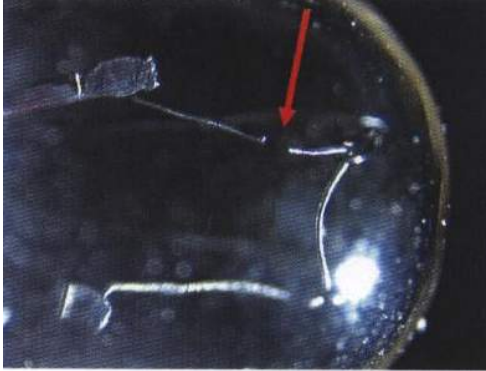
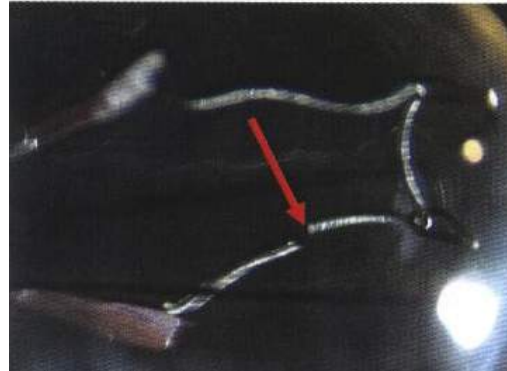
Warning lights GEN #1 TRANSFER BUS OFF and GEN #2 TRANSFER BUS OFF

The bulbs of several warning lights, including the TRANSFER BUS OFF, BUS OFF, GEN OFF BUS and APU GEN OFF BUS, were examined as the following photos illustrate. Their examination showed that most of the filaments were broken on impact.
