**PB90-910406
NTSB/AAR-90/06**

AIRCRAFT ACCIDENT REPORT

**UNITED AIRLINES FLIGHT 232
McDONNELL DOUGLAS DC-10-10
SIOUX GATEWAY AIRPORT
SIOUX CITY, IOWA
JULY 19, 1989**

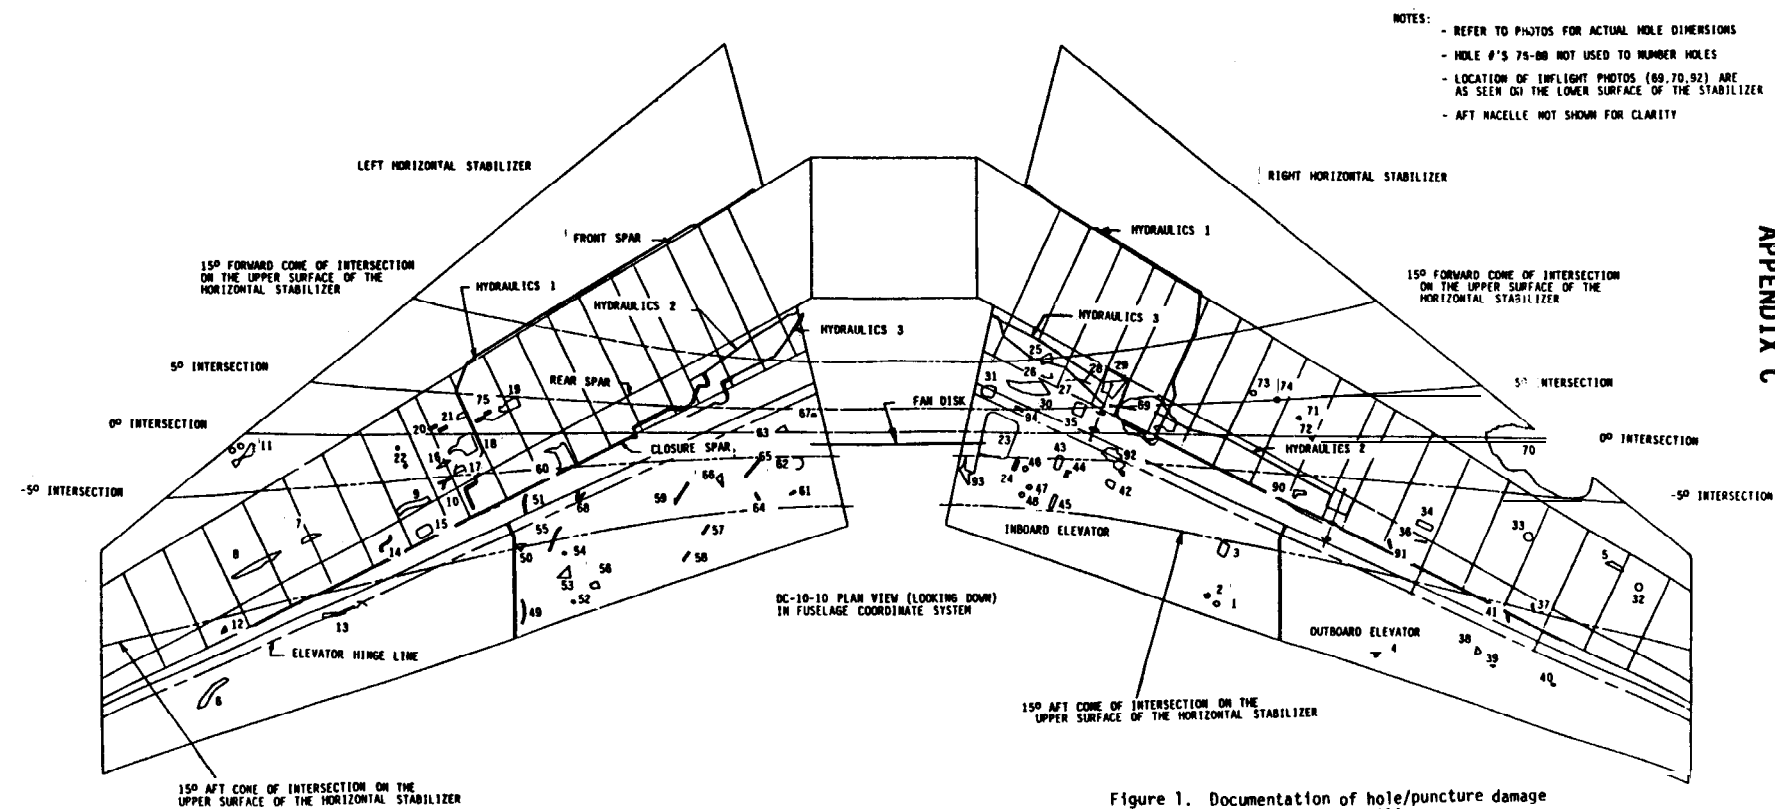
# HORIZONTAL STABILIZER DAMAGE DIAGRAM

Four punctures on the vertical stabilizer were noted as probable fragment damage prior to ground impact. Documentation of hole/puncture damage to the horizontal stabilizers is contained in Appendix C. There were 79 punctures recorded from fragment damage and one large hole, about the same size as the large piece of recovered fan disk. The flight control surfaces were recovered in the aircraft wreckage and had varying degrees of damage that could have occurred before or after impact.
