Crash During Approach to Landing, Air Tahoma, Inc., Flight 185, Convair 580, N586P, Covington, Kentucky, August 13, 2004

Investigative Body: National Transportation Safety Board (NTSB), USA

NTSB/AAR-06/03

**Crash During Approach to Landing
Air Tahoma, Inc., Flight 185
Convair 580, N586P
Covington, Kentucky
August 13, 2004**

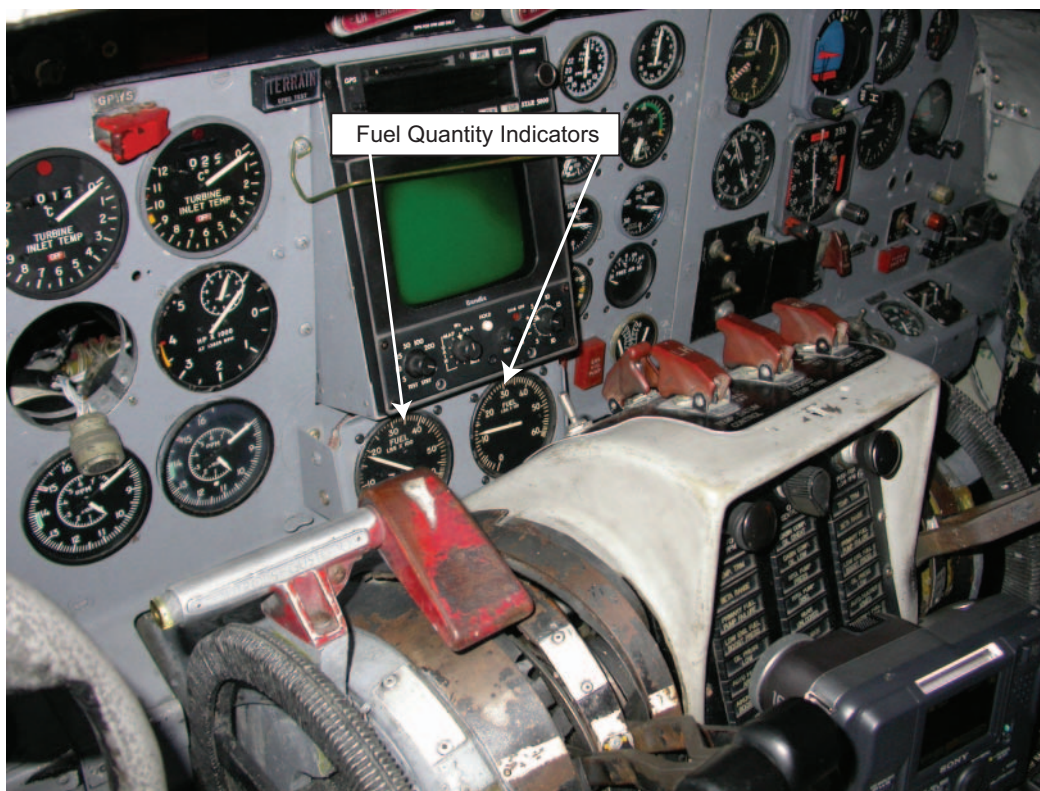
Figure 3. The Convair 580 fuel quantity indicators and center pedestal.

Postaccident interviews with Air Tahoma personnel and an inspection of another Convair 580 revealed that, at some seat positions, it was difficult to see the fuel quantity indicators. Specifically, if the seats were in an aft position, the indicators were difficult to see because the throttle control console and the gust lock lever partially blocked the indicators. The inspection revealed that, in the aft position, a pilot had to sit up and lean forward to completely see the fuel quantity indicators.
