I am truly honoured to have been given the opportunity to head the Investigation into the Accident at Kozhikode on 07 August 2020 involving B737-800 aircraft VT-AXH operated by M/s Air India Express Limited.

SYNOPSIS

Air-India Express Limited B737-800 aircraft VT-AXH was operating a quick return flight on sector Kozhikode-Dubai-Kozhikode under 'Vande Bharat Mission' to repatriate passengers who were stranded overseas due to closure of airspace and flight operations owing to the Covid-19 pandemic. The aircraft departed from Kozhikode for Dubai at 10:19 IST (04:49 UTC) on 07 August 2020 and landed at Dubai at 08:11 UTC. The flight was uneventful. There was no change of crew and no defect was reported on the first sector. The aircraft departed from Dubai for Kozhikode at 10:00 UTC as flight AXB 1344 carrying 184 passengers and six crew members.

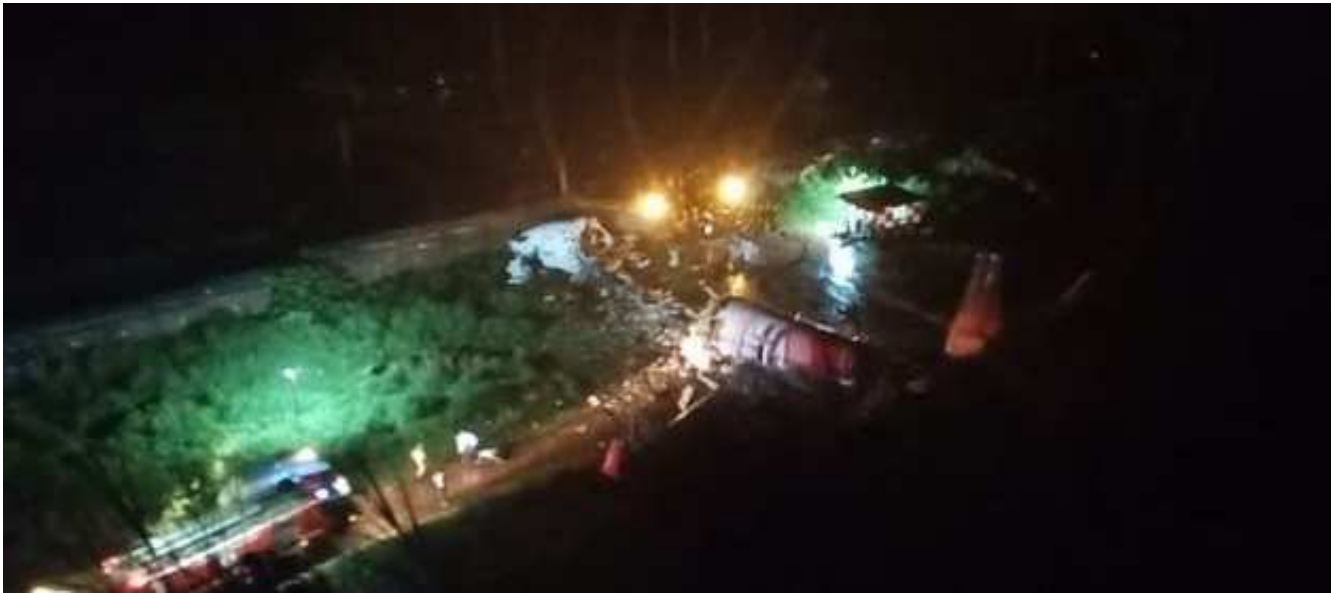
Figure 1: One of the first images of accident site before commencement of ARFFS Operations.

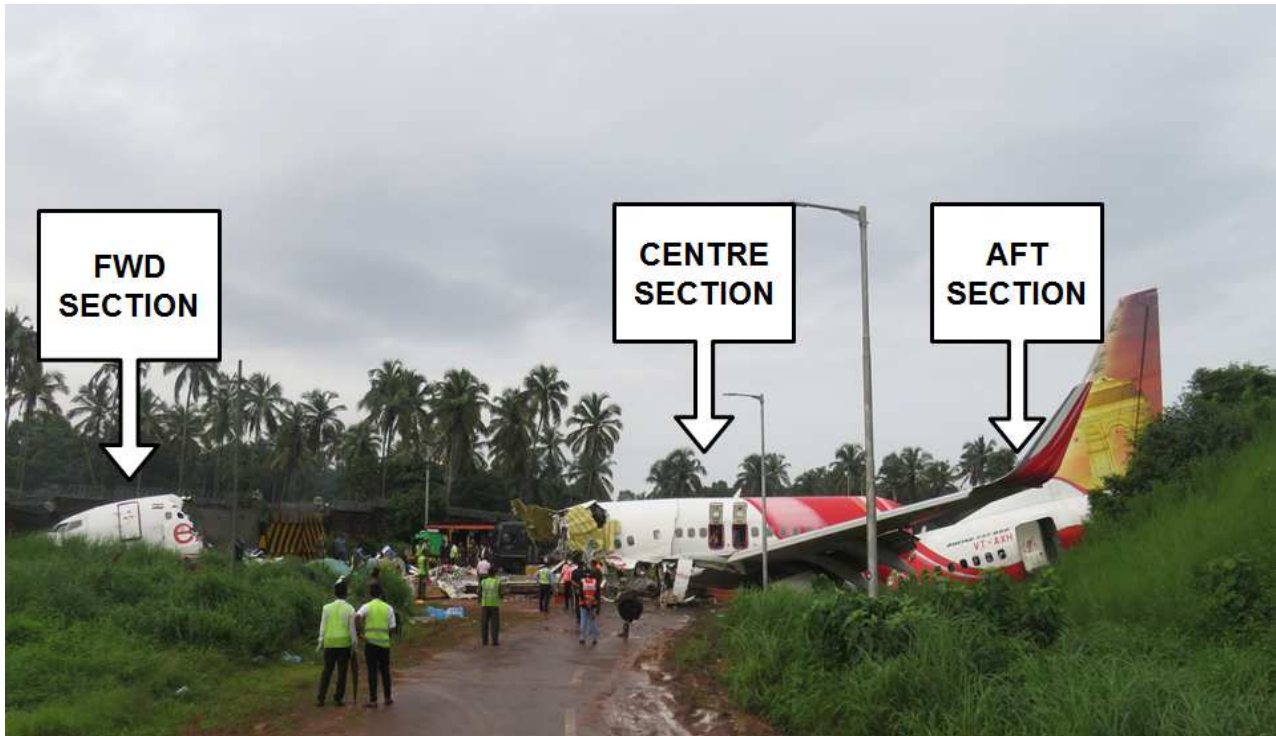
Aircraft was completely destroyed in the accident and the fuselage split into three sections. Detailed information is given in 1.12 – Wreckage and Impact information.

Figure 2: Aircraft broken into three sections.

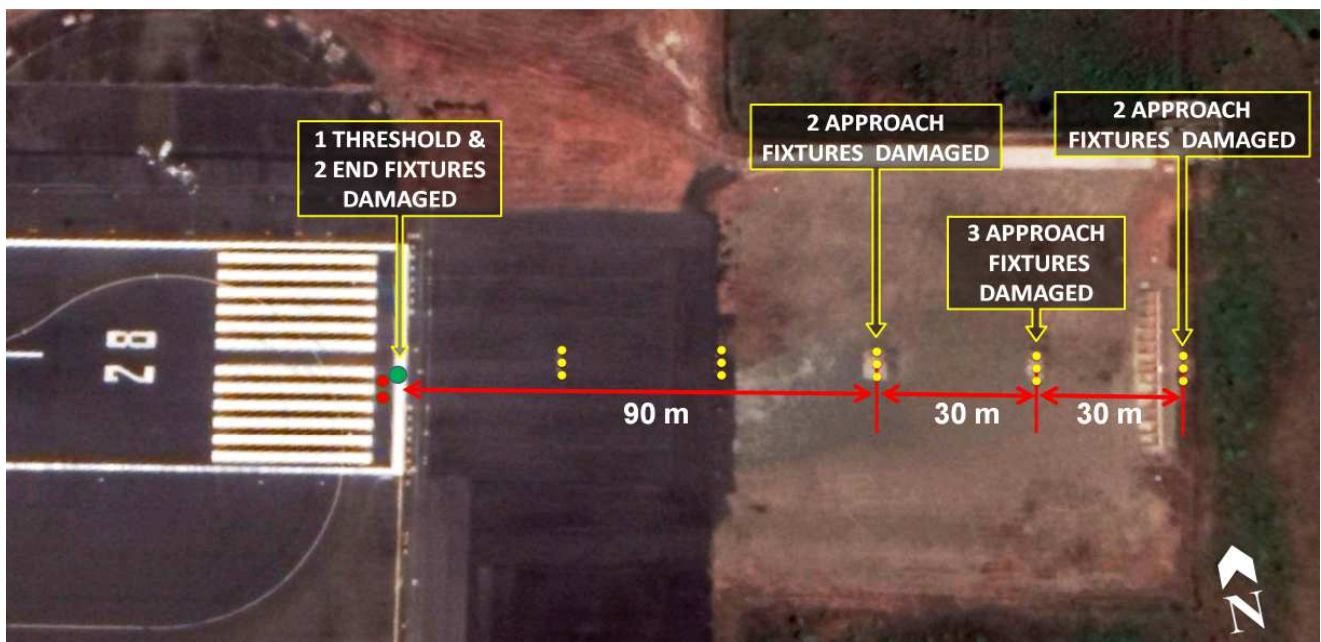
Figure 3: The location of the damaged lights in RESA.

- (a) 02 Runway End Lights and 01 Threshold Light was damaged by the aircraft wheels.
- (b) 03 units of SALS were partially damaged by the aircraft wheels.

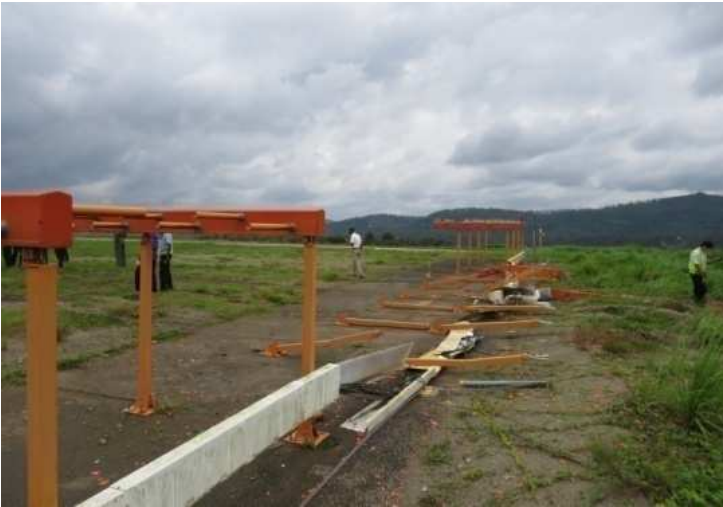
Figure 4: Damage to ILS Localiser Antenna

- (c) Localiser Antenna Array was damaged when the aircraft went through the array.
- (d) Runway Area Perimeter Fence was damaged due to impact with aircraft as it slid down the slope after overshooting the runway and RESA.

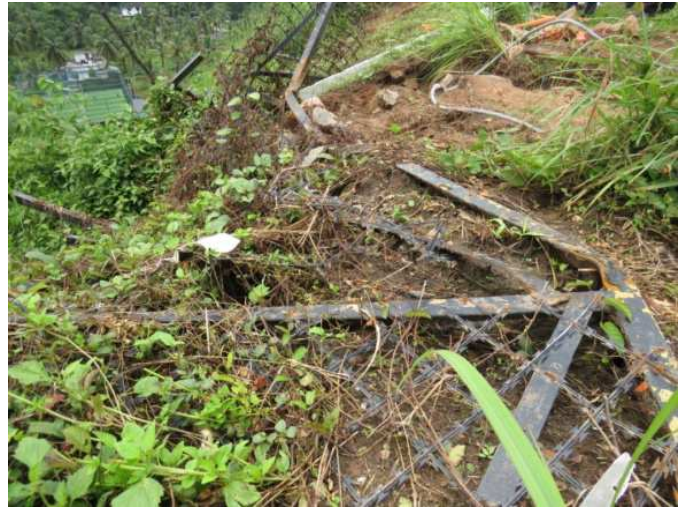
Figure 5: Damage to fence at end of RESA

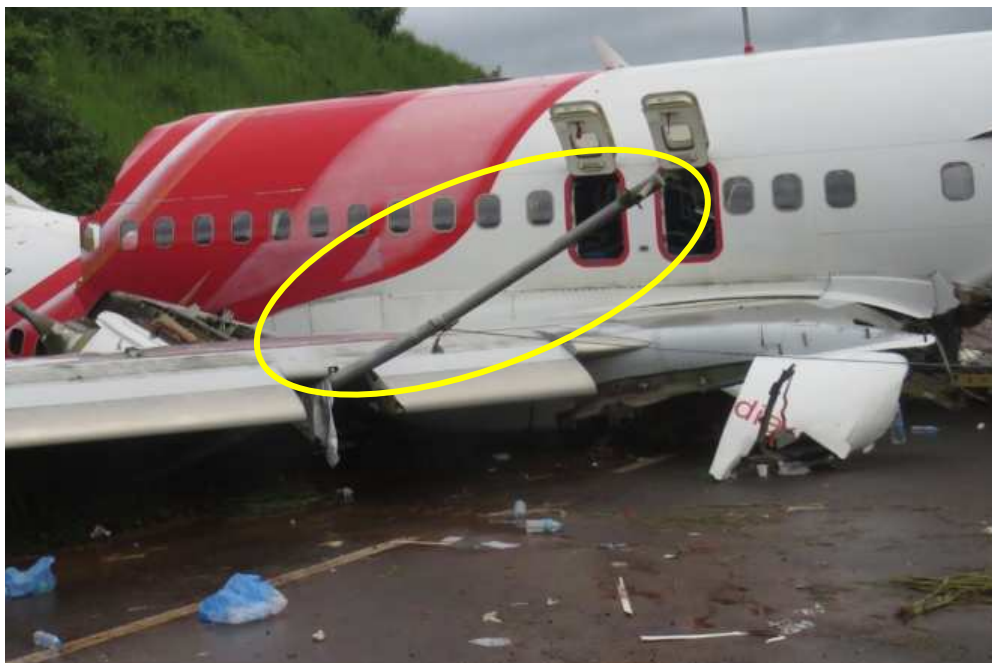
Figure 6: Lamp post broken by impact with right wing

- (e) A lamp post on the perimeter road was also broken due to impact with the right wing of the aircraft.

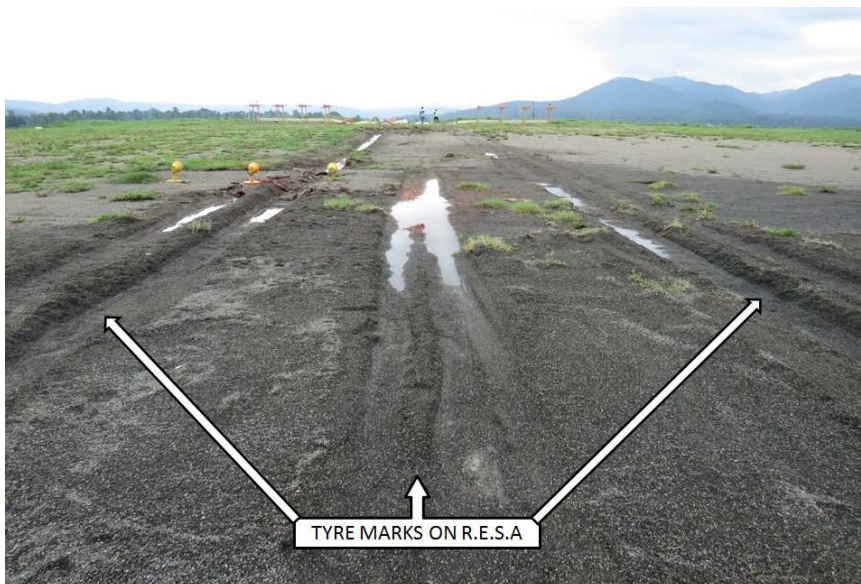
The aircraft touched down at 4438 ft from the threshold of runway 10. Airport Safety Investigation Co-ordinator and the AAIB investigators did not observe any distinct tyre marks on the Runway during runway inspection as Aerodrome was experiencing continuous rains during the accident and later throughout the night.

Figure 26: Tyre Marks on RESA.

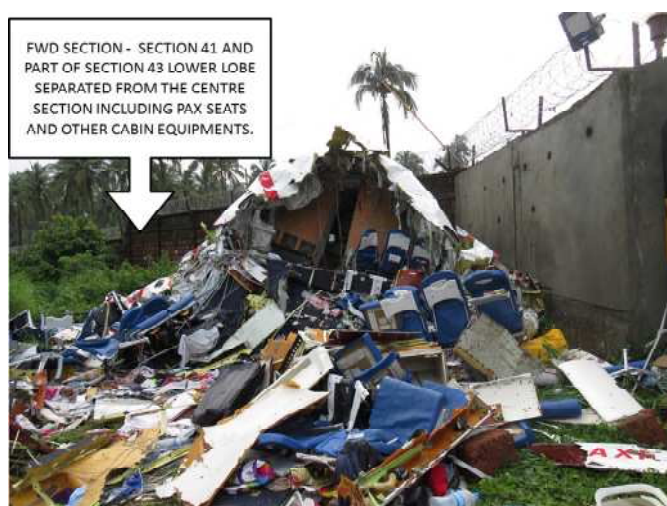
Figure 29: Forward Section Debris

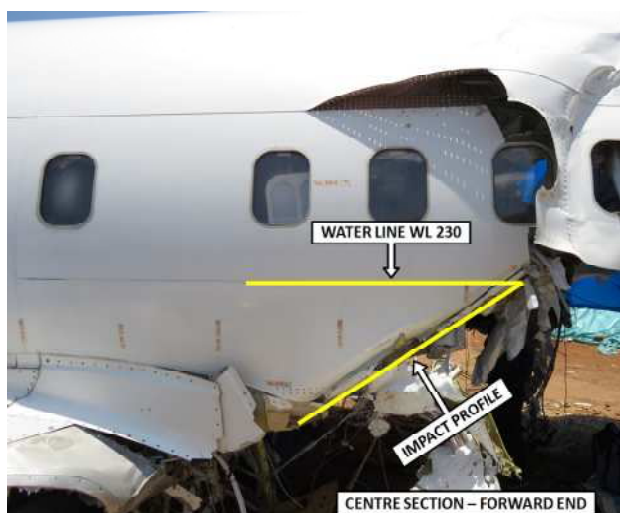
The centre wing box including the centre tank structure was exposed and severely damaged. The air conditioning system components were crushed and damaged. Section of the fuselage skin, cargo floor panel, generator cables and system tubing showed signs of a rippled pattern resembling corrugated sheet.

Figure 31: Centre section impact profile

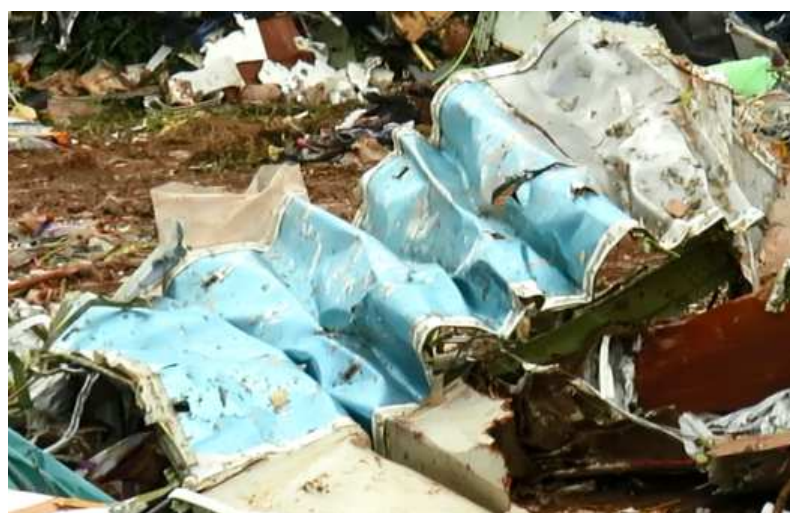
Figure 32: Centre Section Debris

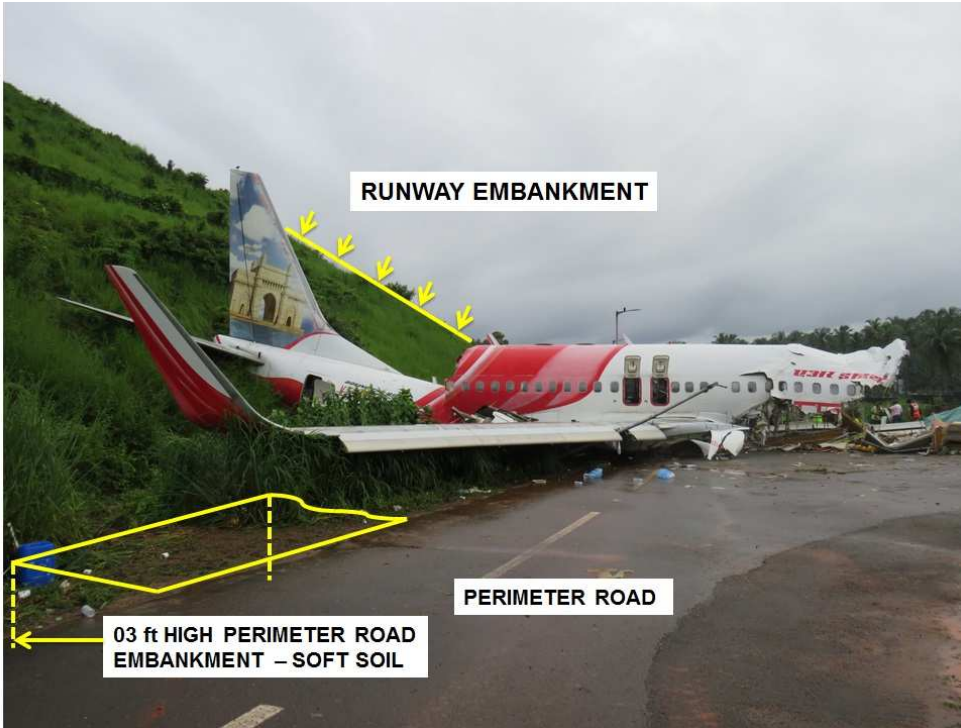
The aft section separated from the centre section between STA 727D and STA 727J during the fall and impact. The centre section was supported on the belly by the edge of the perimeter road embankment. Due to momentum the aft section continued moving down and separated from the centre section. It was supported at the forward end by the base of a storm drain and at the aft end by the runway embankment. Due to this orientation it was at a relative angle of 10-12 degrees with the centre section.

Figure 33: Layout of Centre & Aft Section Wreckage

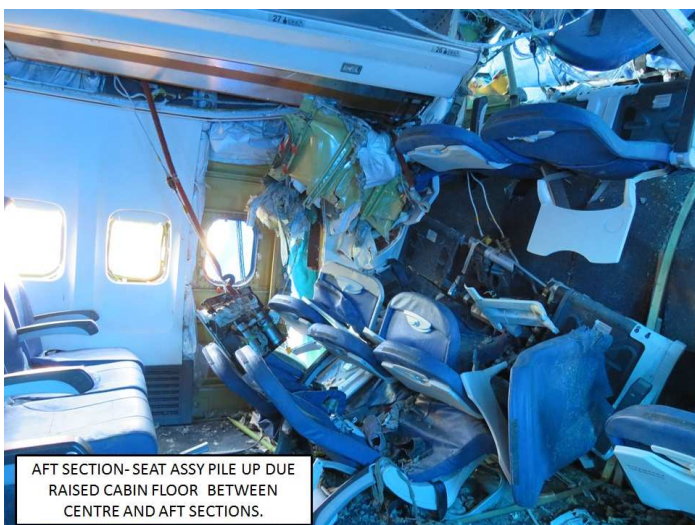
The cabin floor structure was damaged but did not separate cleanly. Due to the height difference between the cabin floor levels of the two sections, the cabin floor rotated from horizontal to near vertical position between seat rows 23 to 26 with the seats still attached causing the passenger seats to pile up at this location. The empennage was relatively intact other than a few post impact damages.

Figure 34: Aft Section Seat Pile up

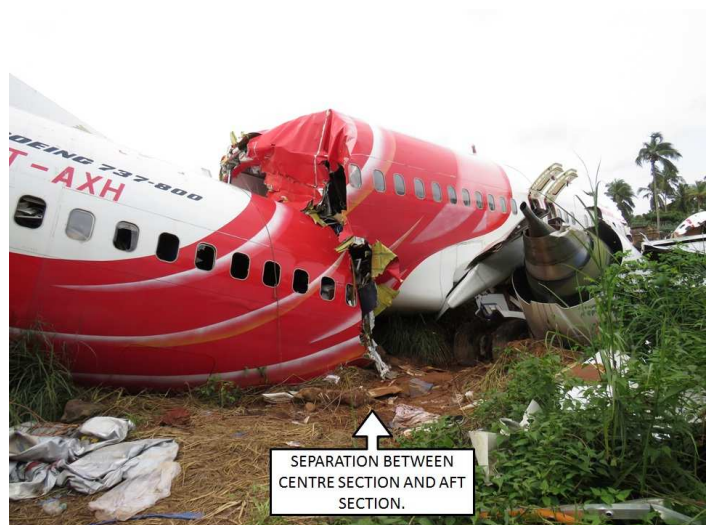
Figure 35: Separation Between Centre and Aft Section

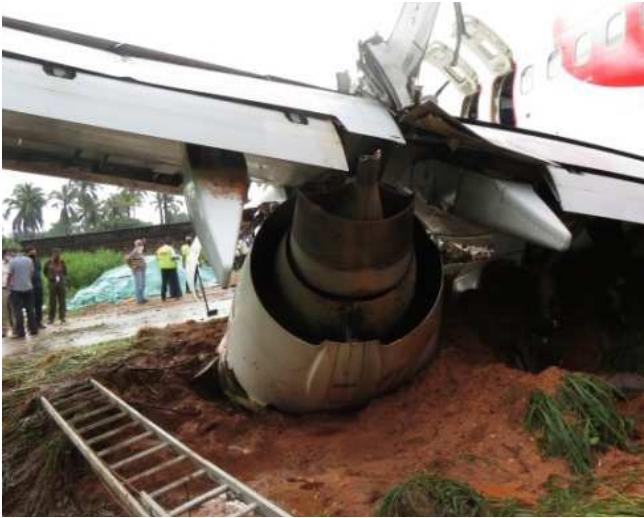
The engines were embedded in the soft ground at an approximate angle of 30°. The left engine came to rest at a distance of 10 ft behind the strut and the right engine was at a distance of 17 ft behind the strut. Both engines suffered extensive impact damage.

Figure 36: Left Engine

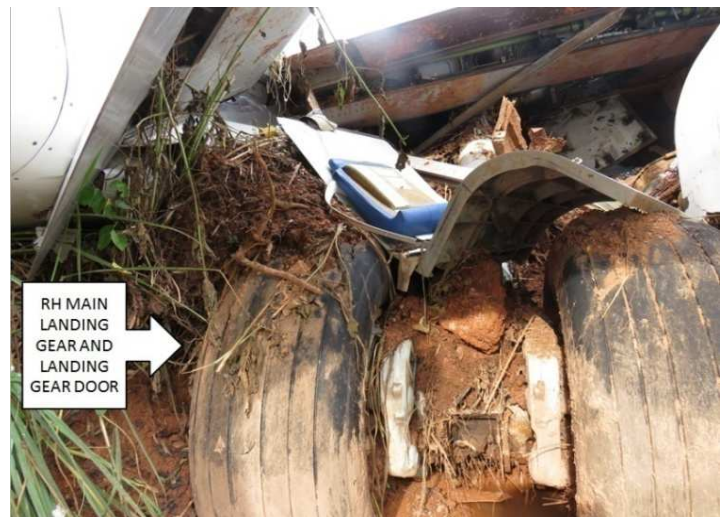
Figure 41: Right Main Landing Gear

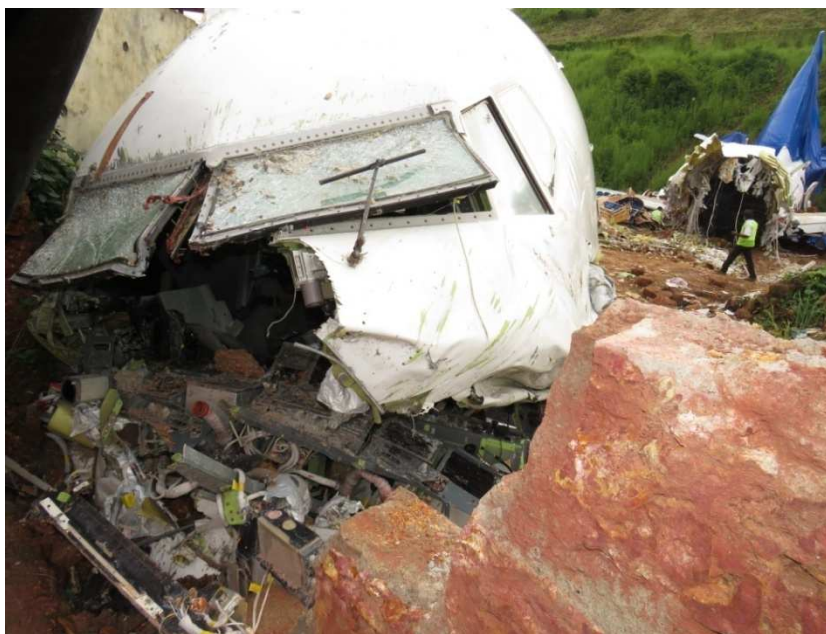
Both the forward windshield glass shattered. The window frame and its support structure was damaged. LH windshield wiper motor converter was retrieved from the wreckage with superficial damage. RH windshield wiper motor converter and arm assembly separated from its location and were retrieved from the debris. Both wiper arm assemblies were found slightly deformed.

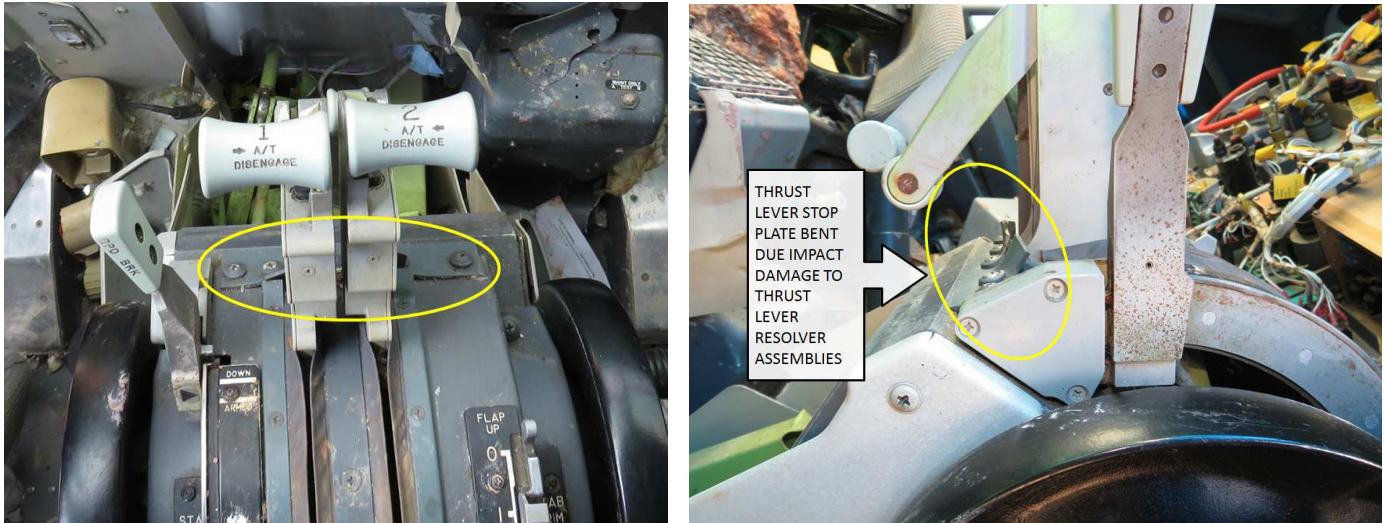
The throttle lever position did not correspond to the last recorded position in the DFDR data before impact. The Engine Throttle Levers were found jammed at the full forward position with the stop plate bent forward. This was attributed to impact damage sustained by the Thrust Lever Resolver Assemblies and Control Rods causing it to move back thereby forcing the throttle lever forward with such a force that it resulted in bending the stop plate. Both the throttle levers were jammed and could not be moved.

Figure 45: Engine Thrust Lever

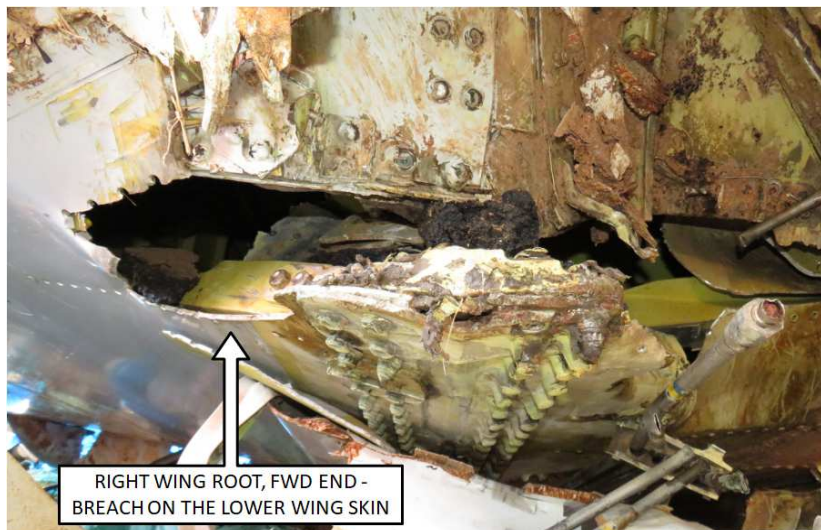
wing main tank. The fuel leaked through the opening created on the lower wing skin. On the left wing the fuel leaked from the separated fuel supply line on the pylon and it continued to leak until the fuel level inside the tank decreased below the level of the separated line. Approximately 650 litres of fuel was later drained from the left wing main tank.
