FINAL REPORT

COL-16-37-GIA

Fuel Exhaustion

AVRO 146-RJ85, Reg. CP 2933

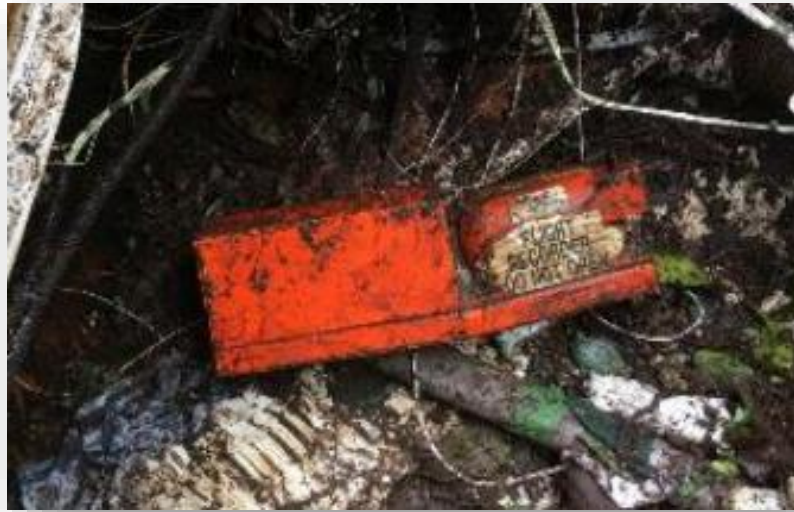
Figure 12. Condition of FDR upon recovery

The FDR was recovered by GRIAA from the accident site. The FDR was found in the main wreckage of the aircraft towards the rear of the fuselage and very near to its original position, detached from its mounting brackets.

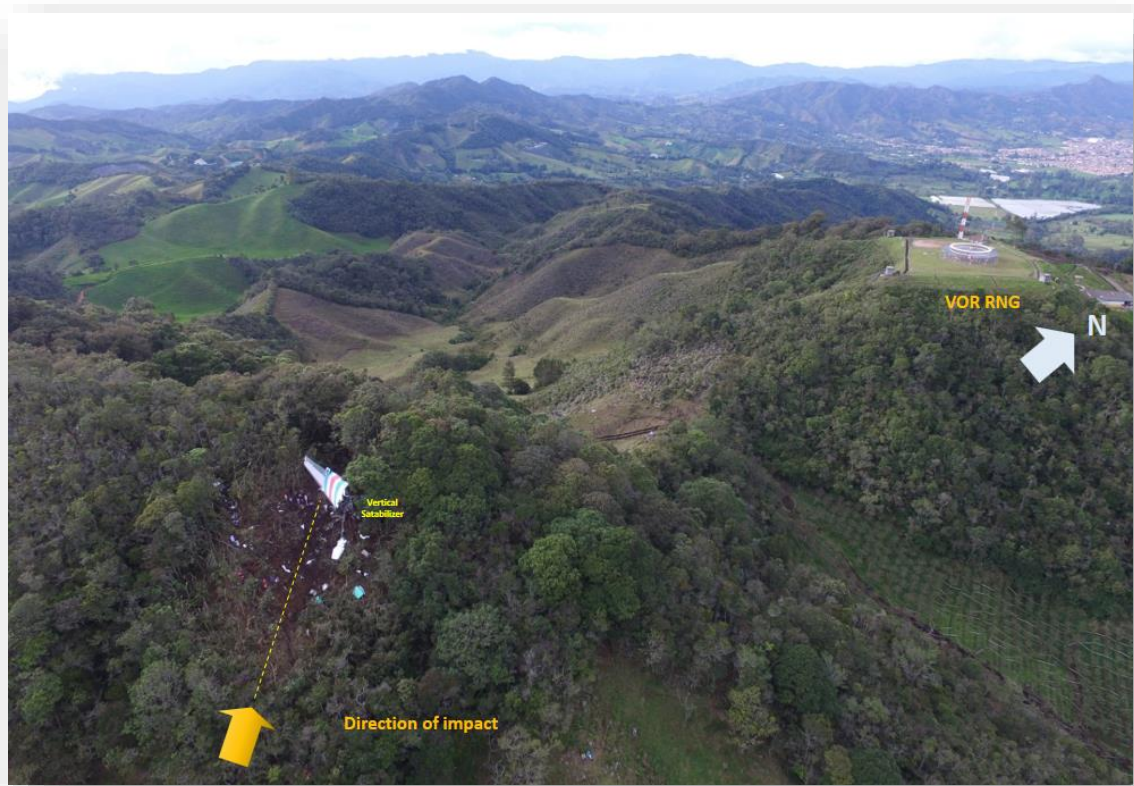
Figure 13. Initial direction of Impact

The geographic coordinates of the initial impact were recorded at N05 ° 58'43.56 " - W075 ° 25'7.86" at an elevation of 8700 feet.

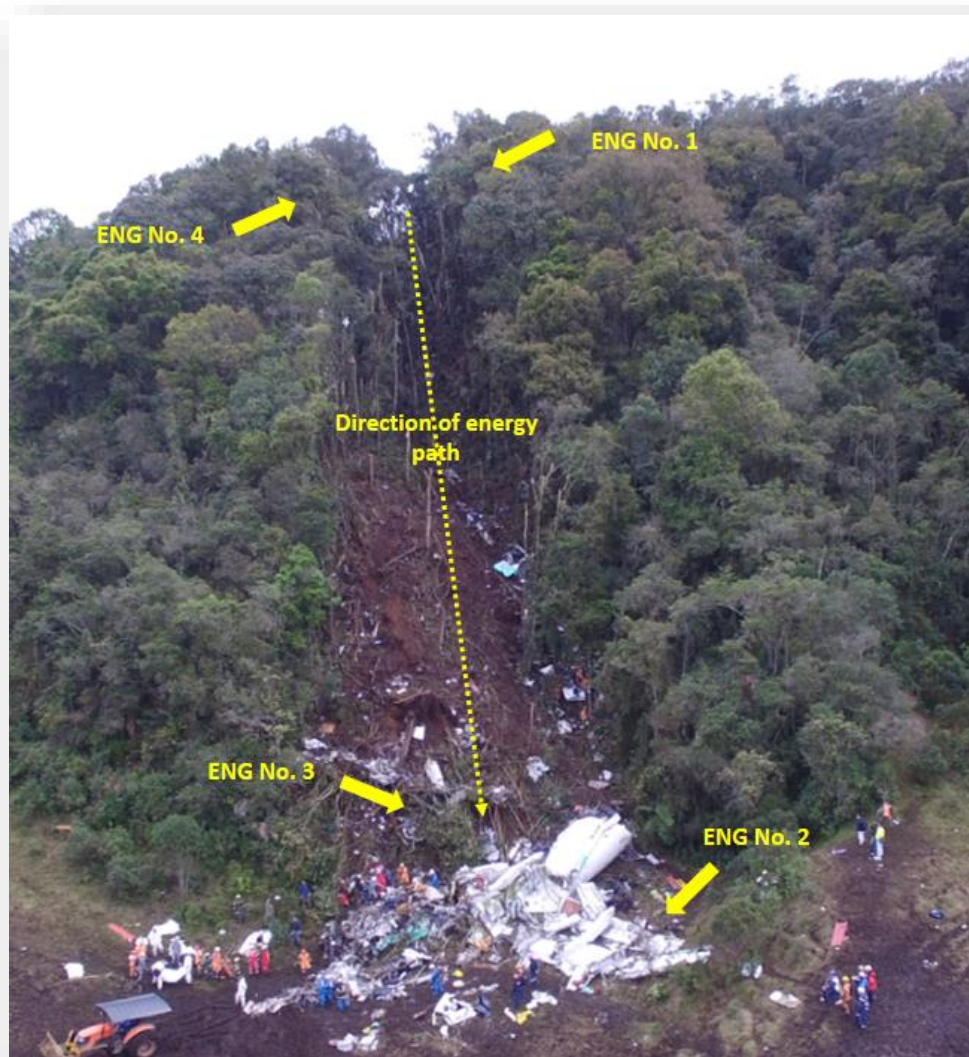
Figure 15. Location of engines in wreckage pattern.

Engines No. 1 and No. 4 were found near the initial point of impact. Engine No. 1 on the left, and No. 4 on the right. Engines No. 2 and No. 3 were found in the area of the main wreckage, engine No. 2 on the left, and engine No. 3 on the right (Figure 15). Engine No. 3 was found supported by a tree that was ripped from the ground on a slope that was considered unstable, so it was not possible to thoroughly examine the engine on site.

The field inspection of engines No. 1, 2 and 4, showed no evidence of fire or internal failure in them. There were different types of damage to the engines and they all had abundant vegetation, dirt and tree debris in their intake sections. None of the engines showed any

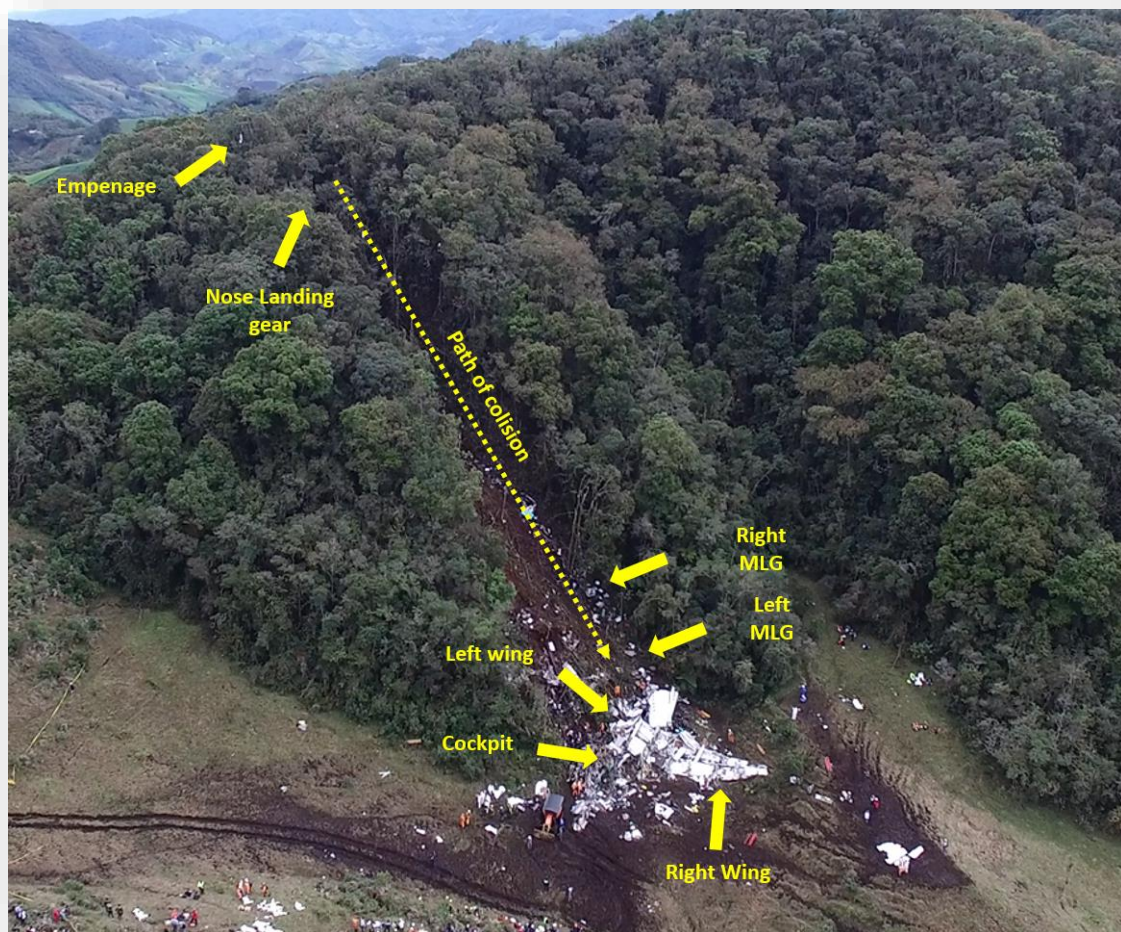
Figure 16. Location of post-impact path and main wreckage

Among the major aircraft parts that could be identified, were the cockpit, the front part of the fuselage, the wings, the rear section of the fuselage and engine No. 2. The remains slid downhill through the vegetation in mountainous terrain (Figure 16).

The wings remained attached to the central section (center fuel tank) in direction of movement and in inverted position.

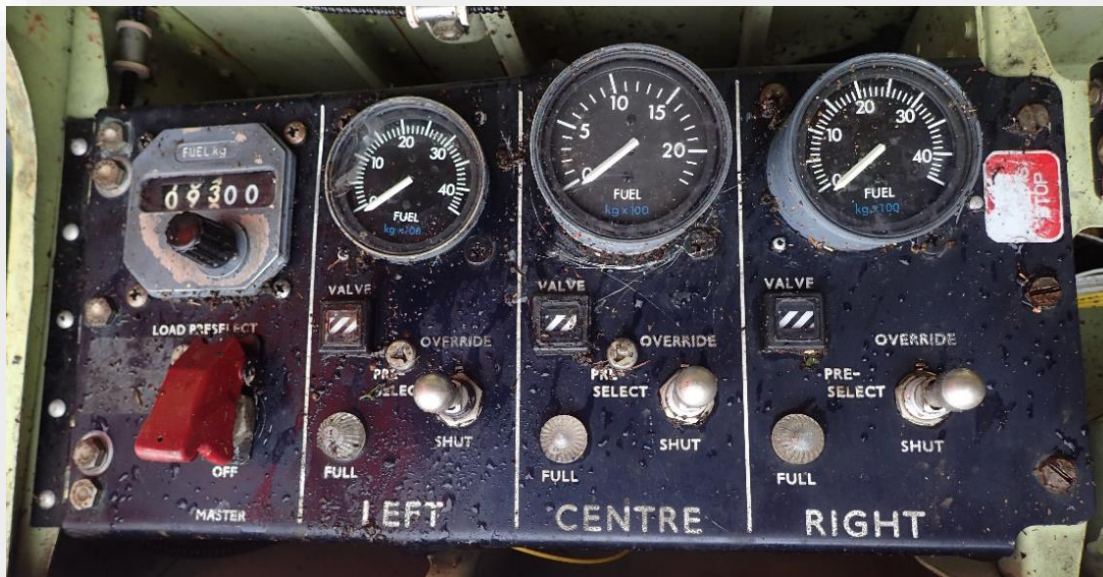
Figure 17. Wing Refueling Panel

The refueling panel (Figure 17) showed a fuel load of 9,300 kg²⁵. The three fuel quantity indicators in the panel indicated zero, a condition that is expected when the power supply is lost. The three fuel valve selection switches were in PRE-SELECT position. This position is not correct since the switches should have been in SHUT position according to the refueling procedure described in the Aircraft Maintenance Manual (AMM), Chapter 12-10-28, Item 5. (D) (9).

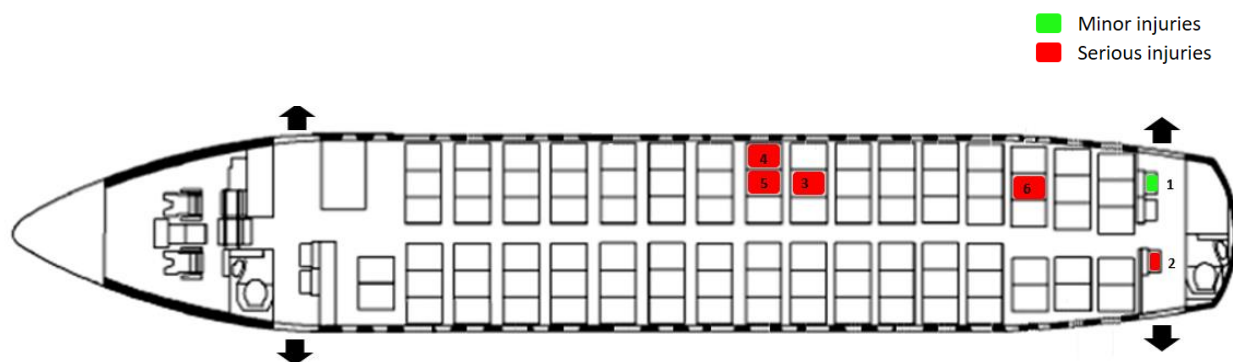
Figure 18. Approximate distribution of minor and serious injuries on CP 2933

The passengers who occupied the positions marked with red and green colors, located on the right side - the right wing section - and in the back section of the aircraft had survival

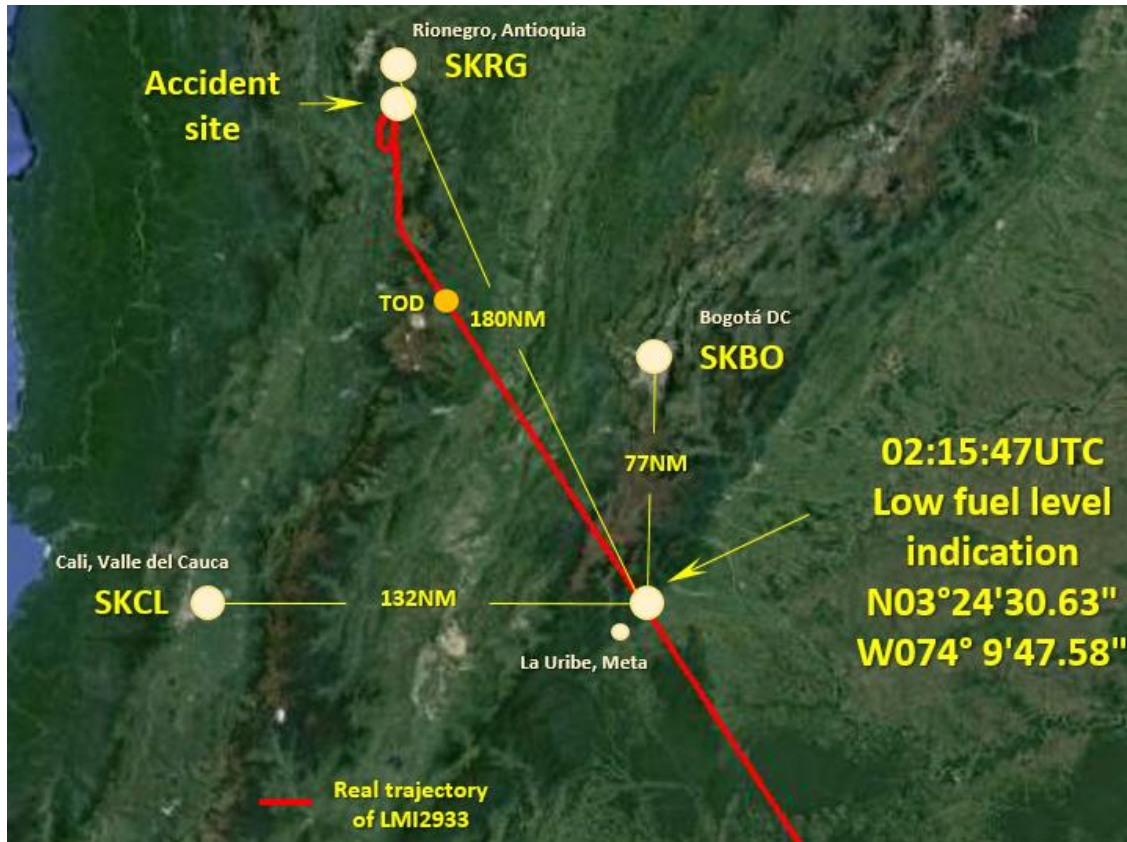
Figure 19. Approximate position of CP 2933 where low fuel level indication occurred.

This is how - according to the FDR fuel consumption data - it was determined that the low fuel level indication event occurred approximately 40 minutes before the end of the FDR recording.

When observing the frequency of recording from the parameters in the FDR, it was not possible to determine with certainty which of the low level feed systems, L or R, would have worked first; however, it is likely that the two systems might have entered into operation within two minutes apart.
