# **The Aircraft Accident Investigation Board of the Islamic Republic of Iran**

## **Flight PS752 Accident Investigation**

# **Final Report**

### **Crash of Ukraine International Airlines Flight PS752**

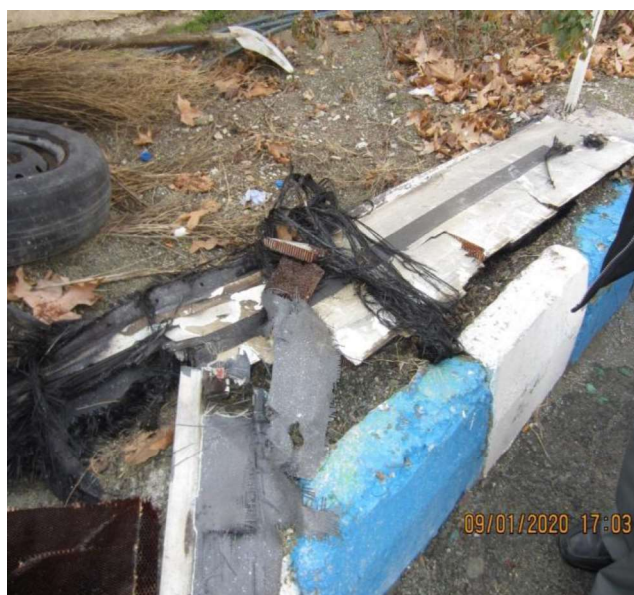
While flying past a village called Boke near Shahriar, some skin pieces belonging to the aircraft wing back end surfaces (Figure 9) were detached and found on the ground at position  $35^{\circ}35'55''\text{N}$ ,  $50^{\circ}59'00''\text{E}$ . Some small pieces and a piece of the air conditioning system (Figure 10) were found at position  $35^{\circ}35'53''\text{N}$ ,  $50^{\circ}59'43''\text{E}$ , about 10 kilometers before the crash site, which was collected by the locals in residential complexes and delivered to the respective rural council.

*Figure 9- Part of the aircraft wing*

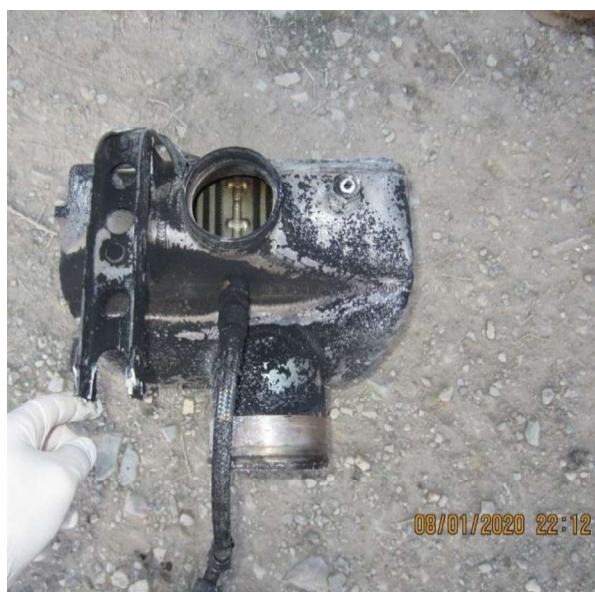
*Figure 10- A part of air conditioner found on ground before crash site*

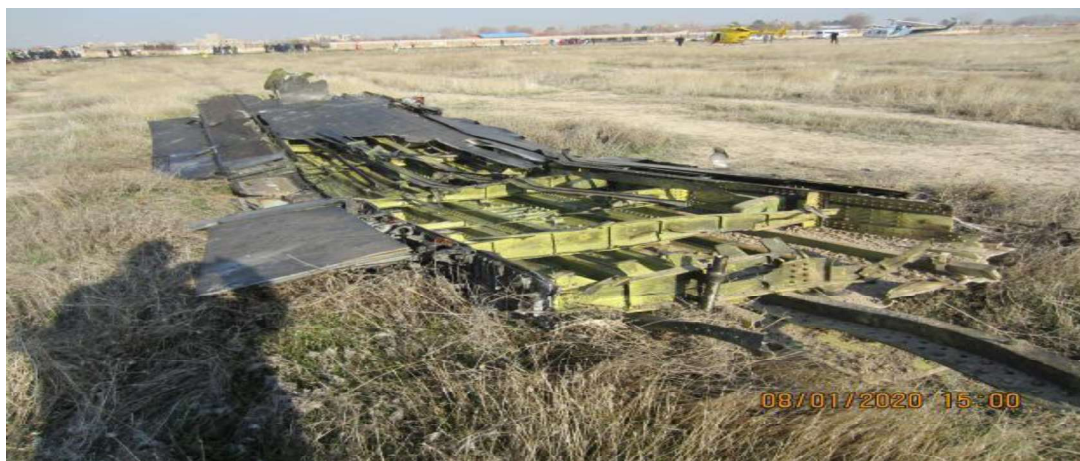
The outer skin of the left wing had signs of burning. There was no sign of fire at the place where the piece was found and the vegetation surrounding

it was undamaged. This showed the burn on the wing had occurred before the crash into the ground. The inner walls of the wing indicated that the fire had not broken out into the aircraft fuel tank. (Figure 11)

*Figure 11- The aircraft left wing at the crash site*

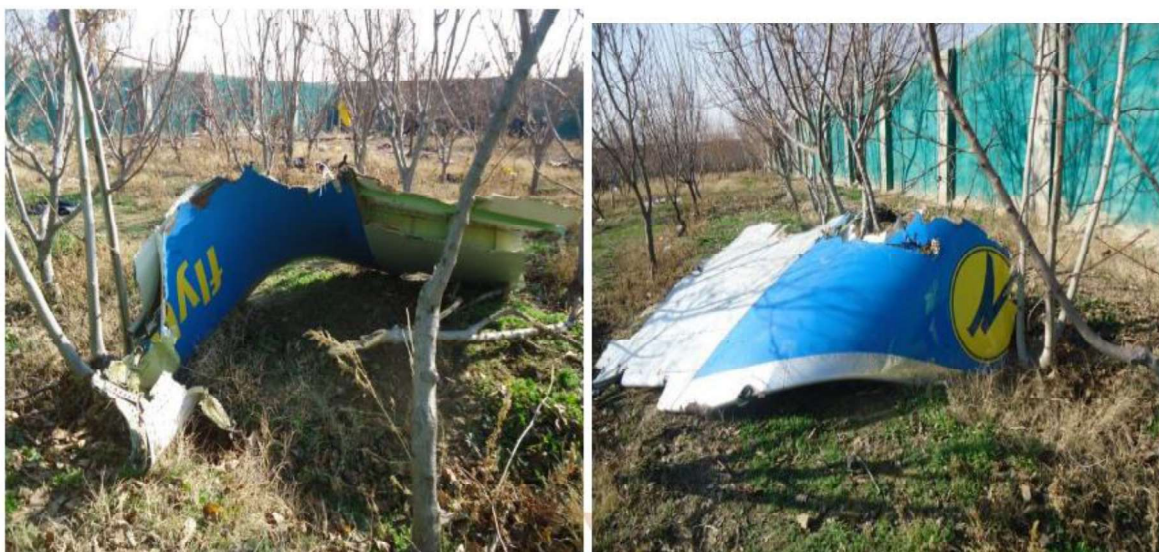
Some parts of the right wing together with the winglet indicated that the fire had not broken out into the right side of it (Figure 12).

*Figure 12- The aircraft right winglet*

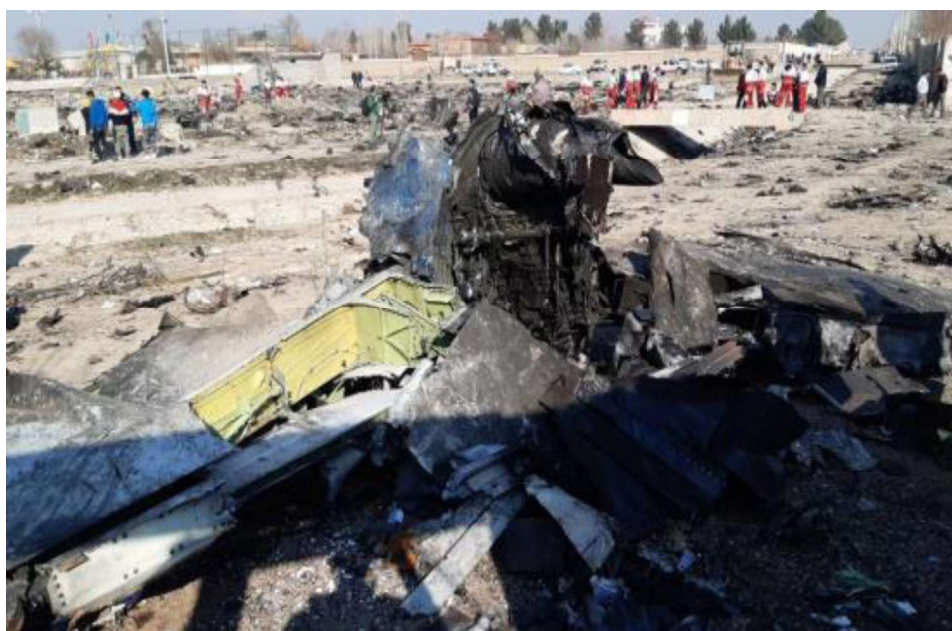
Smoke and burn were observed on the ground close to the Auxiliary Power Unit (APU) (Figure 13).

*Figure 13- Auxiliary Power Unit*

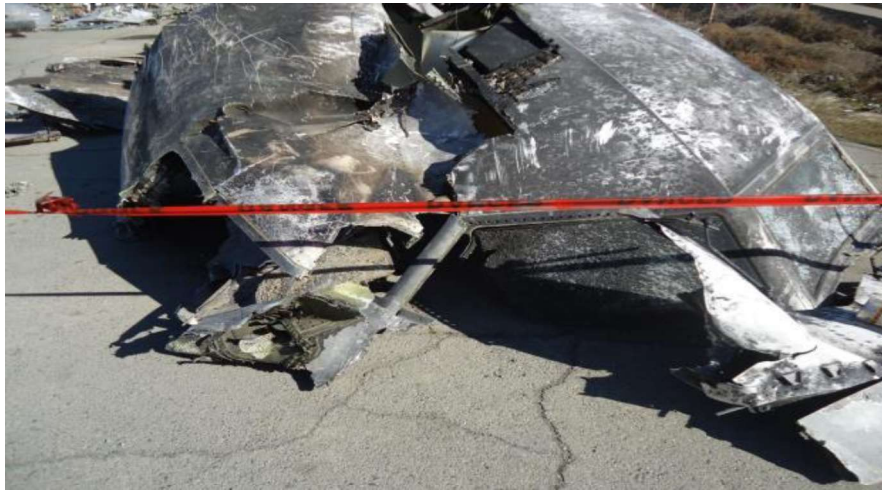
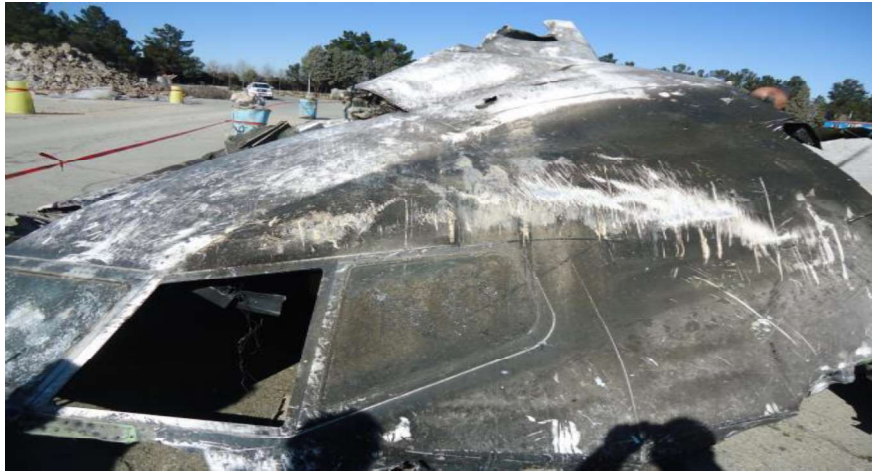
*Figure 14 - Closer view of the cockpit*

The traces of fire and smoke on the cockpit outer skin mark two situations: before and after the ground impact. In fact, it revealed that the fuselage had caught fire before the ground impact.

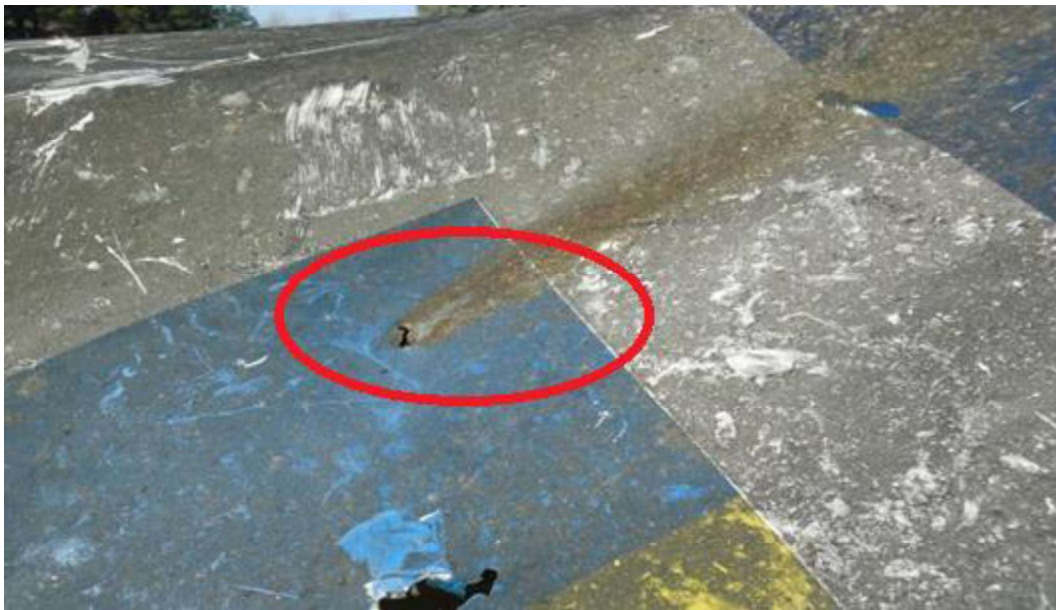
Laboratory results from the sample smoke layers around the holes show that the chemical base of the smoke was carbon, in which no traces of explosives were found.

*Figure 16- Hole in the fuselage with a trace of a different color of smoke*

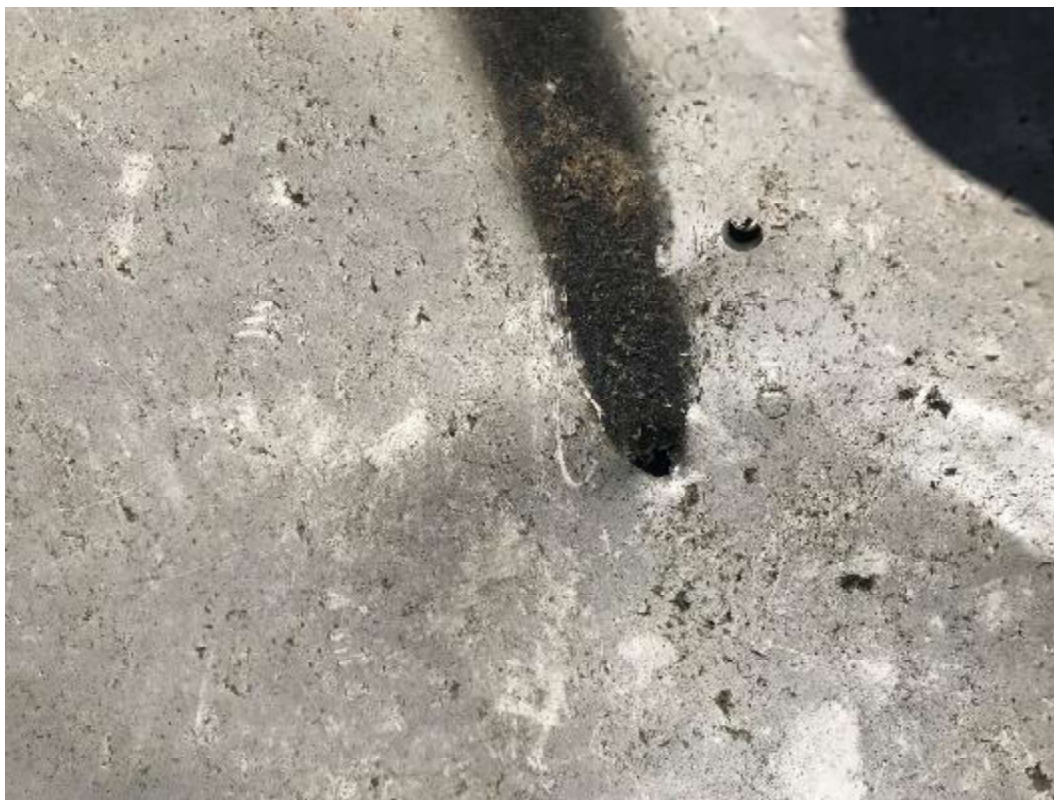
*Figure 18- Hole on the fuselage near the cockpit and exhaust fumes*

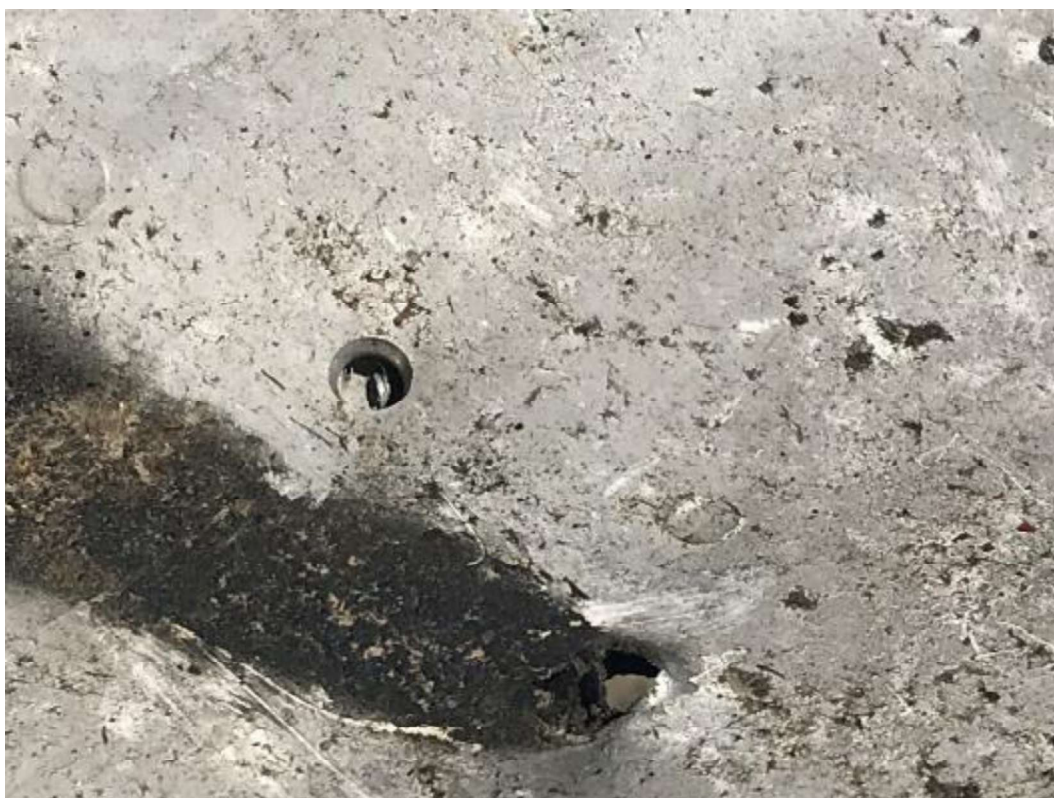
*Figure 19- Closer view of the hole on the fuselage near the cockpit and burn signs in the hole area*

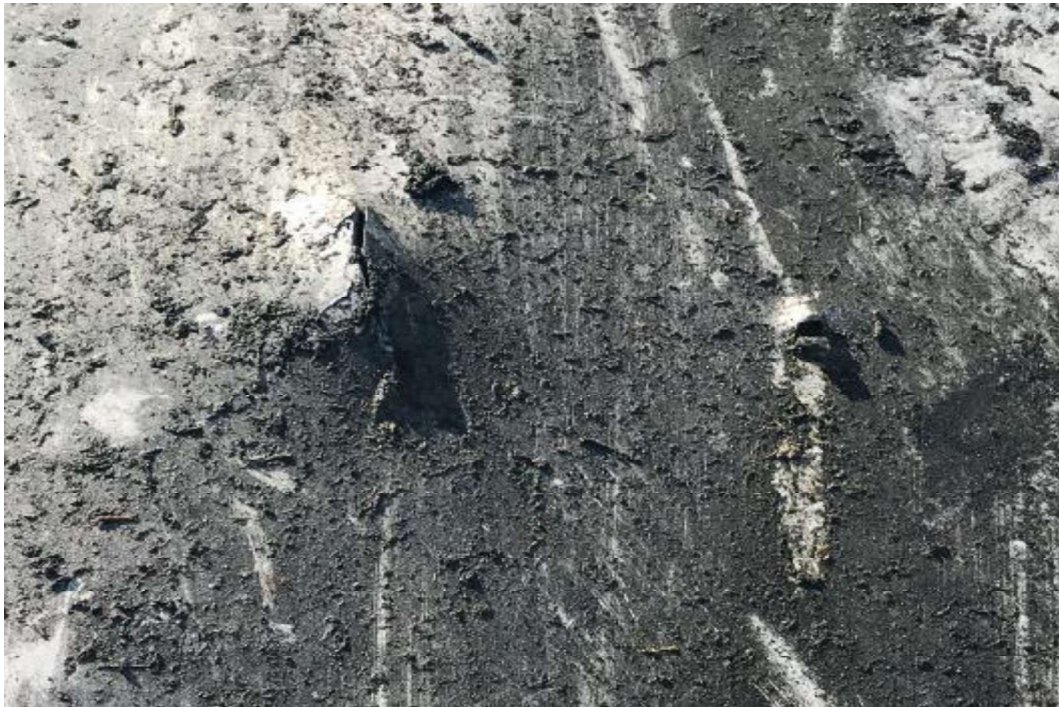
*Figure 20- Crack with an outward hole in the skin of the structure near the cockpit*

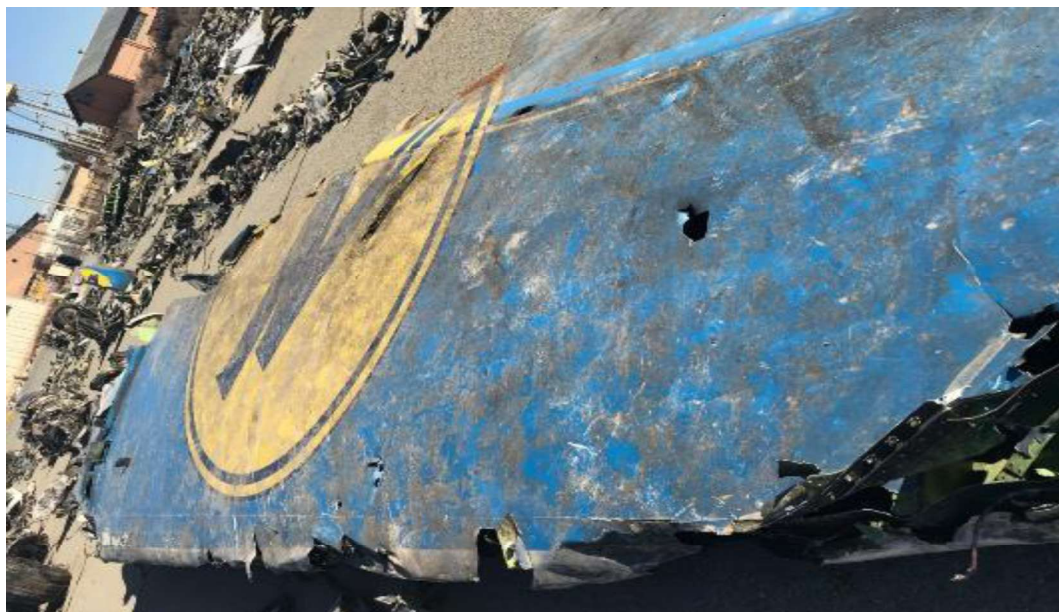
*Figure 21- Holes and cracks on vertical stabilizer*

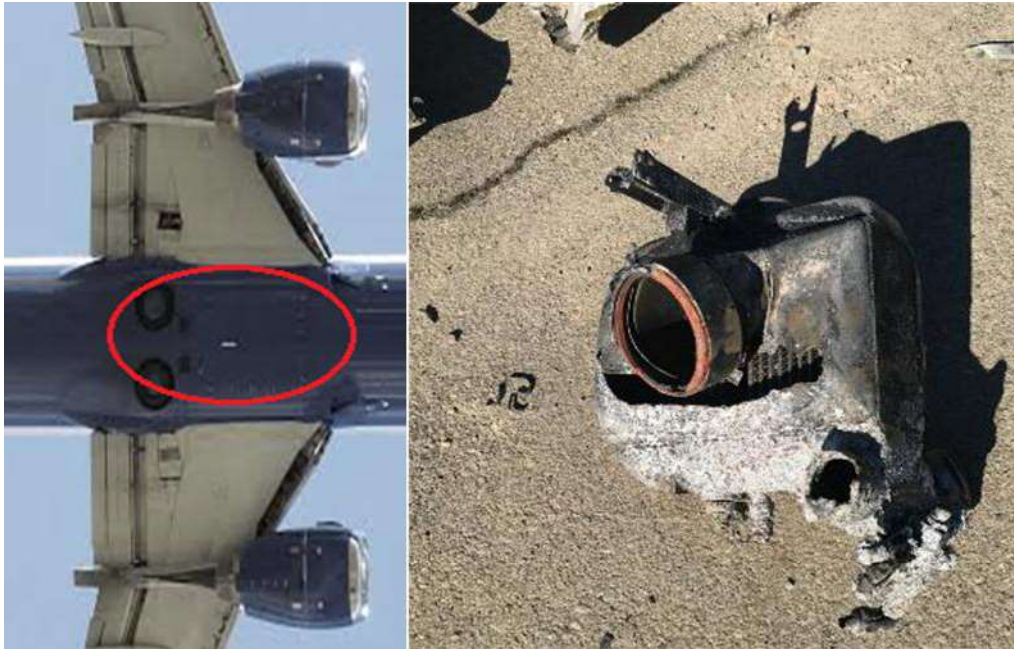
another heat exchanger found at the crash site, on which molten aluminum was observed, indicating a severe fire in this part.

*Figure 22- The second heat exchanger found at the accident site and its installation point on the fuselage*

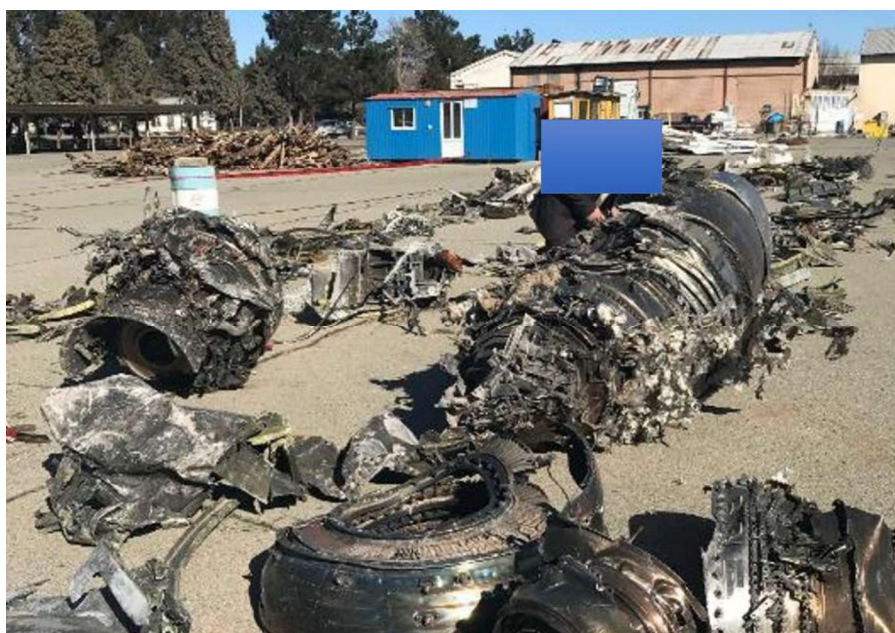
Two aircraft engines were found at the accident site, which were totally destroyed (Figure 23). The damage observed on the rotating parts shows that the engines were working. The evidence revealed no explosion or severe fire on the engines and it seemed that most of the damage had been caused by deforming due to ground impact.

*Figure 23- The two aircraft engines*

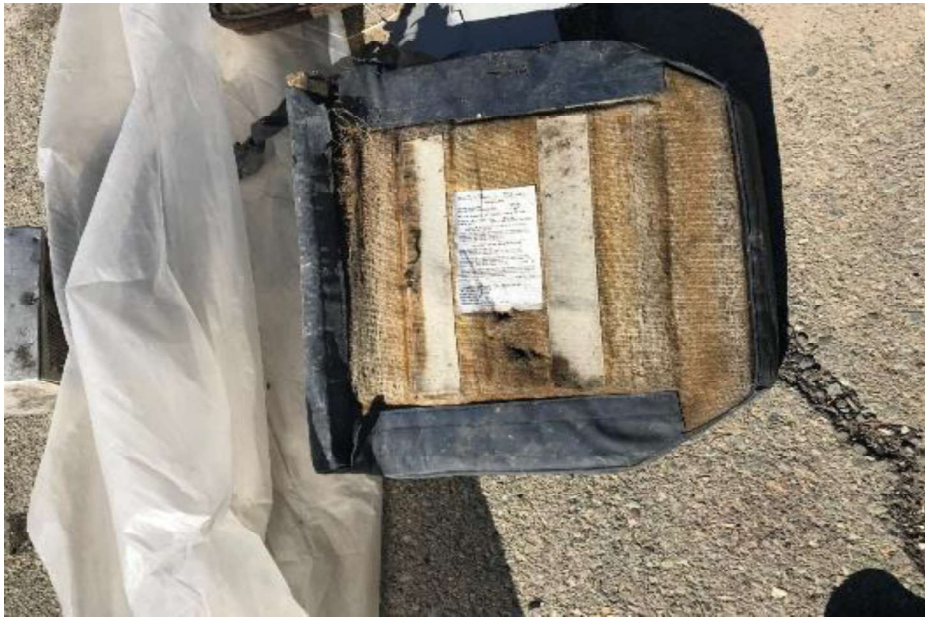
Figure 25- One of the remaining passenger seats with holes in it

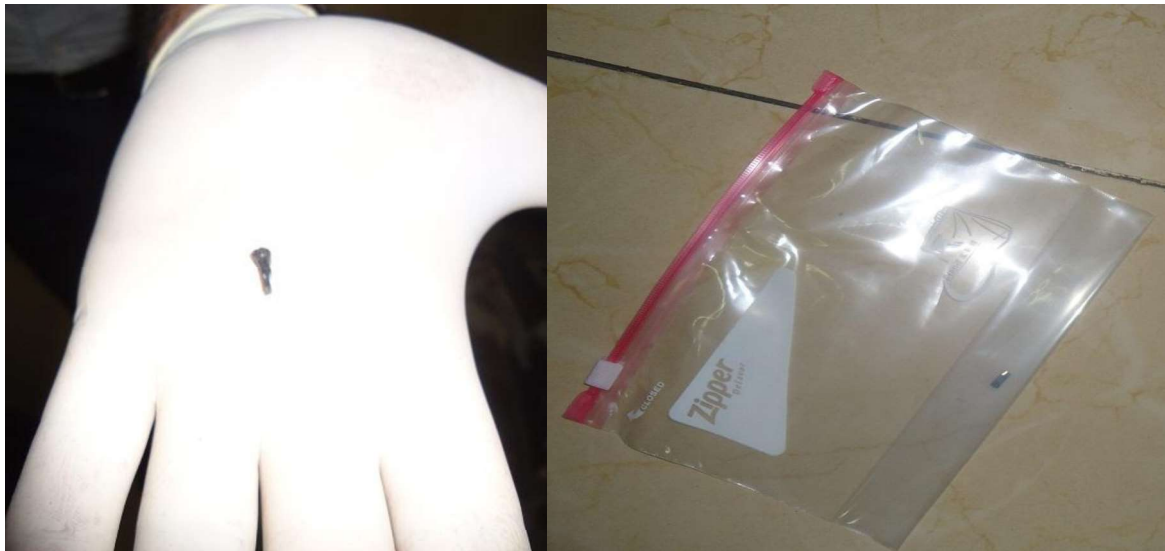
Figure 26- Metal objects found in the passenger seats

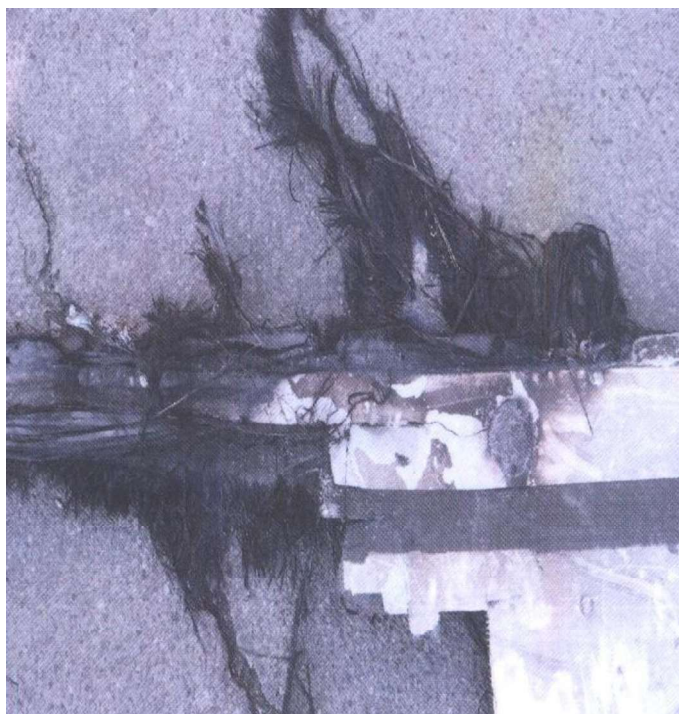
Based on the results yielded through GC/Mass chemical analysis, the existence of Trinitrotoluene (TNT) explosives with a chemical formula C<sub>7</sub>H<sub>5</sub>N<sub>3</sub>O<sub>6</sub> was confirmed in the aircraft wing skin, which was found before the crash site. (Figure 27)

*Figure 27- The wing piece found before the accident site*

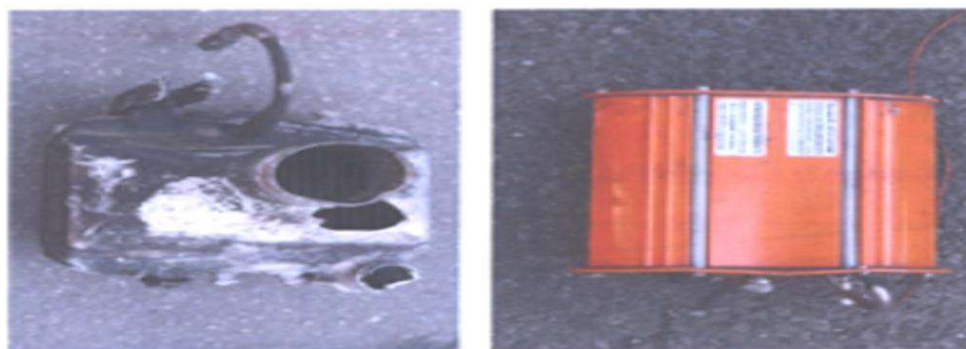
Figure 29- Pieces on which the explosive test was done

By sampling the air conditioning system and the two ELT pieces of the aircraft (Figure 29) and performing gas-chromatographic-mass spectrometry on each of the parts, the presence of negligible amounts of Dinitrotoluene (DNT) with the chemical formula  $C_7H_6N_2O_4$  was proven.

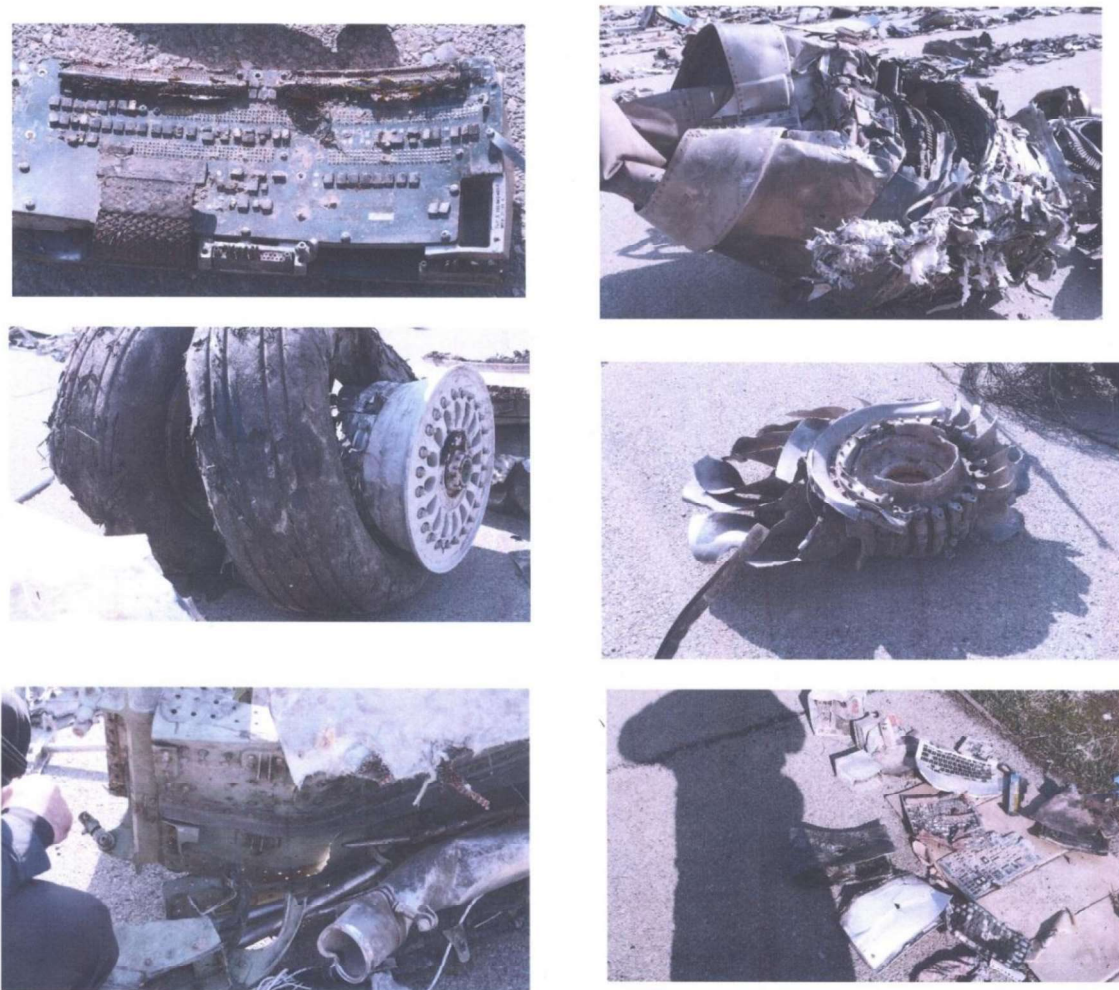
It should be noted that no explosive contamination was observed in the samples taken from the engines and other aircraft pieces or the objects inside the passenger cabin (Figure 33).

*Figure 33 -Some of the aircraft parts free from explosives*

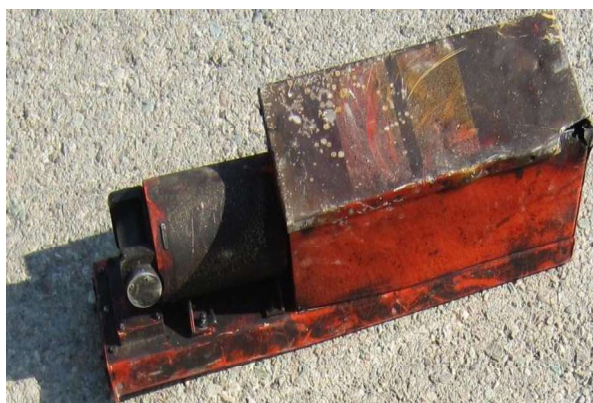
Damage to CVR had been more serious, whose main memory (CSMU) was detached due to the impact severity. The condition of these recorders indicated that the CVR and FDR had not been exposed to the fire in the aircraft, and after the ground impact, they were damaged or exposed to fire. (Figure 35 and Figure 36)

Figure 35- FDR physical appearance after the crash
