National Transportation Safety Board Aircraft Accident/Incident
Summary Report: Controlled Flight into Terrain GP Express
Airlines, Inc., N115GP, Beechcraft C-99, Shelton
Nebraska, April 28, 1993

CONTROLLED FLIGHT INTO TERRAIN
GP EXPRESS AIRLINES, INC., N115GP
BEECHCRAFT C-99
SHELTON, NEBRASKA
APRIL 28, 1993

**Adopted. January 19, 1994
Notation 6249**

Accident Number: **CHI-93-MA-143**
Airplane Operator: **GP Express Airlines, Inc.**
Airplane Type: **Beech Aircraft Corporation C-99, N115GP**
Location: **Shelton, Nebraska**
Date and Time: **April 28, 1993; 2350 cdt**
Injuries: **2 Fatal**
Type of Occurrence: **Controlled Flight into Terrain**

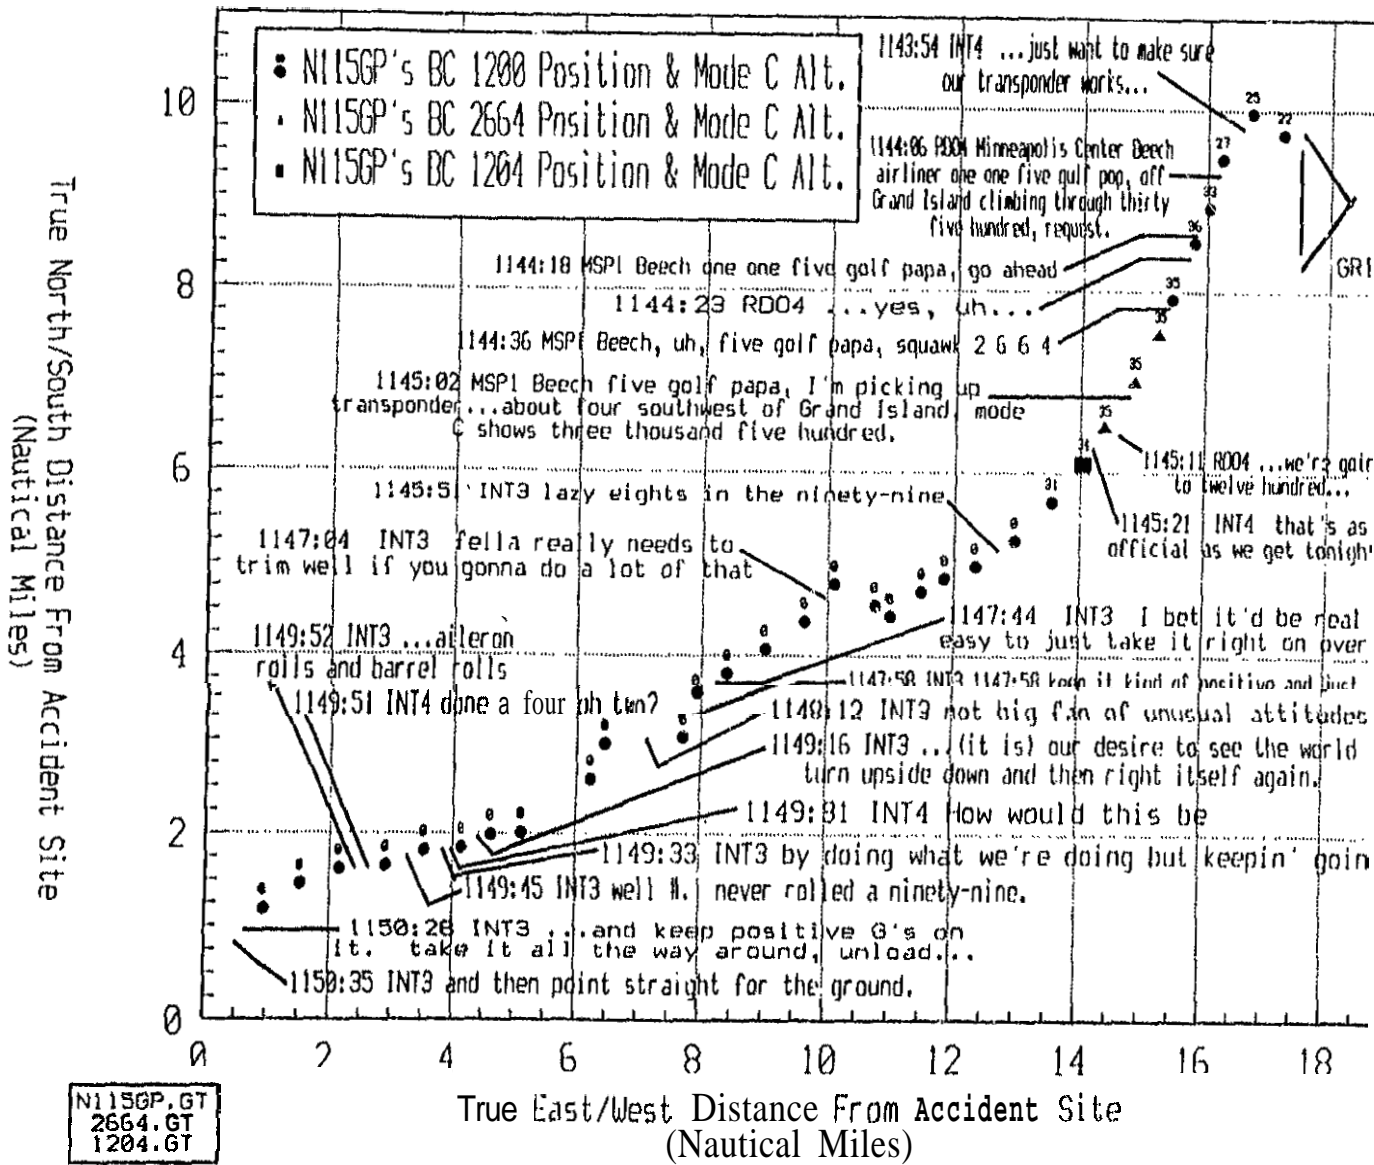
Figure 2—Ground Track of N115GP

The airplane was equipped with a cockpit voice recorder (CVR) that recorded the conversation between the pilots throughout the flight. The examination of the recording disclosed that the pilots were discussing the flying technique for rolling an airplane (an aerobatic maneuver) immediately before the crash. The ground track of the accident flight, plotted from radar data recorded at the FAA's Minneapolis Center, annotated with remarks from the CVR, is presented as Figure 2.
