Accident
on 25 December 2003
at Cotonou Cadjèhoun
aerodrome (Benin)
to the Boeing 727-223
registered 3X-GDO
operated by UTA
(Union des Transports Africains)

REPORT TRANSLATION
3x-o031225a

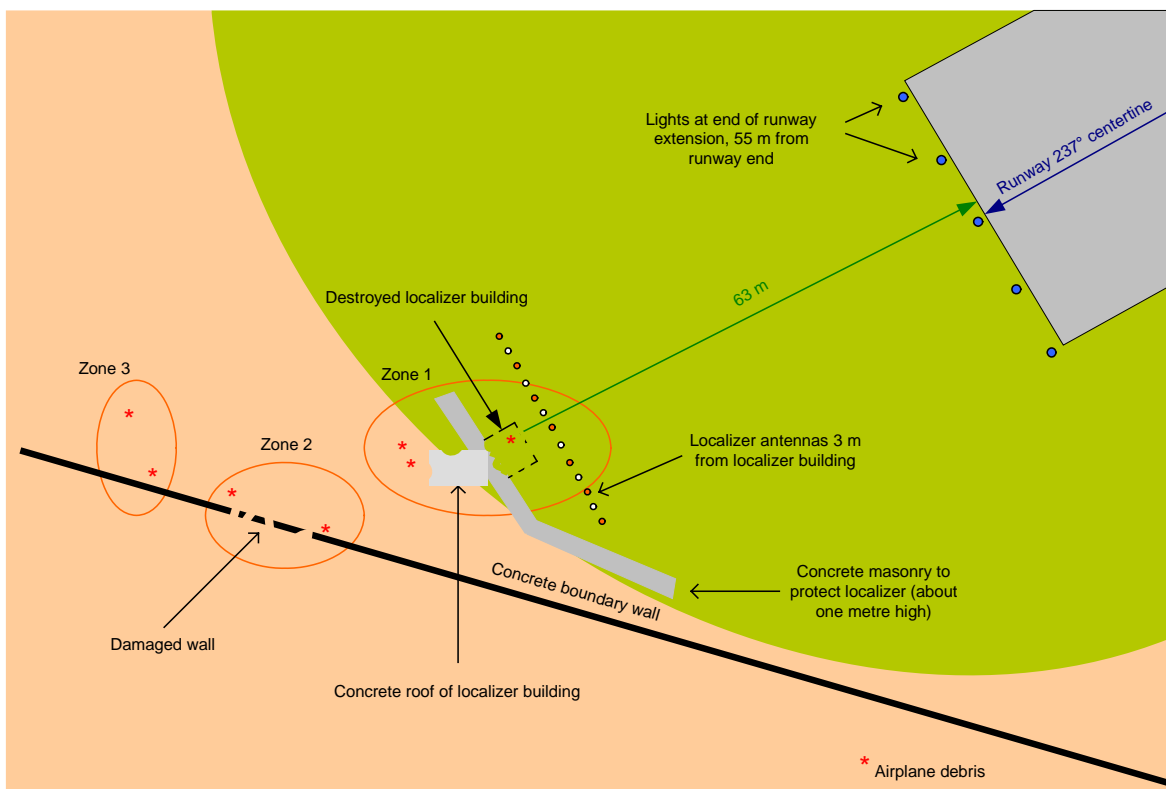
The illustration of site 1 (below) shows the distribution of the airplane debris in three distinct zones, with a total area of about 1,550 m².

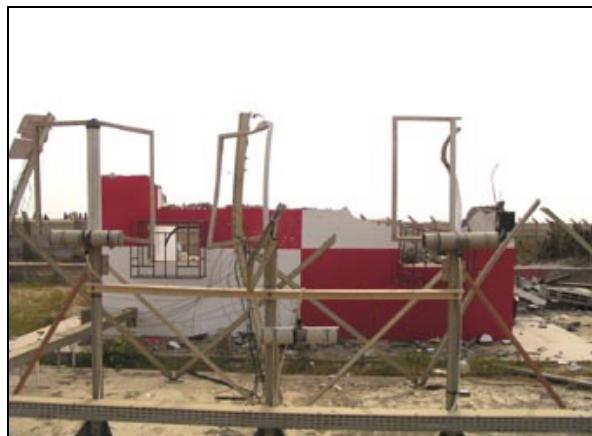
The photo below shows the north wall of the building with a black mark on the right side caused by the right inner tire. This mark was one meter twenty from the ground.

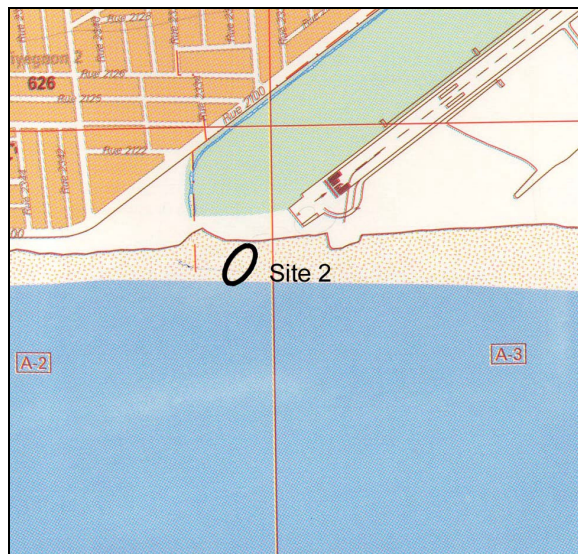
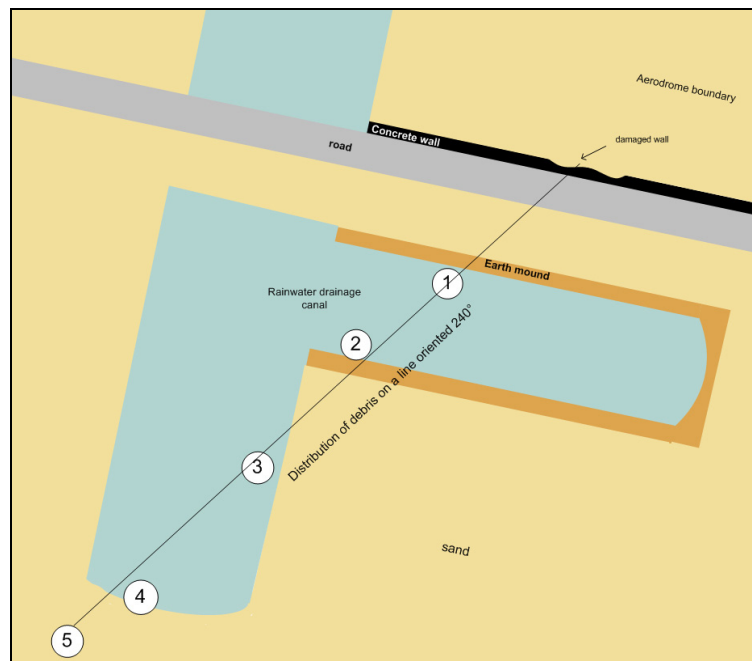
The plan of site 2 shows the position of the parts found in the rain drainage channel that crossed it. The heavy parts, numbered ① to ⑤ indicate the airplane's path after it passed over the aerodrome boundary wall.

The cylinder, the drag strut, the pivot link, parts of the side strut, the lock crank and the right ① main landing gear support beam ① were found in the canal, a hundred and fifty meters from the boundary.

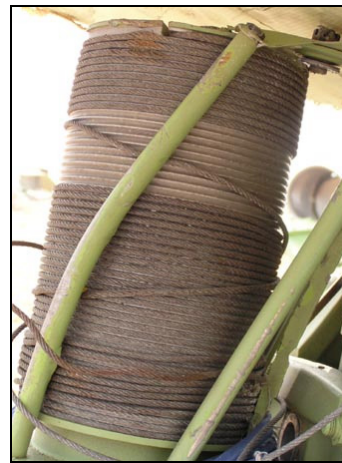
During recovery operations, the tail broke in two, the rudder and the central engine in one part and the stabilizer and the elevator in the other. The stabilizer jackscrew was intact; its drive cables were broken.

The position of the jackscrew did not make it possible to validate the position of the stabilizer, the cause and the sequence of the cable ruptures being undetermined.

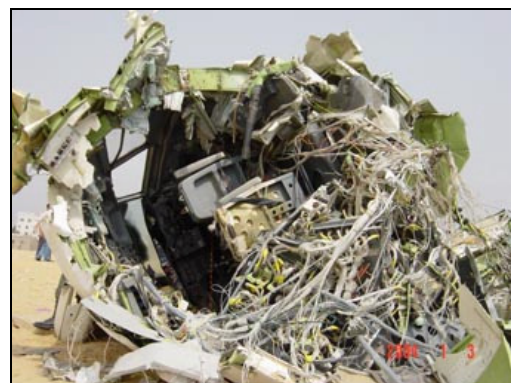
Cockpit

The cockpit was not very damaged, except for the Flight engineer's panel and a large part of the equipment. There was a strong compression mark on the floor and the skin of the partition and the outer right side of the fuselage. The nose gear had been ripped off.
