# DESCENT INTO THE VALLEY OF DEATH

It is 25 years since investigators reported on the crash of American Airlines Flight 383. Macarthur Job reviews the accident's significance.

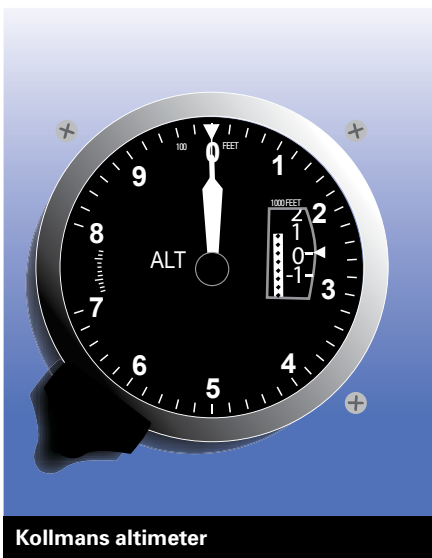
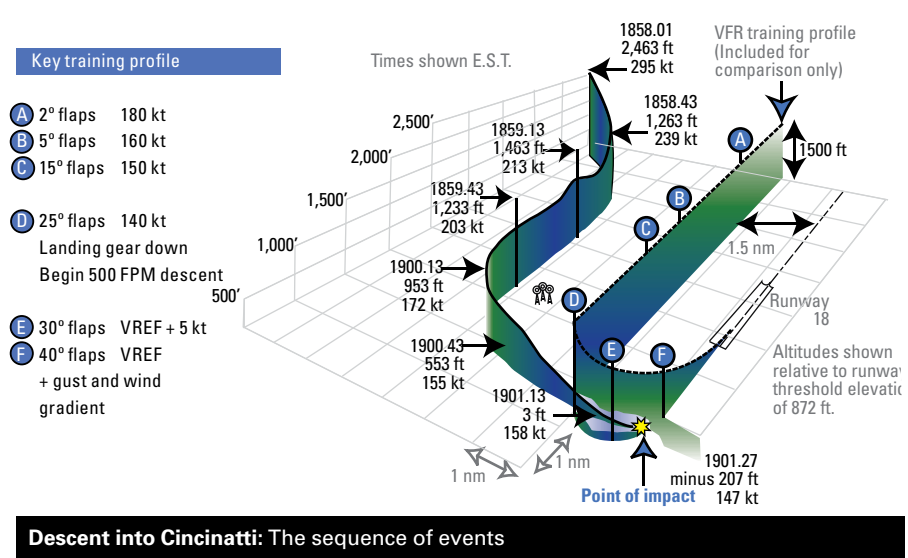
**Altimeters:** Another possible factor could have been altimeter misinterpretation. On the Kollsman drum-pointer altimeters fitted to the Boeing 727, hundreds of feet are

indicated by a single radial pointer. But thousands of feet are shown on a rotating drum, the relevant portion of which is viewed, like the barometric subscale, through a "window" in the face of the dial. (a cross-hatched marking on the drum emphasises the significance of indications less than 1000 ft).

The number below the drum index is read for the thousand foot indication, and the radial pointer for hundreds of feet. At constant altitudes or low rates of climb or descent when the drum is almost stationary, care is required to associate the correct thousands reading with the hundreds reading. For example, a reading of 900 ft would show "1" slightly above the drum index (with the "0" below the index), while the radial pointer would indicate "9" on the dial.

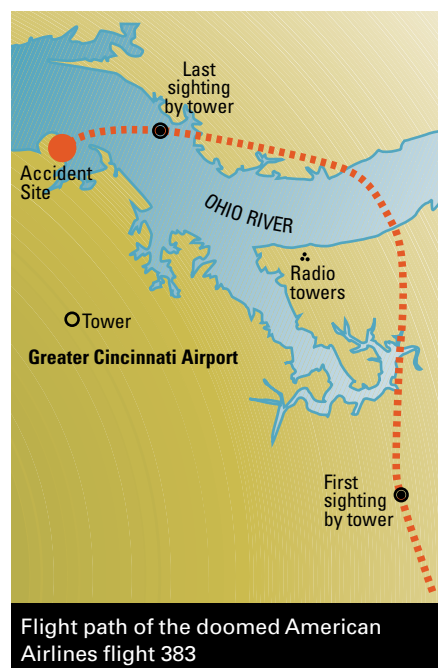
But in descending to a "below airport" elevation, as would have occurred on the QFE-set altimeters when the Boeing sank into the river valley, the radial pointer, rotating anticlockwise, would not point to the number of feet below.

Rather, a reading of 225 ft below zero (the level at which the aircraft crashed) would be displayed with the drum zero slightly *above* the index, and the radial pointer indicating immediately *below* the figure "8" (775 ft) on the dial. Thus, at negative values, the number above the drum index rather than the number below the index provides the thousands of ft reading. In other words, the drum presentation reverses at below zero readings.

Under conditions of infrequent or distracted altitude monitoring, the investigators thought that a misinterpretation of the pilots' altimeter readings could have occurred.
