**Aircraft Accident Investigation Bureau**

Aircraft Accident Investigation Preliminary Report

B737-8 (MAX) Registered ET-AVJ

Report No. AI-01/19

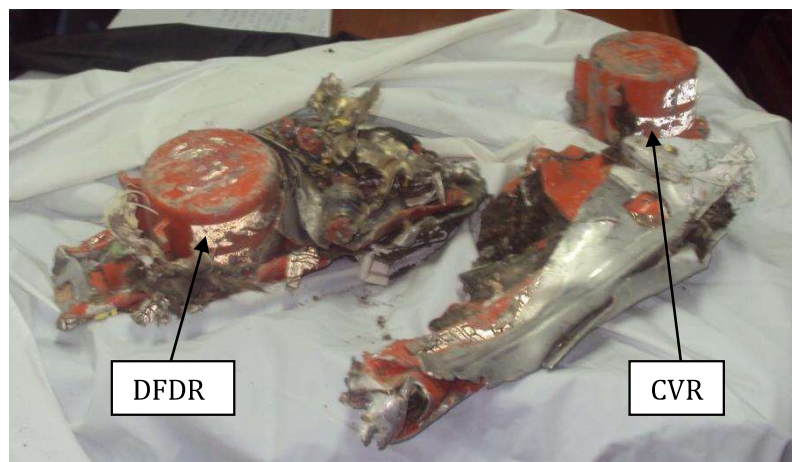
DFDR and CVR as discovered on the accident site.

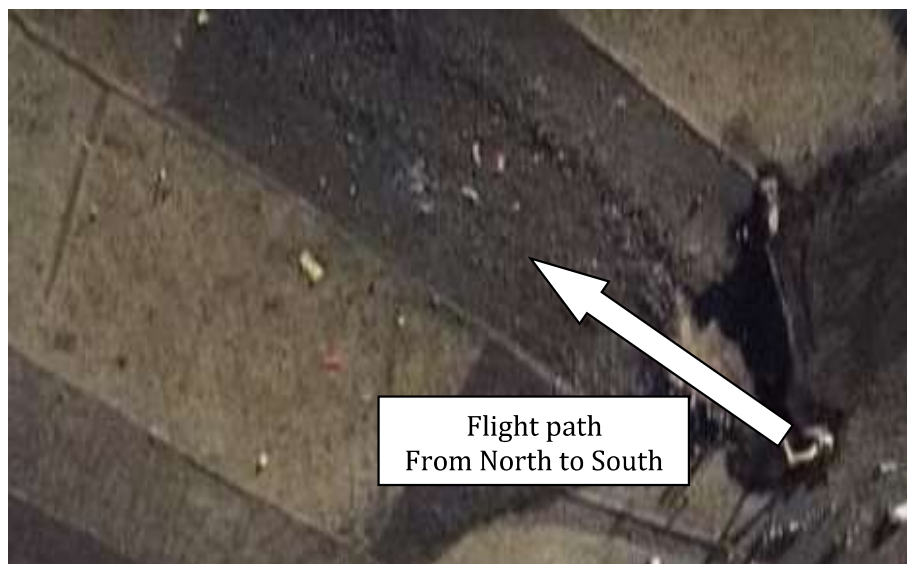
The Aircraft impacted in a farm field and created a crater approximately 10 meters deep (last aircraft part found) with a hole of about 28 meters width and 40 meters length. Most of the wreckage was found buried in the ground; small fragments of the aircraft were found scattered around the site in an area by about 200 meters width and 300 meters long.

The damages to the aircraft are consistent with a high energy impact.

Top view of the crater

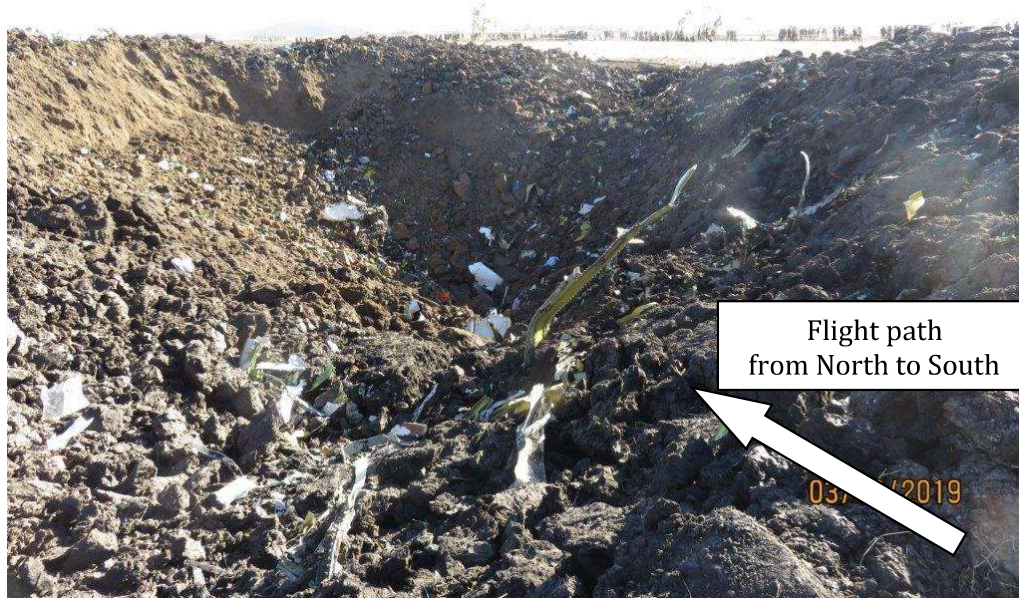
Close view of the crater before excavation

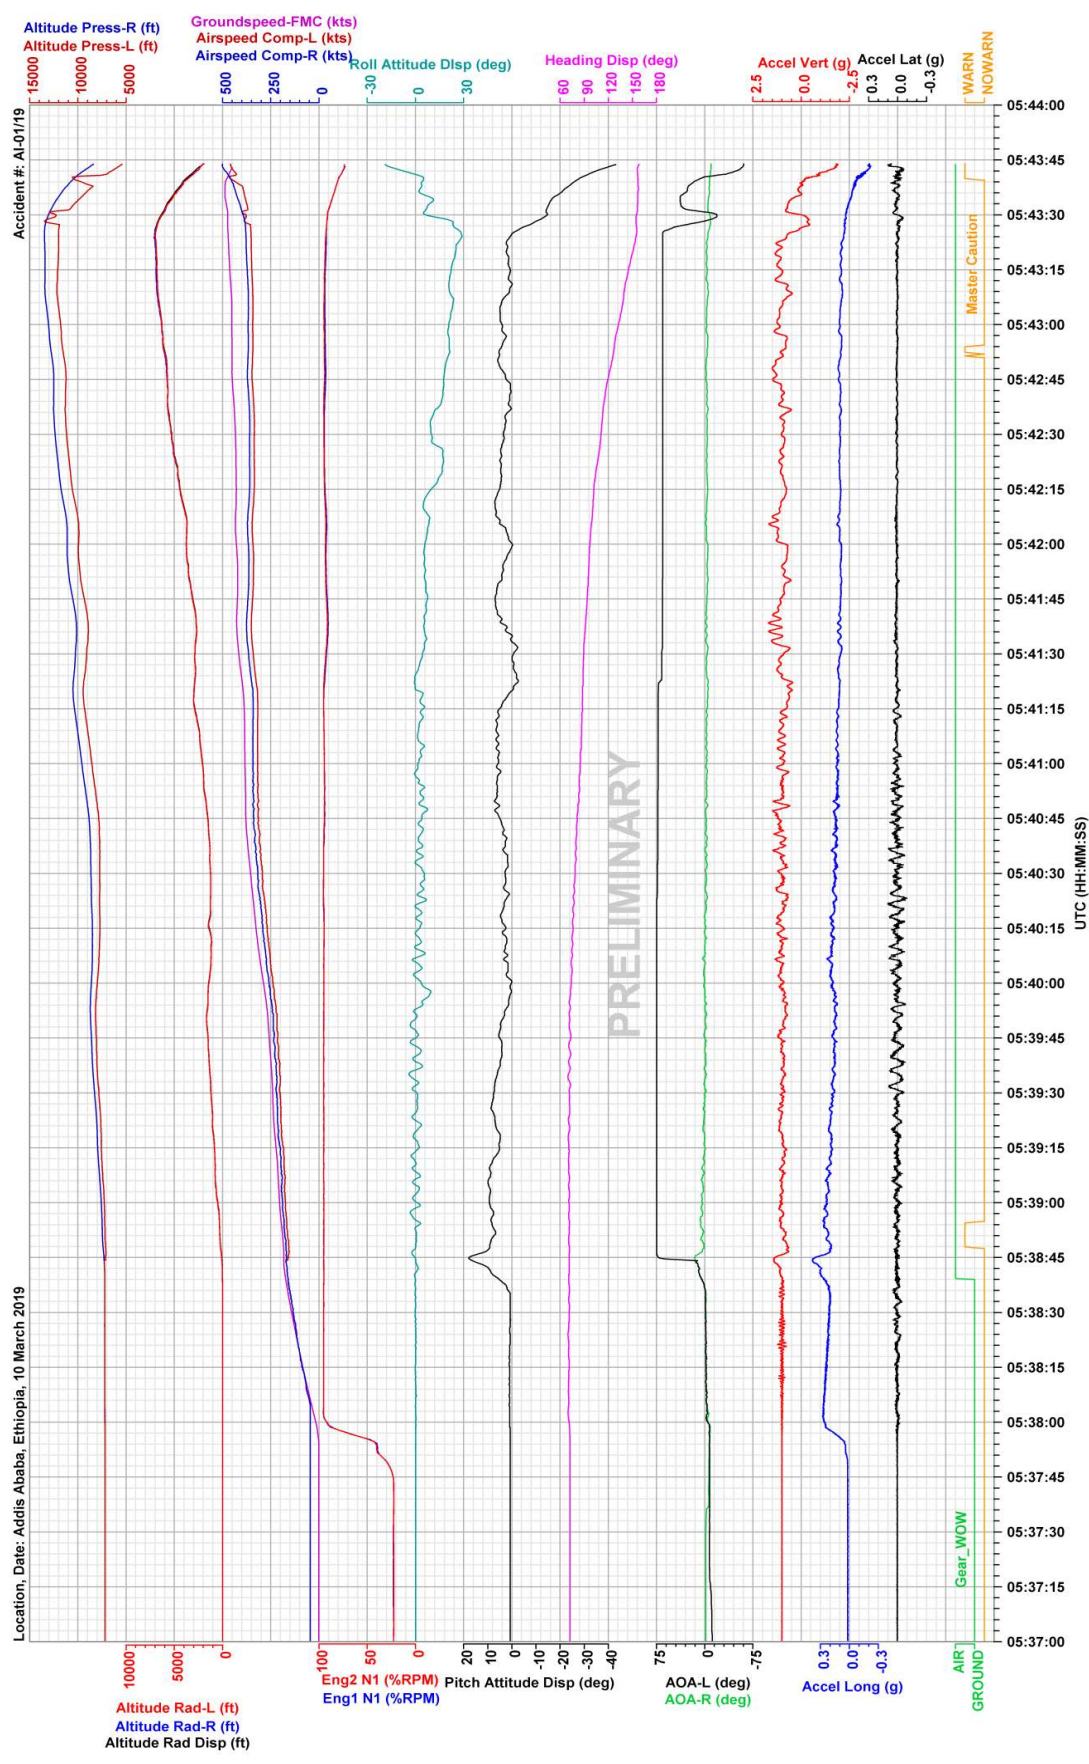
General Overview of Flight

At 05:38:44, shortly after liftoff, the left and right recorded AOA values deviated. Left AOA decreased to 11.1° then increased to 35.7° while value of right AOA indicated 14.94°. Then after, the left AOA value reached 74.5° in ¾ seconds while the right AOA reached a maximum value of 15.3°. At this time, the left stick shaker activated and remained active until near the end of the recording. Also, the airspeed, altitude and flight director pitch bar values from the left side noted deviating from the corresponding right side values. The left side values were lower than the right side values until near the end of the recording.

At 05:40:00 shortly after the autopilot disengaged, the FDR recorded an automatic aircraft nose down (AND) activated for 9.0 seconds and pitch trim moved from 4.60 to 2.1 units. The climb was arrested and the aircraft descended slightly.
