THE DUTCH
SAFETY BOARD

**CRASHED DURING APPROACH, BOEING 737-800,
NEAR AMSTERDAM SCHIPHOL AIRPORT,**
25 February 2009

The Hague, May 2010 (project number M2009LV0225_01)

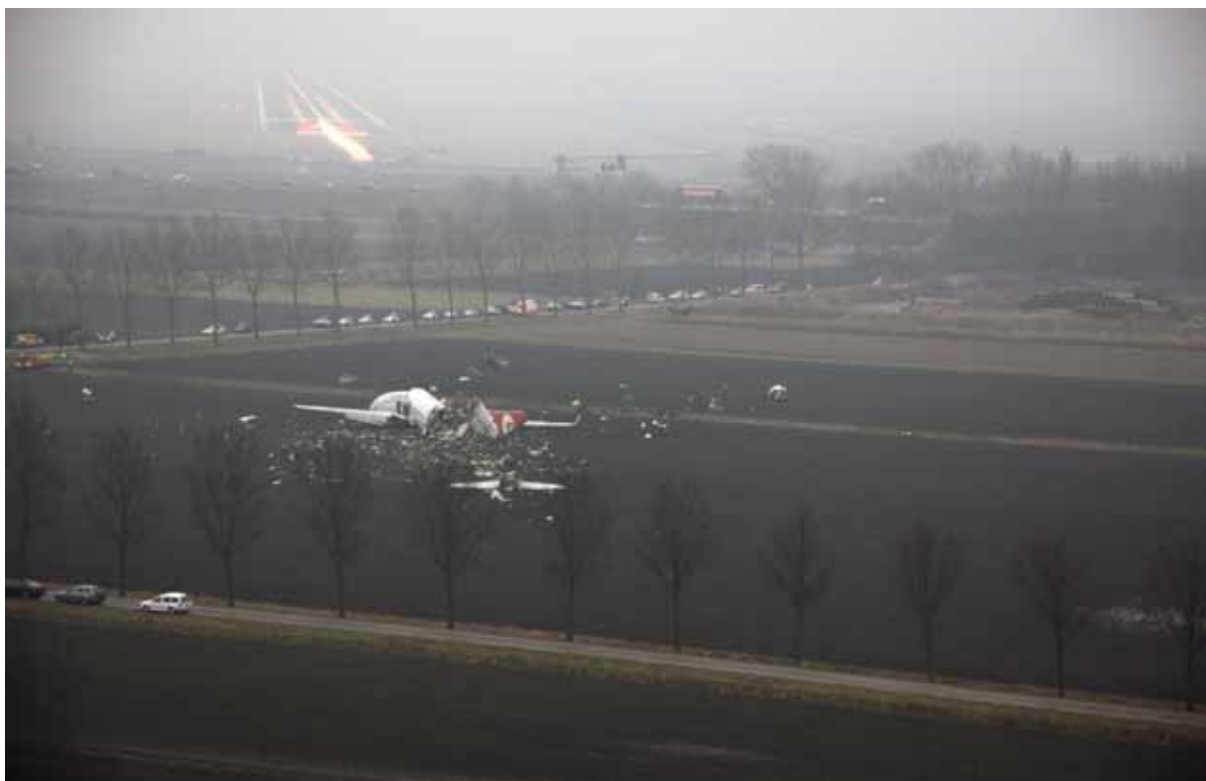
A Boeing 737-800 of Turkish Airlines made a flight from Istanbul Atatürk Airport in Turkey (LTBA) to Amsterdam Schiphol Airport (EHAM) on 25 February 2009.¹ The aircraft crashed while on the approach for runway 18R (the 'Polderbaan') and ended up in a field at a distance of approximately 1.5 kilometres from the runway threshold (see illustration 1). Four crew members and five passengers died and three crew members and 117 passengers were injured.²

Illustration 1: the Boeing 737-800 that crashed with runway 18R in the background (source: KLPD)

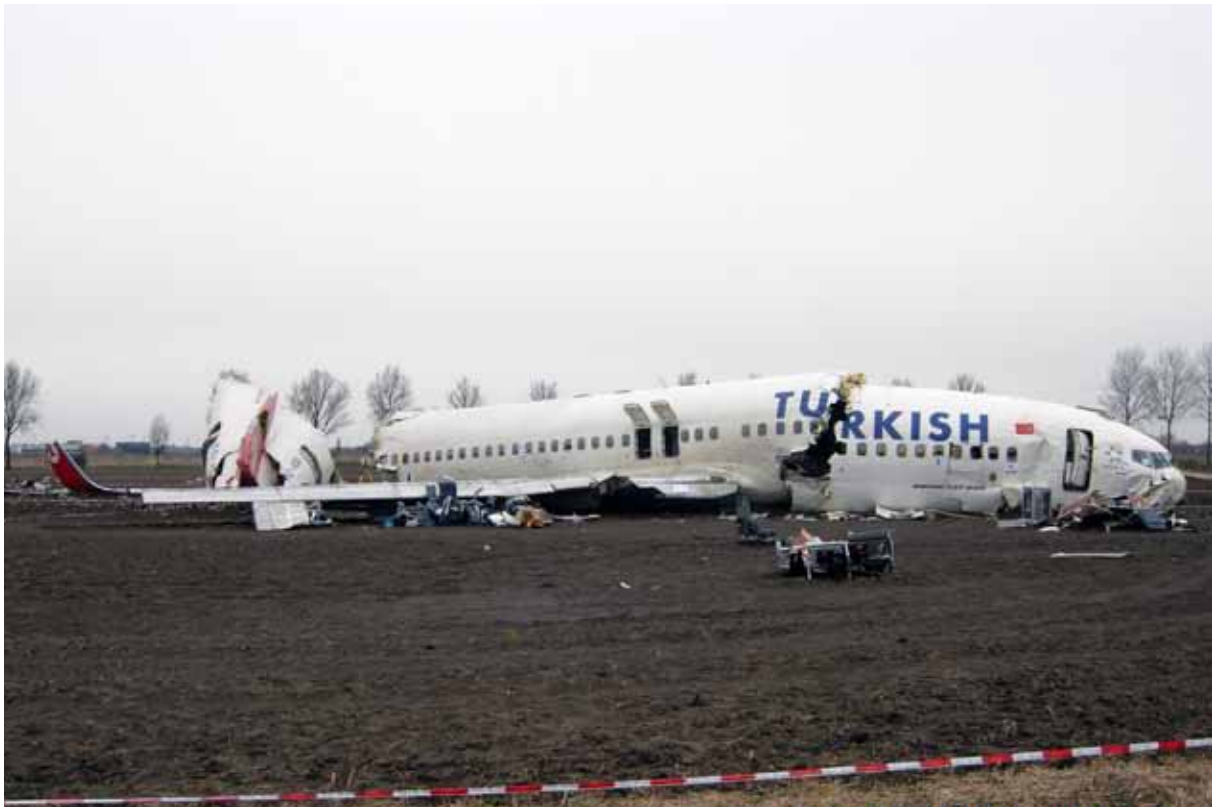
The aircraft was destroyed as a result of the impact. The fuselage of the aircraft broke into three sections; the tail section, the main section with the wings and the front section with the cockpit. The material damage to the aircraft is described in appendix K.

Illustration 5: side view of the Boeing 737-800

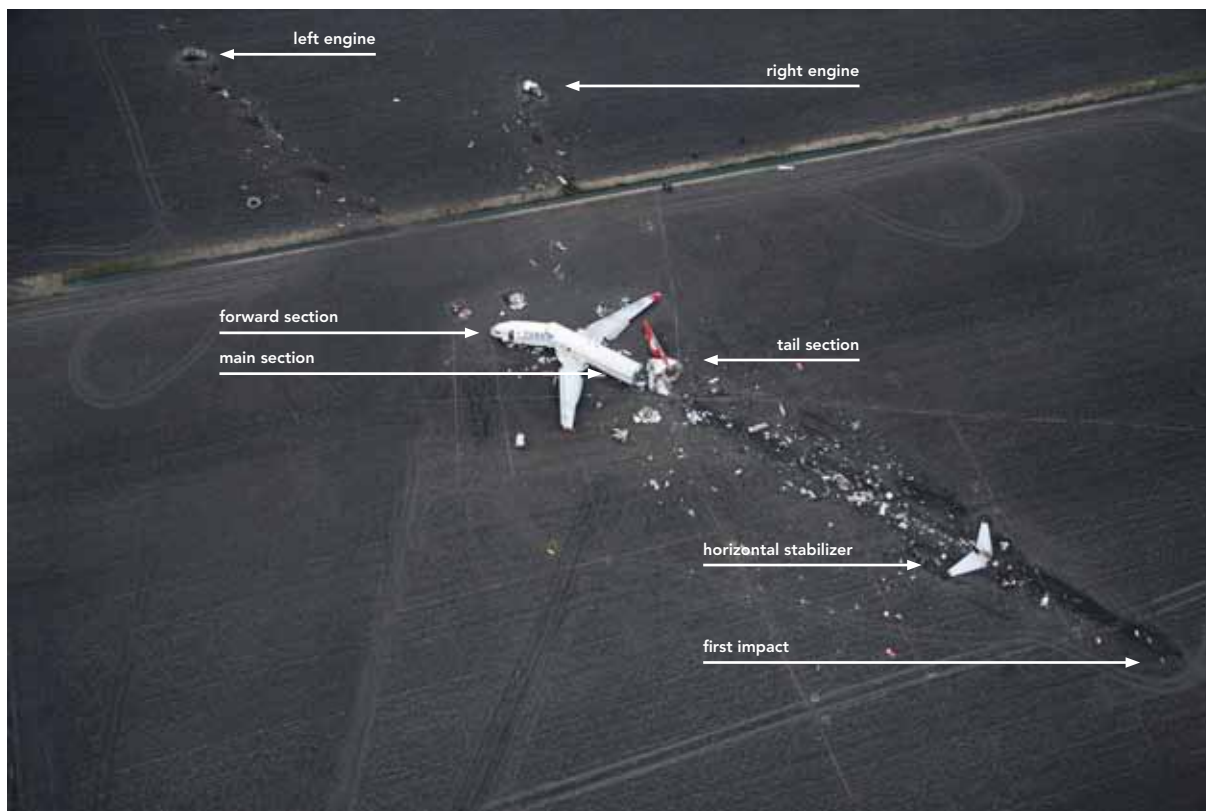
The traces of the impact revealed that the rear part of the fuselage was the first to hit the ground. The aircraft came to a standstill in a field relatively quickly due to the low forward speed that the aircraft had when impact took place. The soil conditions may possibly have had an additional braking effect.

All parts of the aircraft have been found at the location of the accident and there are no indications that something may have broken off during the flight. The flight data recorder and cockpit voice recorder data do not indicate this in any way either.

Illustration 6: aerial photo of the aircraft that crashed (source: KLPD)

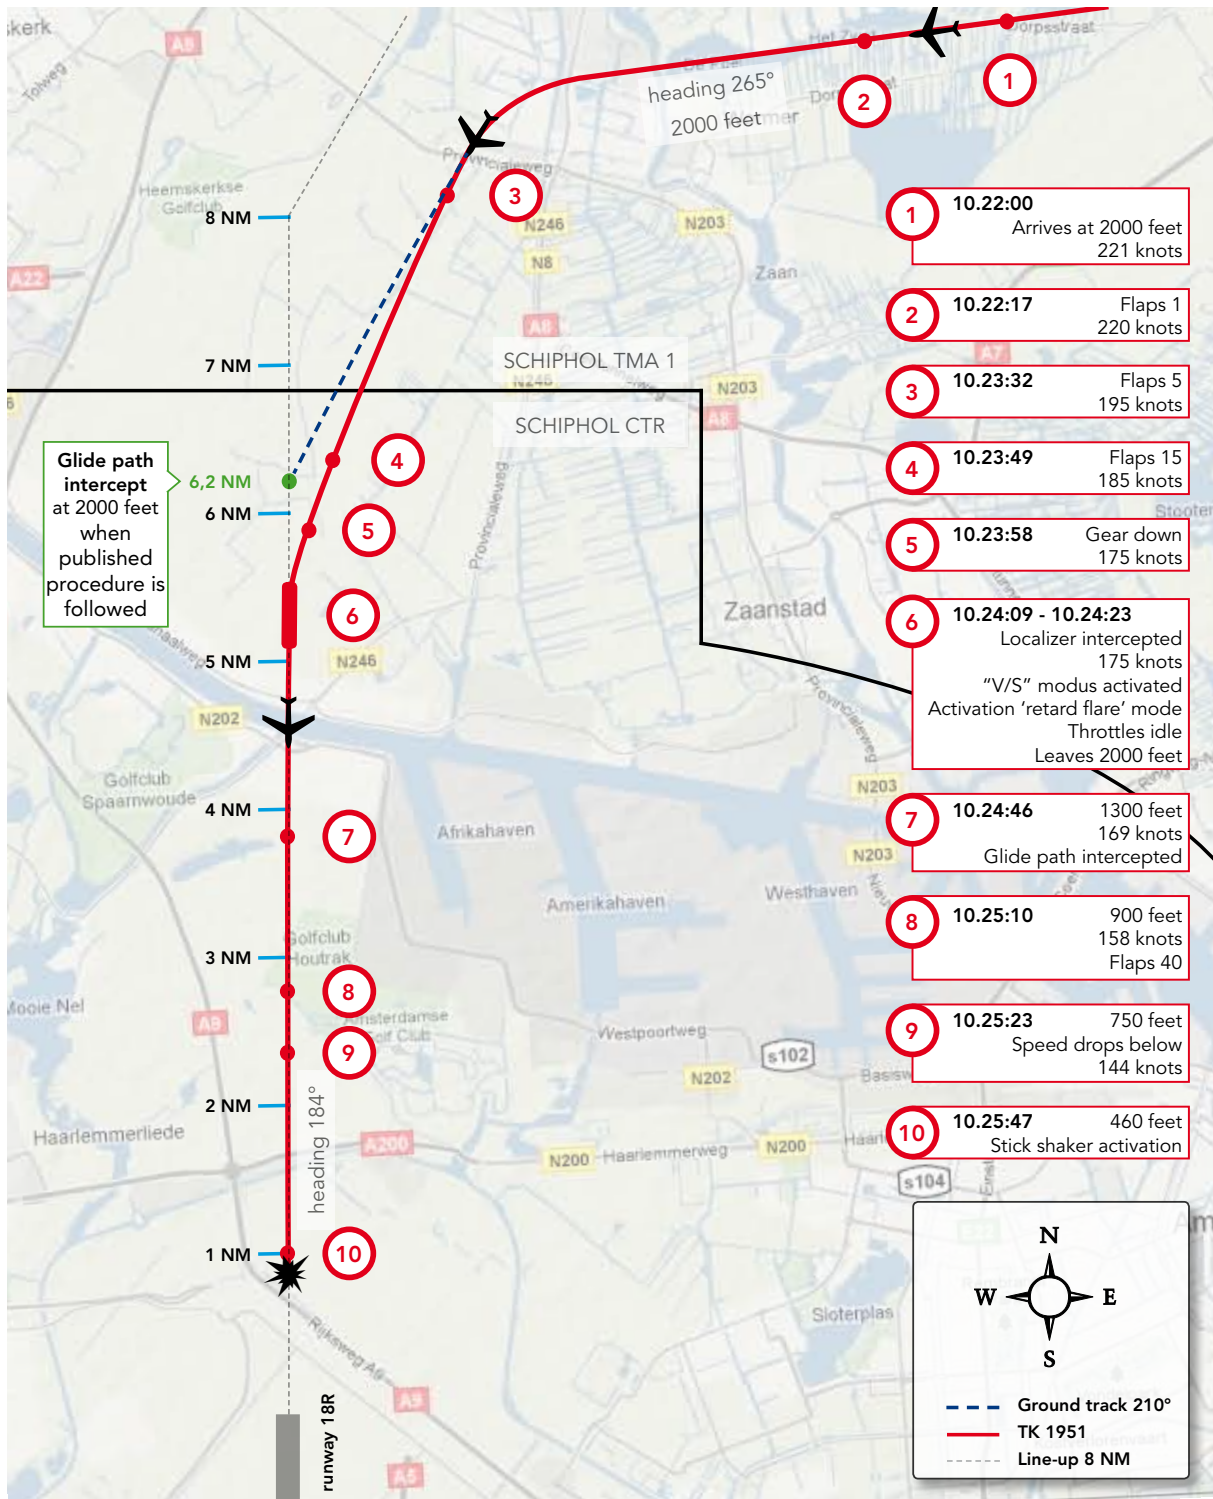
Illustration 8: top view of the ILS approach of flight TK1951 versus the intended ground track of the controller

Air Traffic Control the Netherlands has indicated that executing a turn-in manoeuvre between 5 and 8 NM for runway 18R at Schiphol airport as it occurred with regard to flight TK1951 occurs in more than 50% of all approaches for this runway. In addition, pilots sometimes ask for a short line up. LVNL is, therefore, of the opinion that aligning aircraft within the 8 NM is a normal situation. Air Traffic Control the Netherlands is also of the opinion for this same reason that aircraft crew do not have to be asked whether they can or wish to accept such a line up. Air Traffic Control the Netherlands states that air traffic controllers may broadly interpret the procedures for lining

The guidelines of the International Civil Aviation Organization say that an aircraft must be set up in such a way as to be flying horizontally on the final approach track before the glide path is intercepted. The Rules and instructions air traffic control is a document produced by Air Traffic Control the Netherlands, which includes guidelines, conditions and operating instructions for air traffic controllers. That document does not state that an aircraft must be given the opportunity to be flying horizontally on the final approach path before it intercepts the glide path. The Rules and instructions air traffic control do indicate that the glide path must be intercepted from below. This does not guarantee in every case that the aircraft can be in horizontal flight, as advised by the International Civil Aviation Organization, at the point when it intercepts the glide path. The Board considers it important that the regulations of Air Traffic Control the Netherlands should be made to coincide with international guidelines.

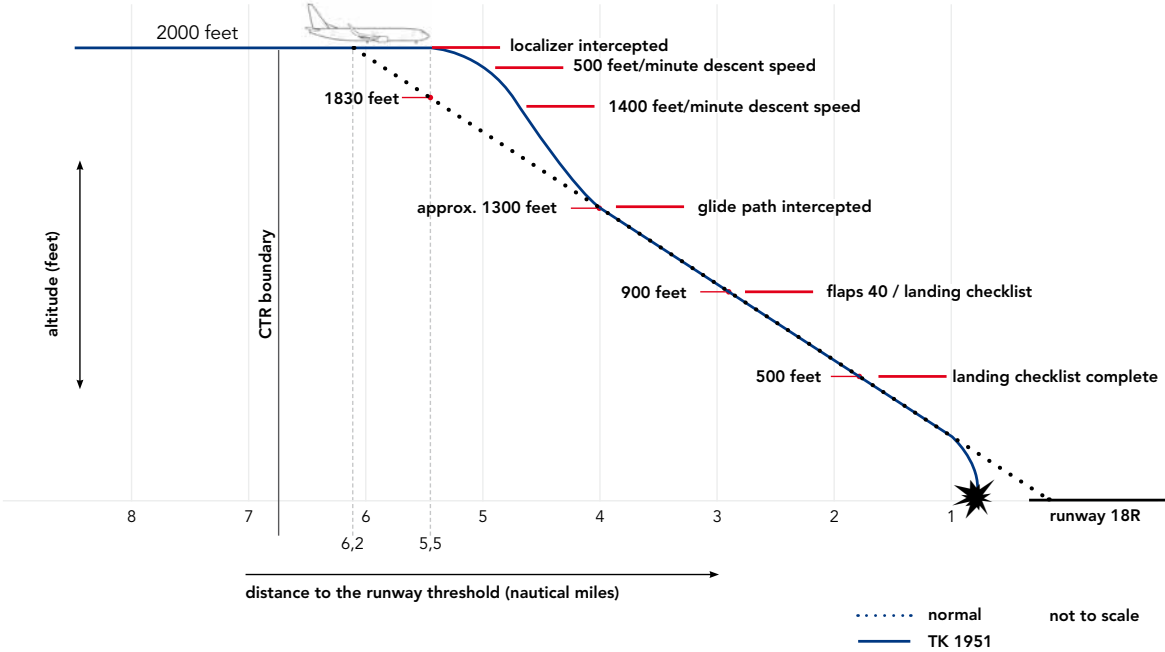
In an ILS approach the localizer and glide slope signal is normally intercepted automatically using the autopilot. The glide slope signal can normally only be intercepted after the localizer signal has been intercepted. The normal ILS procedures were not followed because the localizer signal was intercepted above the glide slope. As a result of this the glide slope signal could not be intercepted automatically. The result was that the cockpit crew had to perform a number of additional actions. The aircraft had to be put in a steeper angle of descend to obtain the required glide slope. This is shown in illustration 10 also. The actions that the crew performed in order to intercept the glide slope from above can be found in the timeline in appendix S. These actions had to be performed quickly and accurately and monitored constantly to prevent the angle of descend becoming too great to intercept the glide slope and to prevent the aircraft stopping the descend too soon to arrive at the selected altitude⁵². According to the cockpit voice recorder these actions were not discussed. Given the sequence and speed of these selections it is not likely that these actions were performed by the relatively inexperienced first officer, but that the captain performed these actions, which would normally be performed by the first officer as pilot flying, in addition to his own tasks. Analysis of the cockpit voice recorder, the timeline and simulator tests has confirmed this.

Illustration 10: side view of the approach of flight TK1951

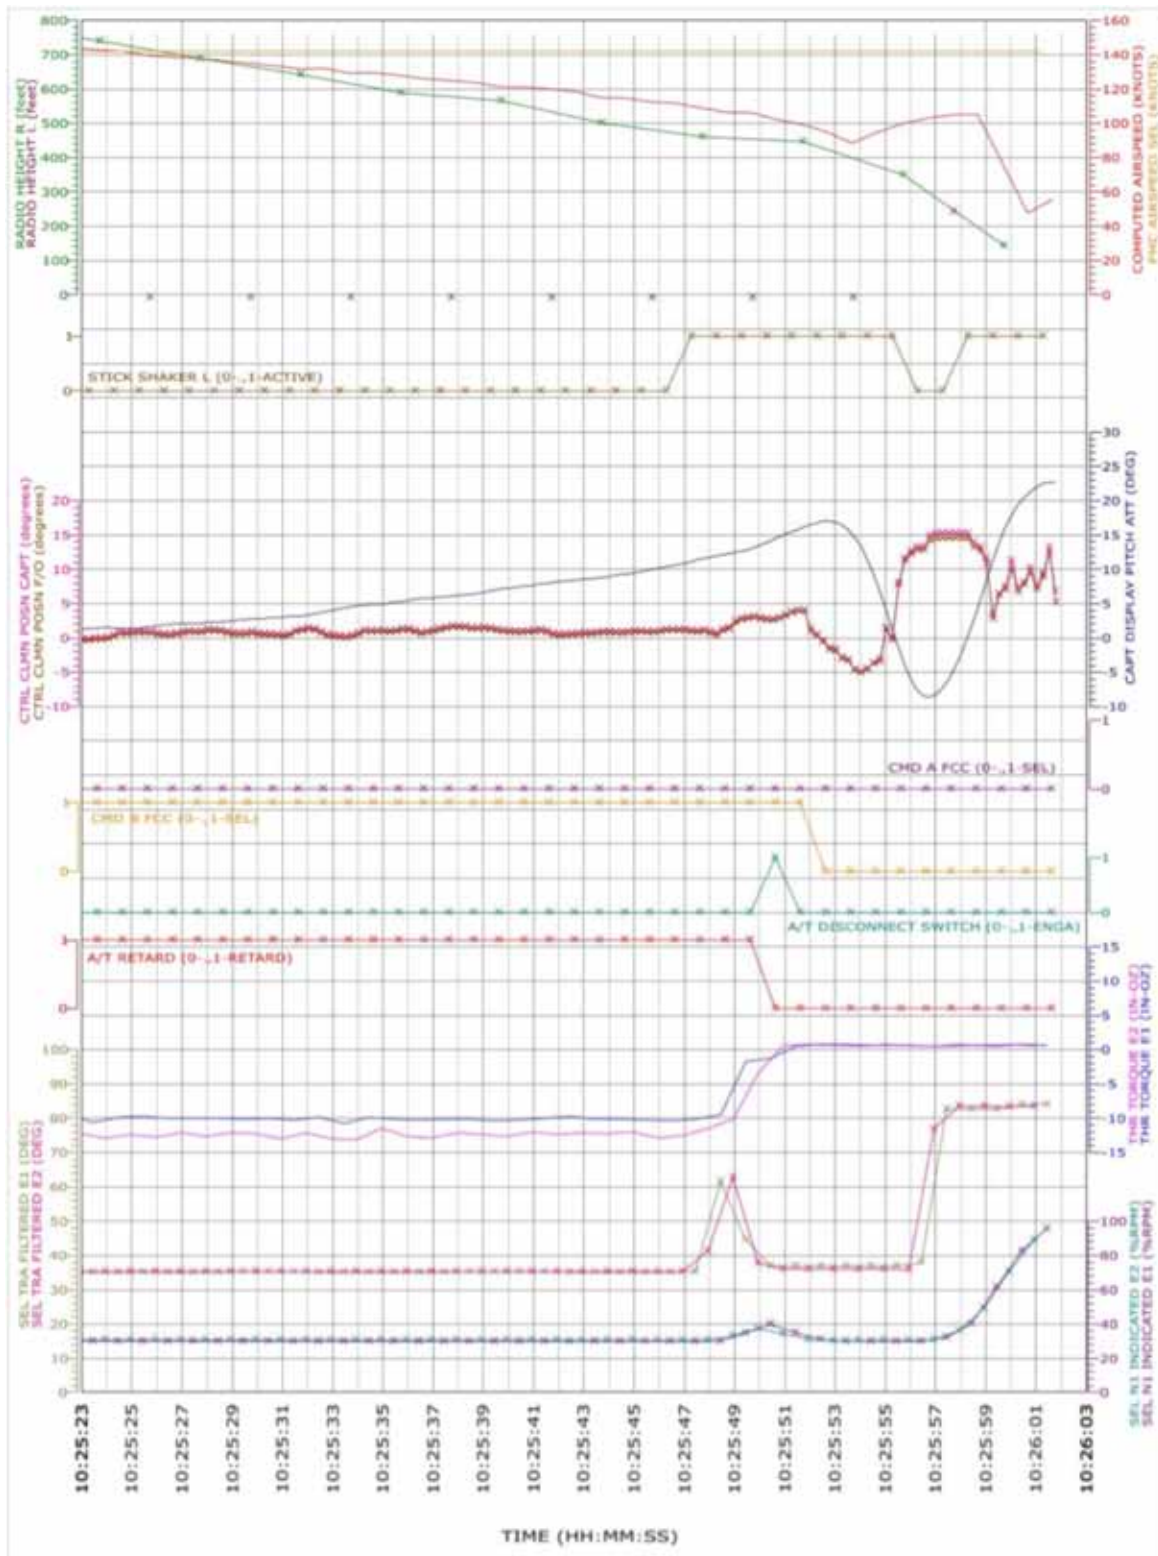
Illustration 13: parameters flight data recorder, last 40 seconds flight TK1951

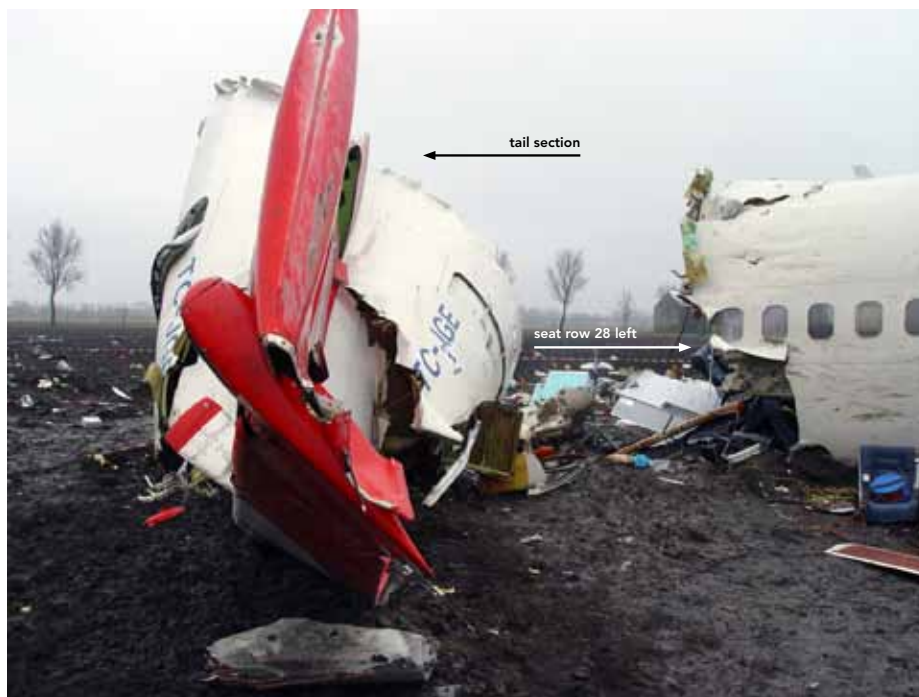
This part of the fuselage with the vertical stabiliser still attached separated in front of the rear cabin doors and sustained heavy damage. This section comprised the rear pantry and the two aft doors and was found turned 114 degrees towards the right wing. The doors of the left and right exits were partially open while the locking mechanism of both doors was still closed. Both the aft facing right and left cabin crew seats were found outside the tail section.

Illustration 14: tail section

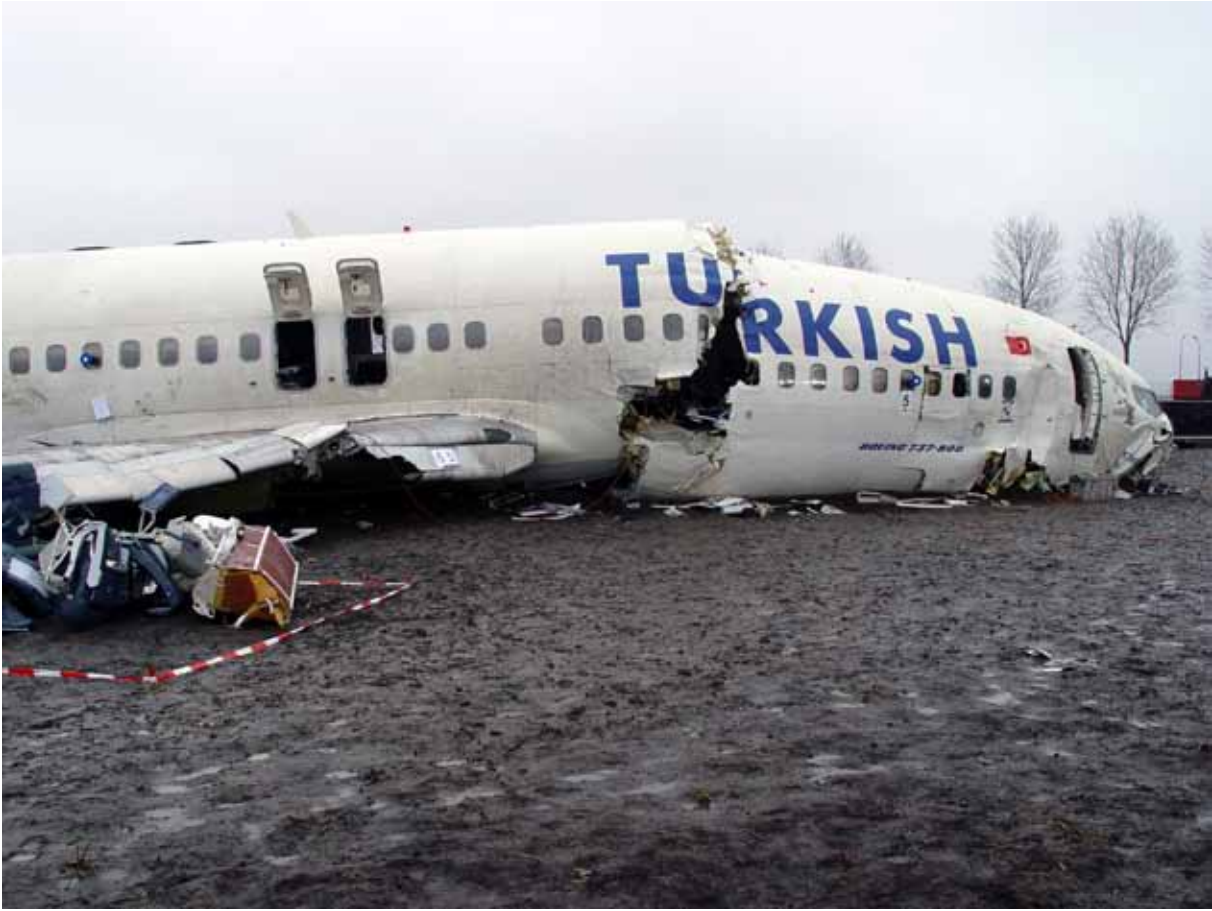
Illustration 15: main section and front section

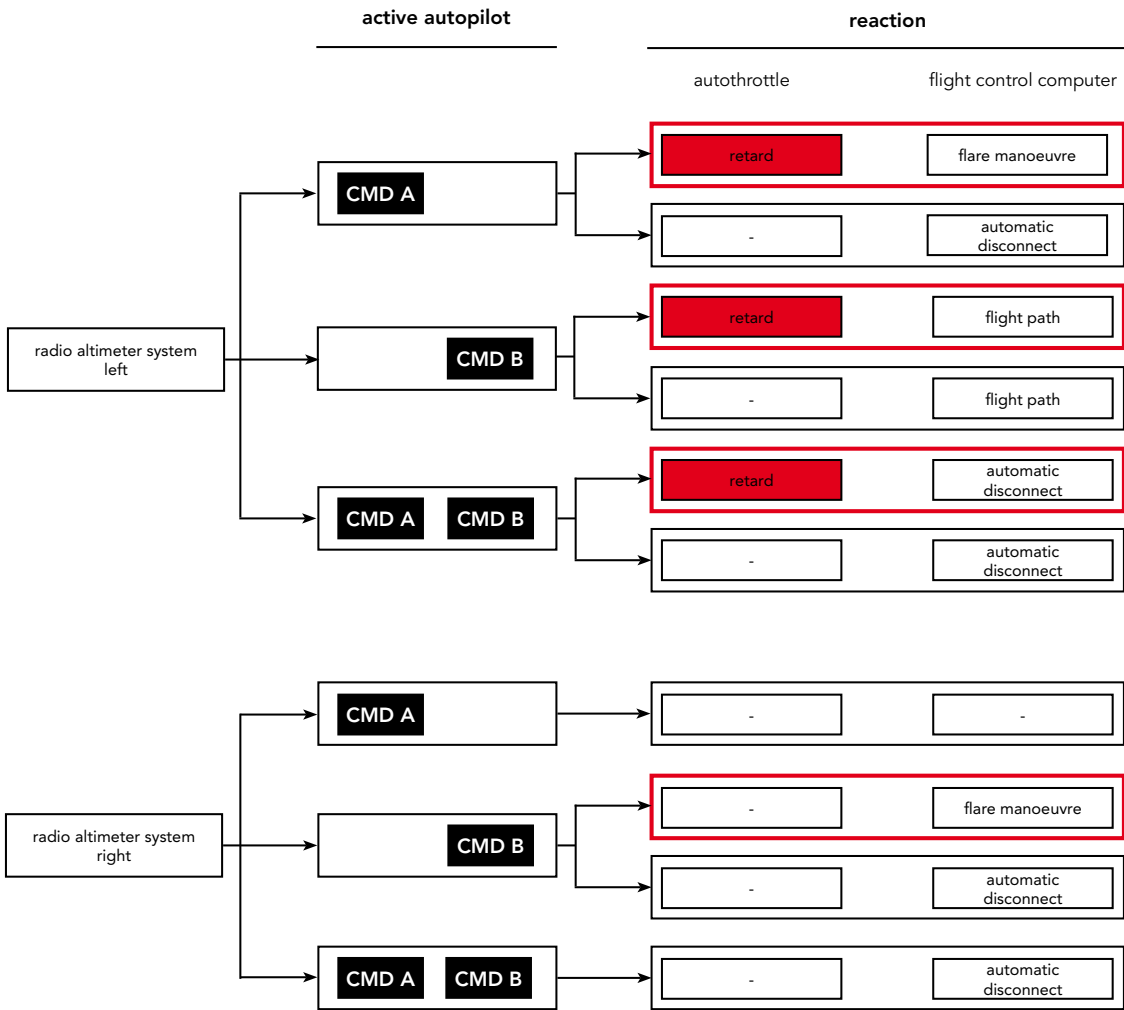
In this test, the 'retard flare' mode was activated during a 'dual channel' approach. The 'master' flight control computer activated the 'flare' command. The flight mode annunciator briefly showed 'FLARE'. The autothrottle used the 'flare' command and activated the 'retard flare' mode. The 'retard flare' mode remained active when the left-hand radio height value was less than 27 feet.

Illustration 18 shows a simplified overview of the most relevant responses to the input data for the three test configurations. Not all of the responses are included in this overview. The overview does not, for instance, include the differences between the Smiths and Collins flight control computers with radio height values characterised as 'non computed data'.

Illustration 18: simplified schematic overview of the responses of the autothrottle and flight control computer to an erroneous radio altimeter signal (<27 feet).

2. The FAA and EASA should ensure that the undesirable response of the autothrottle and flight management computer caused by incorrect radio altimeter values is evaluated and that the autothrottle and flight management computer is improved in accordance with the design specifications.
