REPORT

on the accident on 12 November 1999 North of Pristina (Kosovo) to the ATR 42-300 registered F-OHFV operated by SI FLY

F-FV991112A

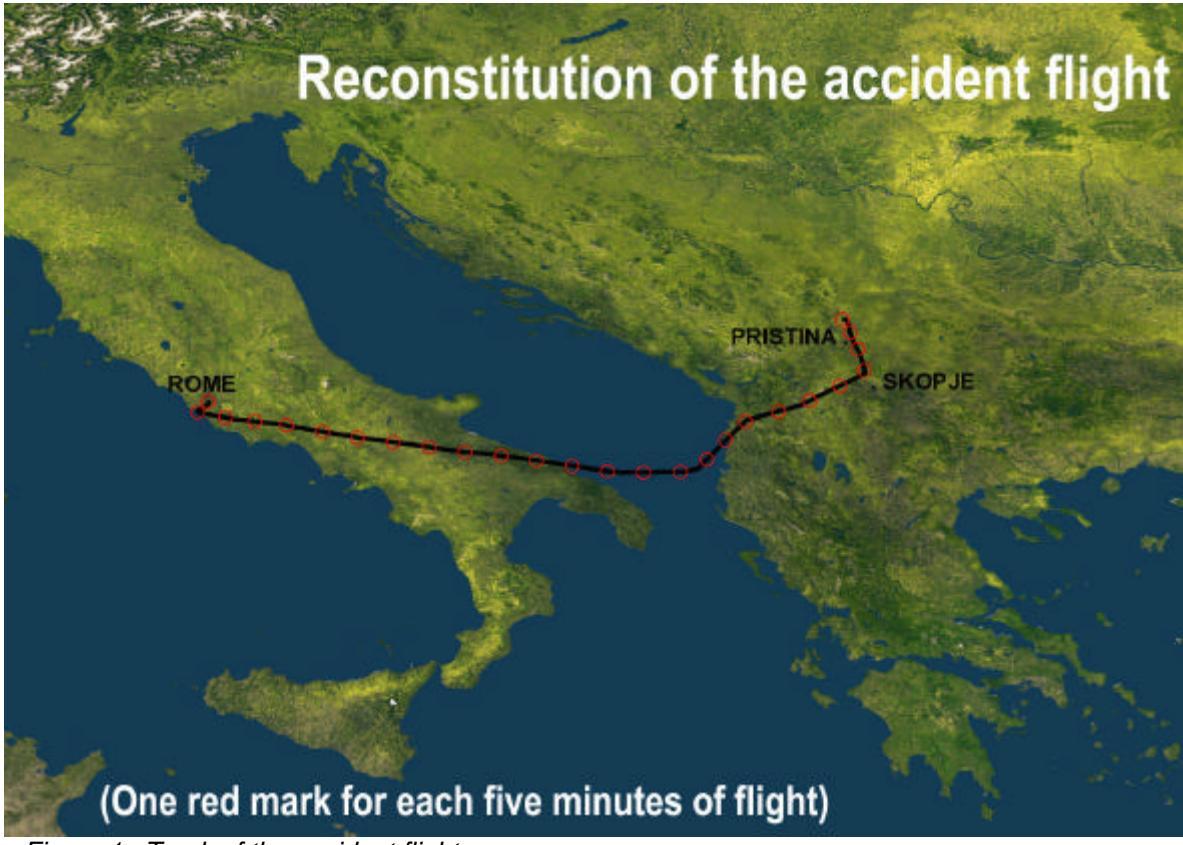
Figure 1 : Track of the accident flight

At 9 h 57 min 34 s, the flight was transferred by Skopje control to the Pristina military air traffic control organisation. The latter identified it on radar and the crew replied "Flight condition is now VFR" to a request from the controller.

At 10 h 14 min 33 s, the CRC alarm was heard, the crew noted 240 feet on the radio altimeter. Two seconds later the aircraft struck high ground.

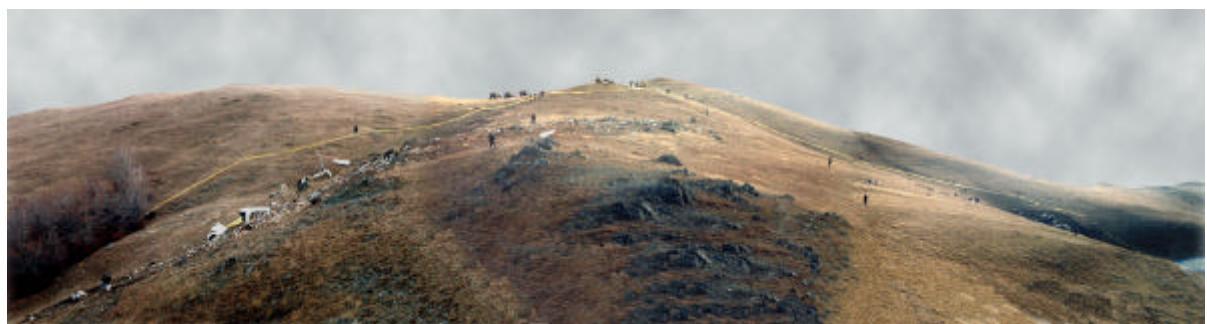
Figure 11 : View of accident site

The accident site is situated 25 NM north of Pristina Aerodrome (10 NM NE of Mitrovica) at an altitude of 4,600 feet. The first impact occurred 15 metres from the top of a ridge, in a rocky mid-mountain area. The peaks in this area vary between 3,380 and 5,800 feet.

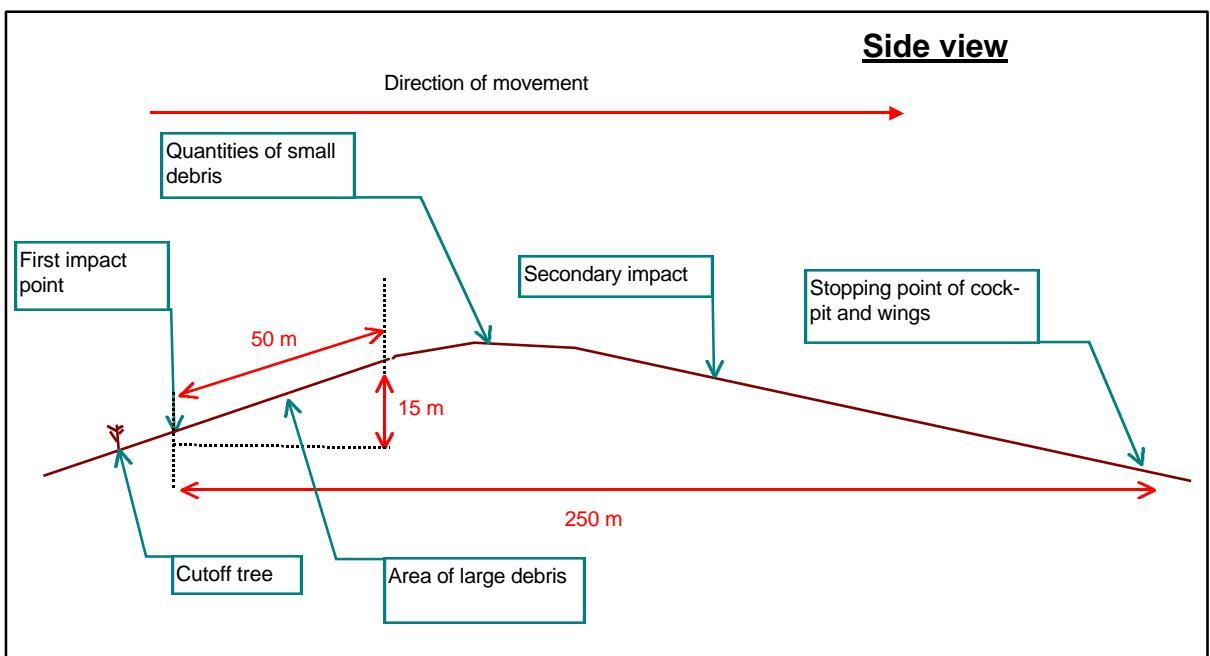
Figure 12 : Side view of site

Twenty-five metres before the impact point, the top of a seven-metre-tall tree had been chopped off on the right side of the track. Then the point of impact of the engine and left propeller slashes were found.

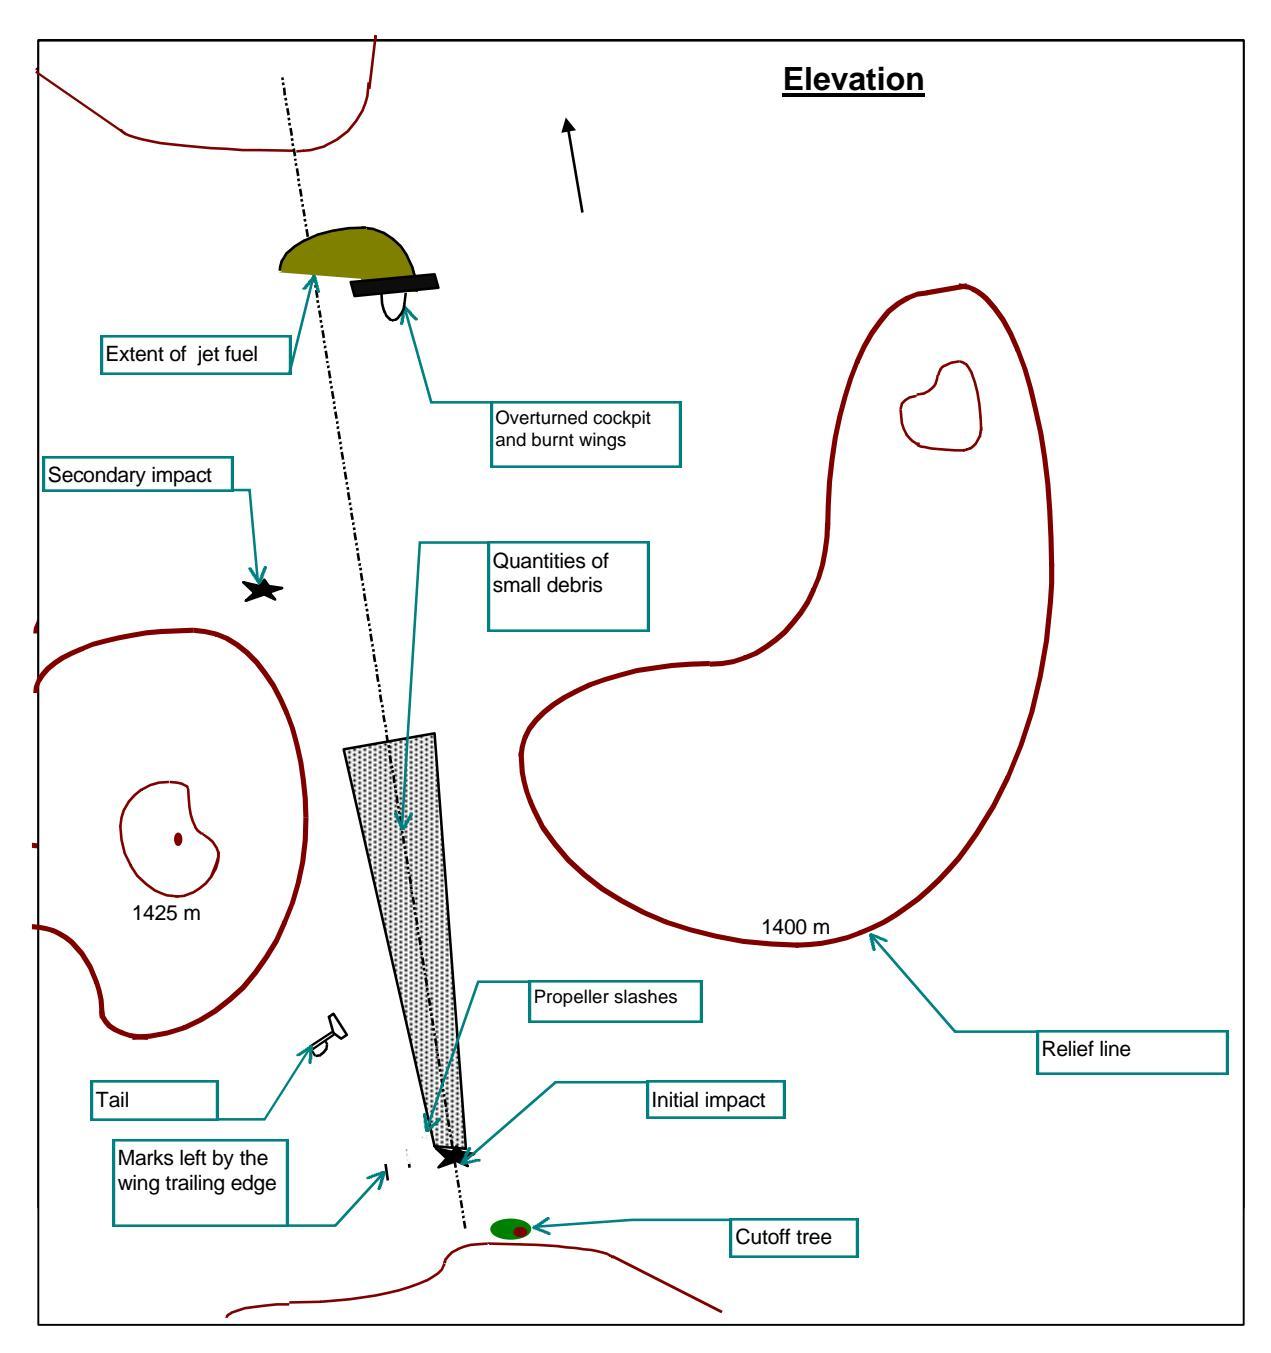
Figure 13 : Accident site seen from above

The fuselage impact point was a little further, about fifty metres from the top of the ridge. The tail, from which half of the left stabiliser was detached, was found on the left.

The debris was then spread about over a length of about 250 m on a line at 250°, on either side of a pass. The lower part of the fuselage had disintegrated on the rocks on a slope rising at 30 %. On the other side of the ridge, the two main landing gears were found in relatively good condition, along with two items of electrical equipment (the GPS and an ADC) and the right engine.

At the end of the track, at about 150 m after the ridge, the main part of the fuselage was found : the upper part of the cockpit, the left engine and the wings, showing signs of fire. The cockpit and the wings were upside down. Slightly to the right the engine control pedestal was found.

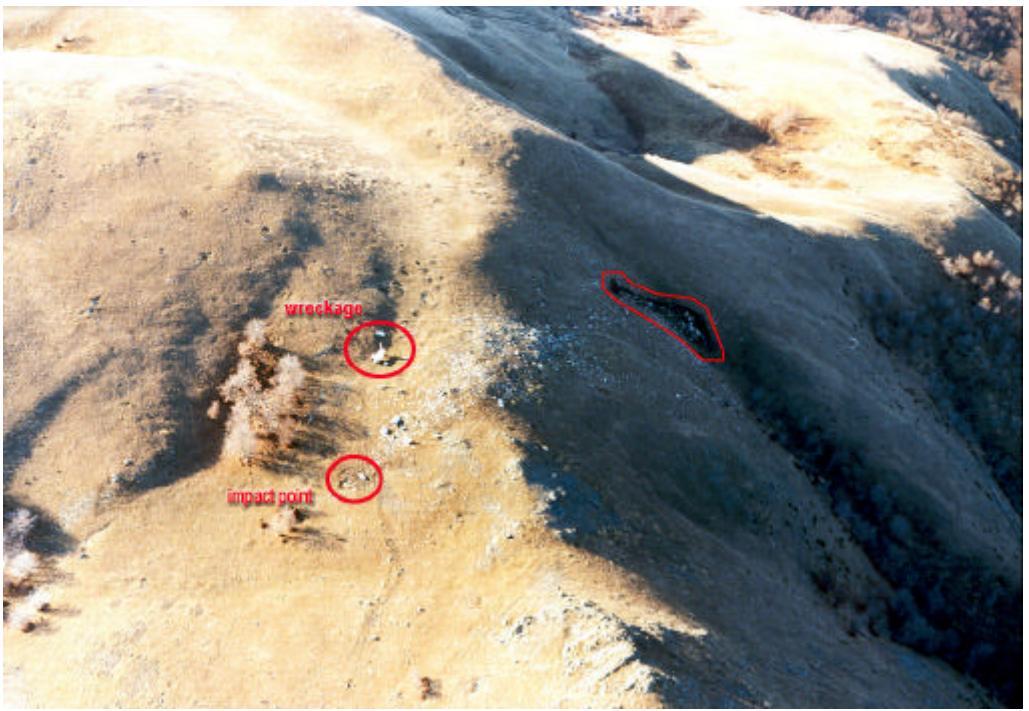
Figure 14 : Debris

The GPWS computer was found beyond the pass in the direction of the track. The references noted on the equipment were as follows : manufacturer : AlliedSignal, GPWS Mark II computer 965-0476-088, serial number 10100. Despite extensive additional searches, the left side panel, where the GPWS switch is situated, could not be found.

- The landing gear control lever was in the UP position. Considering the condition of the wheels, we can therefore assume that the landing gear was retracted at the time of the impact.
- The altimeter on the left instrument panel indicated 4 600 feet. It was set at 1028 hPa.
- The backup altimeter showed 5 000 feet for a setting of 30,31 inches of mercury.
- The Power Management Panel button was in the CRZ (Cruise) position.
- Some Jeppesen charts were found at the site.

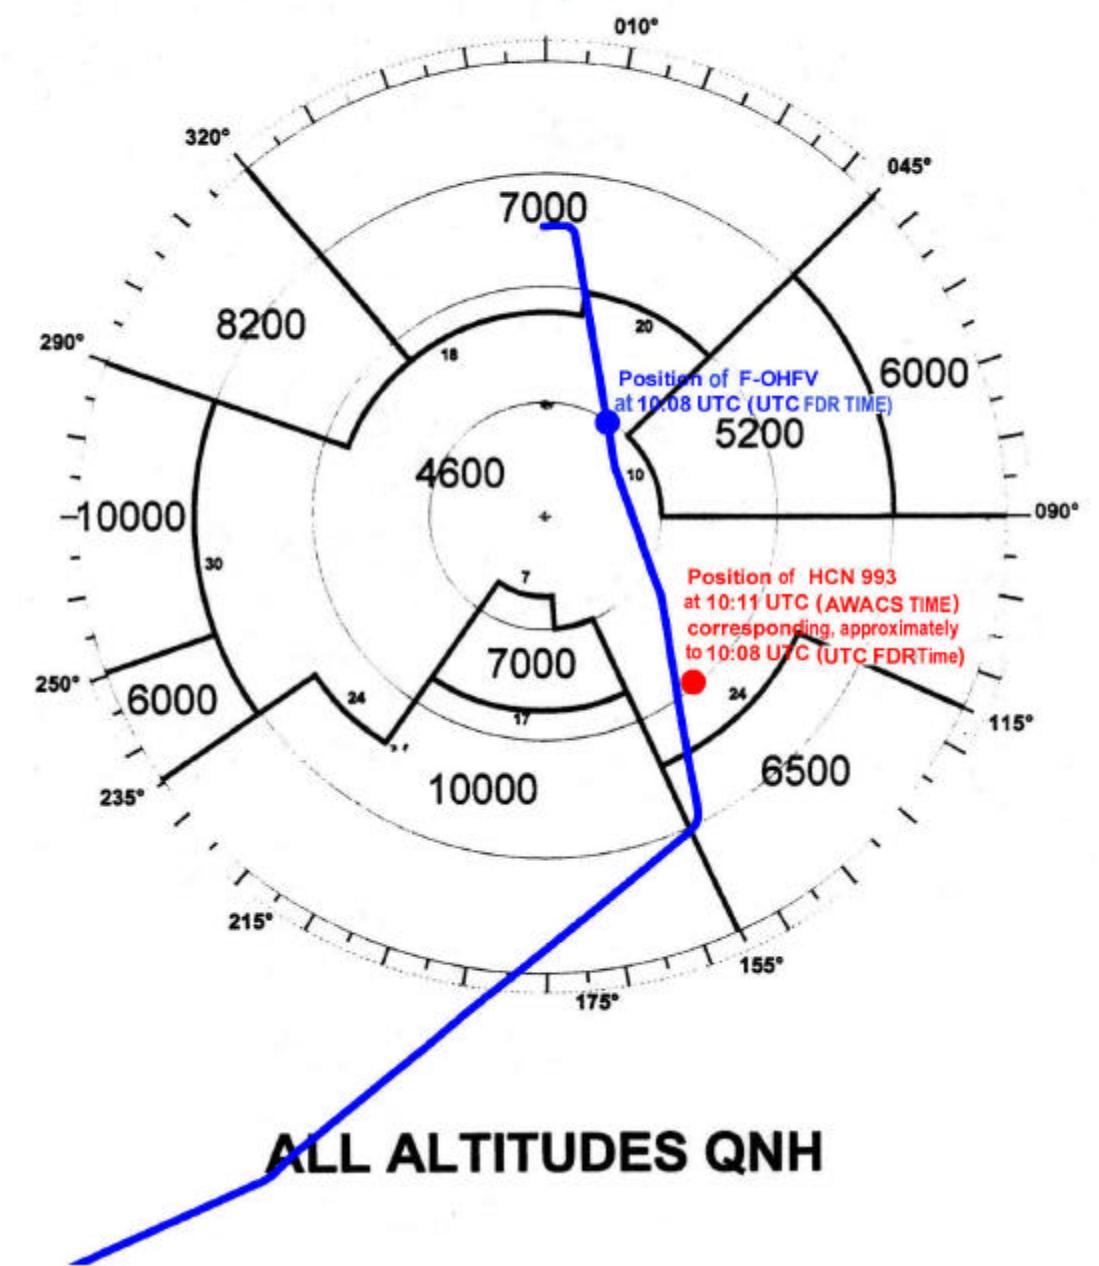
Figure 18 : Relative position of aircraft F-OHFV and HCN 993 when HCN 993 took number one position for landing

These relative positions must be viewed with caution due to the low sample rate of data related to HCN 993, and to the difference of around 3 minutes between the UTC time on F-OHVF's FDR and that of the AWACS which recorded the track of HCN 993

After announcing the type of service provided, RIS in this case, the controller gave headings and altitudes to flight KSV 3725 which were in accordance with the minimum radar safety altitudes in the sector to vector it towards the ILS interception point. However, having changed its position to number two for approach, he had to extend its track away to the north a little more than he had planned, which took the aircraft into an area where the radar minimum safety altitude went up from 4,600 to 7,000 feet. This manoeuvre probably led to the loss or clutter of the ATR's radar signal, because of poor detection in this mountainous region. This
