NATIONAL TRANSPORTATION SAFETY BOARD

AIRCRAFT ACCIDENT REPORT

DELTA AIR LINES, INC., LOCKHEED L-1011-385-1, N726DA DALLAS/FORT WORTH - INTERNATIONAL AIRPORT, TEXAS AUGUST 2, 1985

NTSB/AAR-86/05

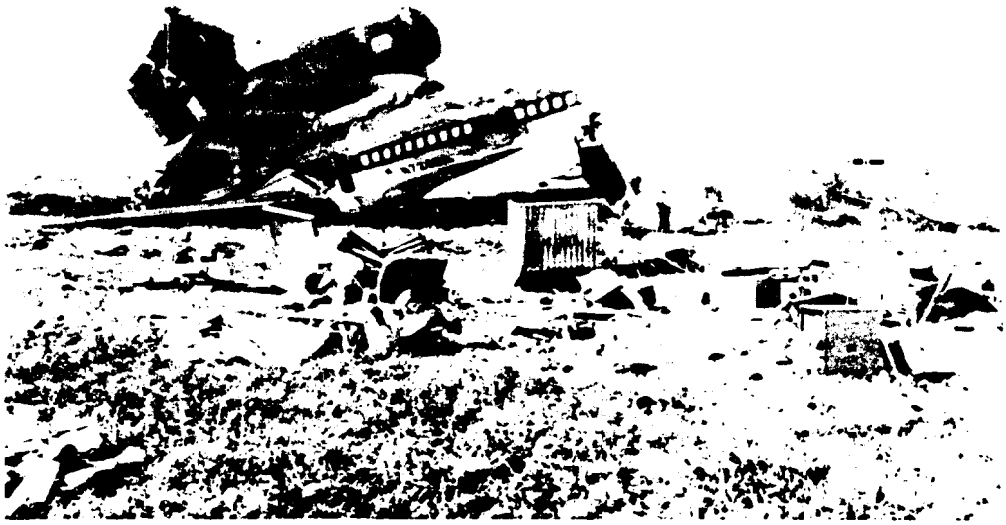
Figure 2.--The aft section of the airplane's fuselage.

The investigation team found the aft fuselage section containing the rear cabin and the empennage was in an upright position. Passengers and flight at tendants reported that this section came to rest on its left side and was rolled to the upright position by wind gusts after the arrival of the rescue personnel. The section was relatively intact and included the No. 2 engine and associated ducting, the right stabilizer and elevator, and the base of the vertical stabilizer and rudder. The upper 12 feet of the vertical stabilizer and rudder had separated as a unit during the impact sequence and was found about 100 feet north of the aft fuselage section.

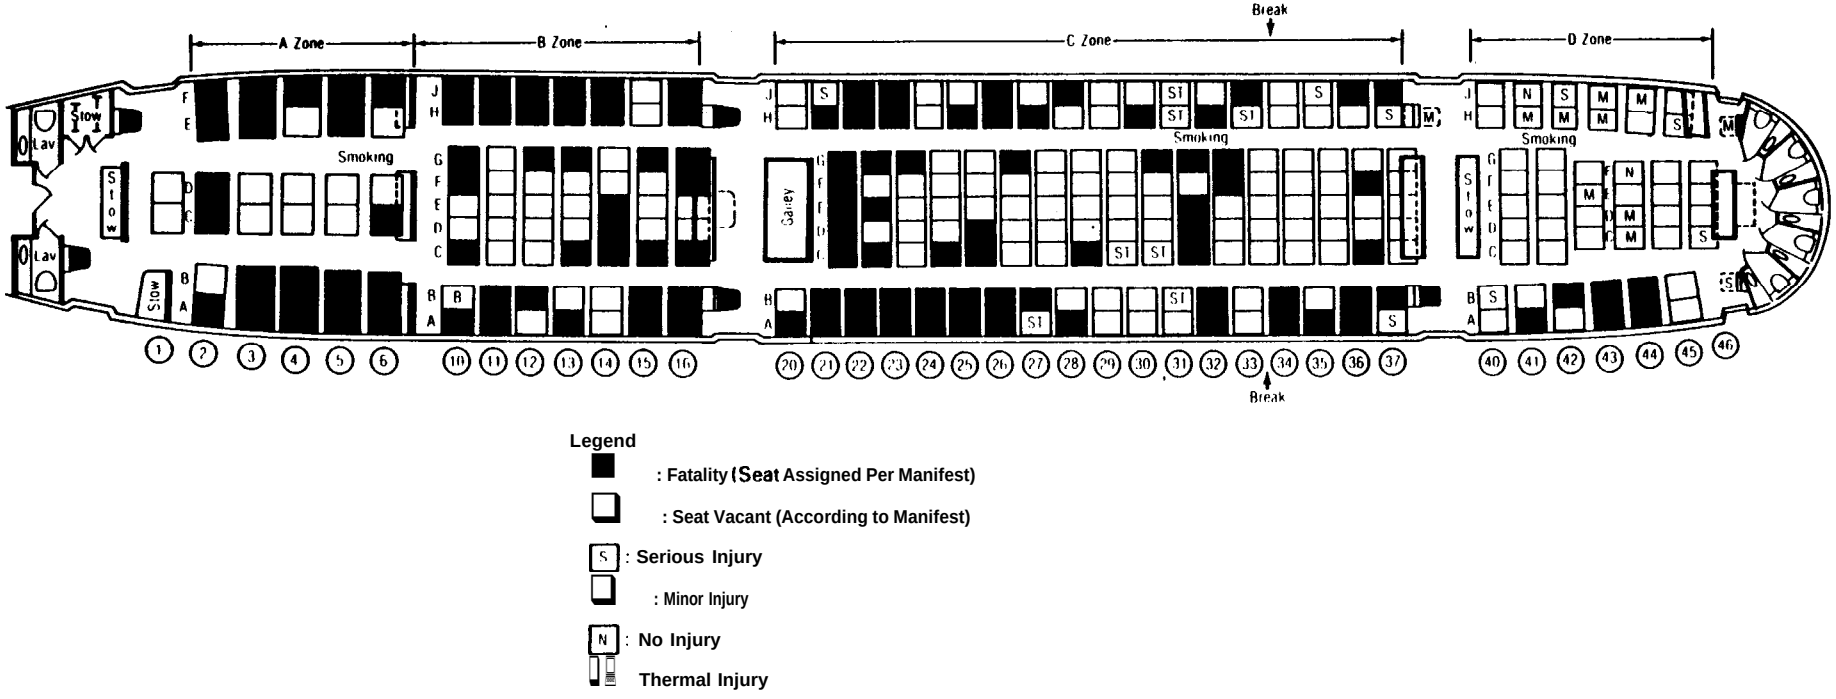
Figure 3.--L-1011 cabin seat diagram.

The airplane's passenger cabin contained 46 rows of seats and a total of 302 seats. (See figure 3.) There were 152 passengers on board flight 191: 71 adult males; 62 adult females; 18 children (24 months or older, but younger than 16 years); and one infant (younger than 24 months). The ages of the passengers ranged from 20 months to '70 years. In addition, 11 crewmembers were aboard.

Except for the left cabin wall, which was missing, the remainder of the separated rear cabin section from row 40 aft to row 46 was relatively undamaged. Six passengers seated along the missing left cabin wall were killed. The remaining 16 occupants of this cabin section, including 2 flight attendants, sustained serious and minor injuries, and 2 passengers were not injured.

The rear cabin section came to rest on its left side. The survivors were either flung from the airplane in their seats or released themselves from their seats and exited at the forward end of the separated fuselage section or through the missing left wall. One flight attendant and three passengers could not escape from the cabin because of injuries and were removed by fellow passengers and rescue personnel. Two other flight attendants had only minor injuries and were able to escape unaided after shouting commands to the passengers to get out of the cabin. The flight attendant seated at the right rear (R-4) exit had difficulty releasing her seatbelt because the buckle was located on her left hip and her weight was on the buckle, The passengers and flight attendants were covered with fuel and some had fuel on their hands and in their eyes, which caused difficulties in climbing down the cabin to the hole created by the missing left cabin wall. Some persons were able to climb downward to the hole over seats while others fell the width of the cabin to the ground.

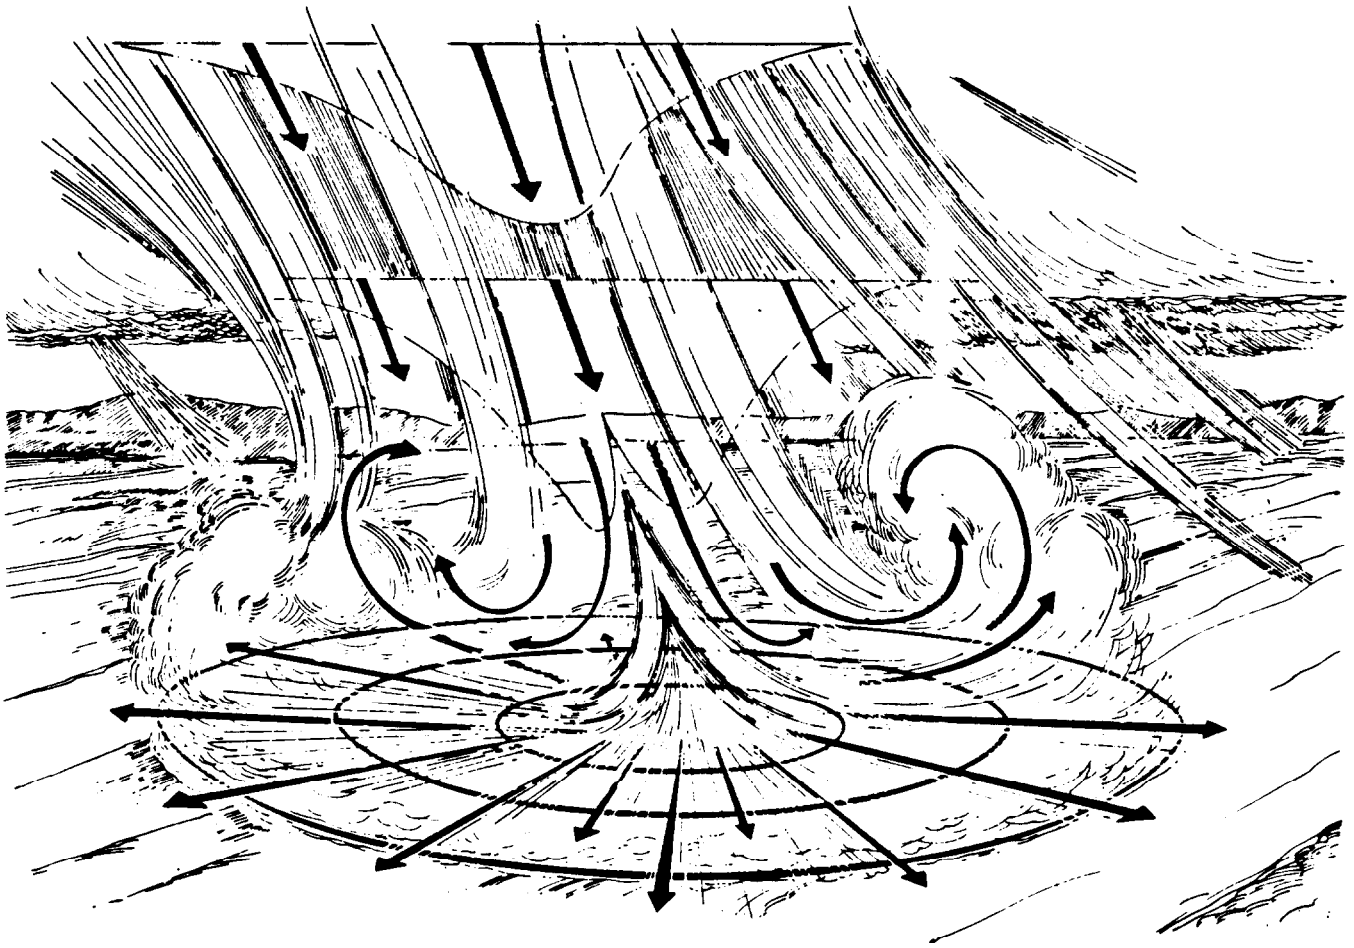
Figure 4.--Typical microburst wind field.

A downburst 20/ is a strong downdraft which induces an outburst of highly divergent damaging winds on or near the ground. Downbursts vary from less than 1 kilometer (0.62 mile) to tens of kilometers in diameter. Downbursts are subdivided into macrobursts and microbursts according to their horizontal scale of damaging winds. A macroburst's horizontal wind field extends in excess of 4 kilometers (2.5 miles) in diameter, whereas the microburst's horizontal wind field extends less than 4 kilometers (2.5 miles) in diameter. (See figure 4.)
