Runway Collision, United Express Flight 5925 and Beechcraft King Air A90, Quincy Municipal Airport, Quincy, Illinois, November 19, 1996

Investigative Body: National Transportation Safety Board (NTSB), USA

**RUNWAY COLLISION
UNITED EXPRESS FLIGHT 5925
AND BEECHCRAFT KING AIR A90
QUINCY MUNICIPAL AIRPORT
QUINCY, ILLINOIS
NOVEMBER 19,1996**

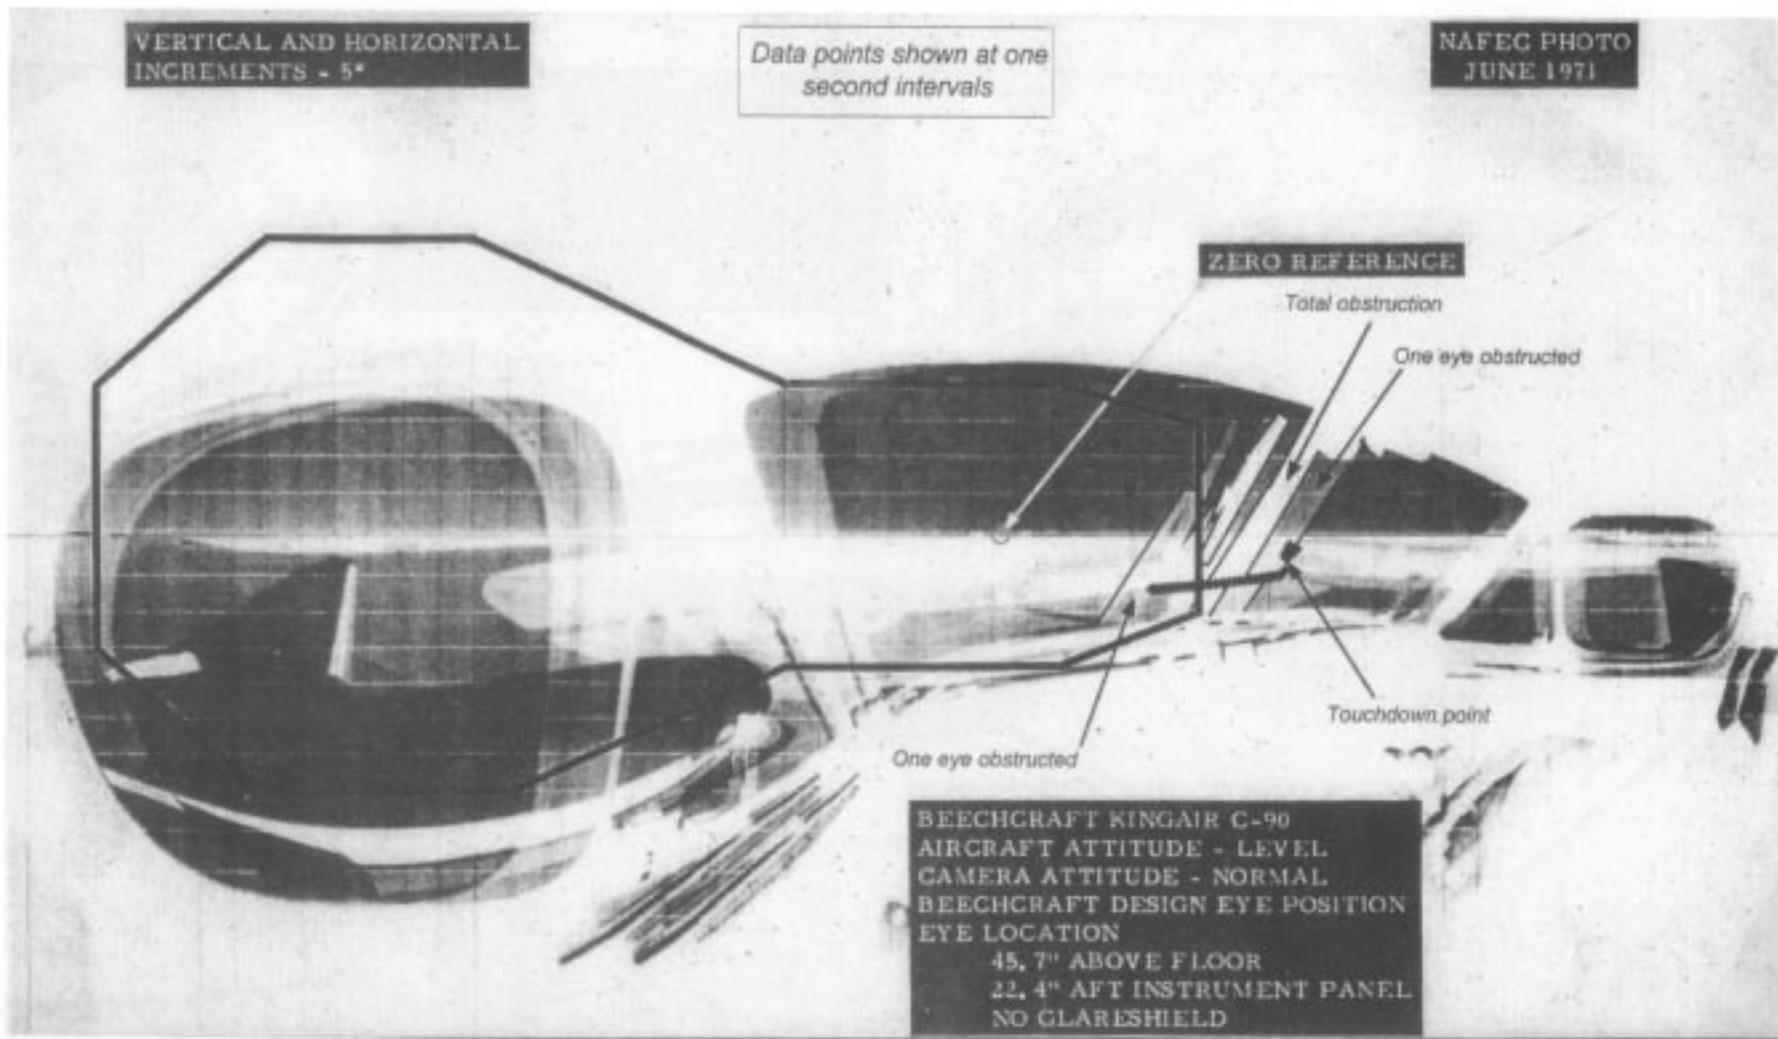
Figure 6.—Beech 1900C captain's view of King Air.

As shown in figure 6, the Safety Board's study using its VIZPC computer program indicated that the view of the King Air from the Beech 1900C captain's position would have been partially obstructed by the center post and windshield wipers during the airplane's final approach and would have been totally obscured by the center post for 6 seconds, starting about 17:00:43. Approximately 10 seconds before touchdown,³⁶ at 1700:49, until the time of the

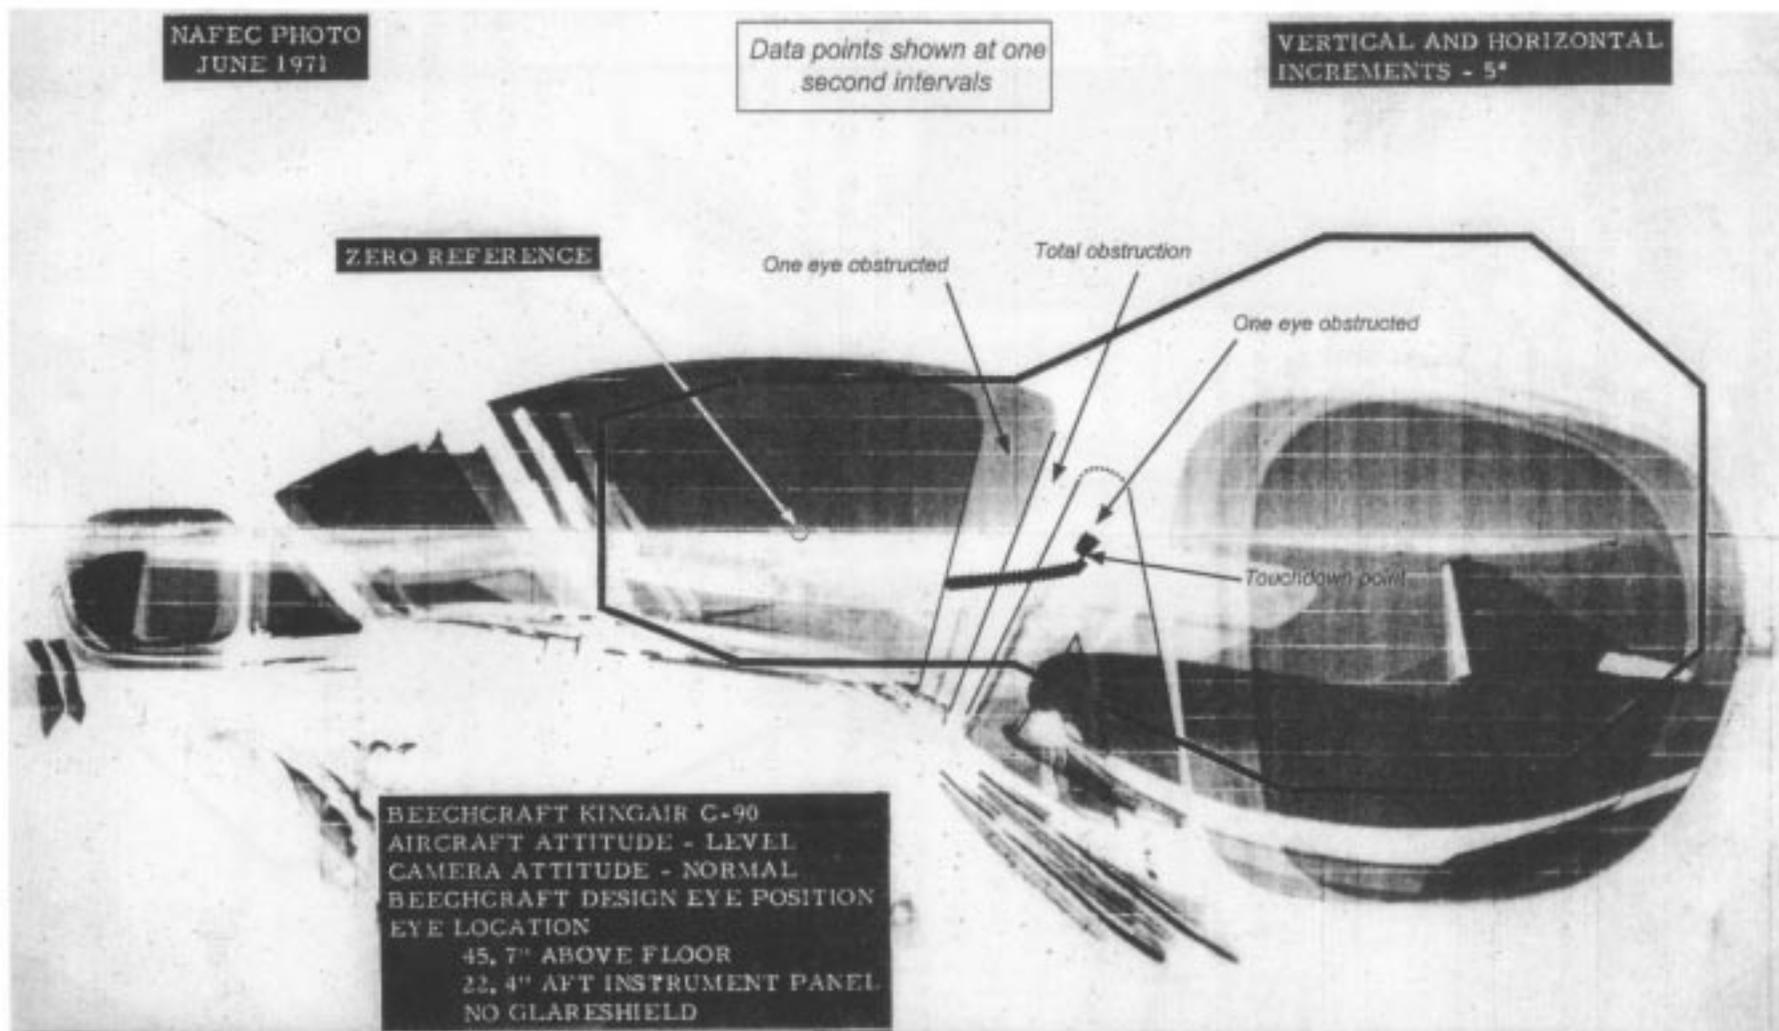
Figure 7.—Beech 1900C first officer's view of King Air.

As shown in figure 7, the view from the Beech 1900C first officer's position would have been partially obstructed by the first officer's side posts for nearly 30 seconds before touchdown until impact, including 6 seconds starting at 17:00:42 when the first officer's view of the King Air would have been totally obstructed by the front windshield side post.

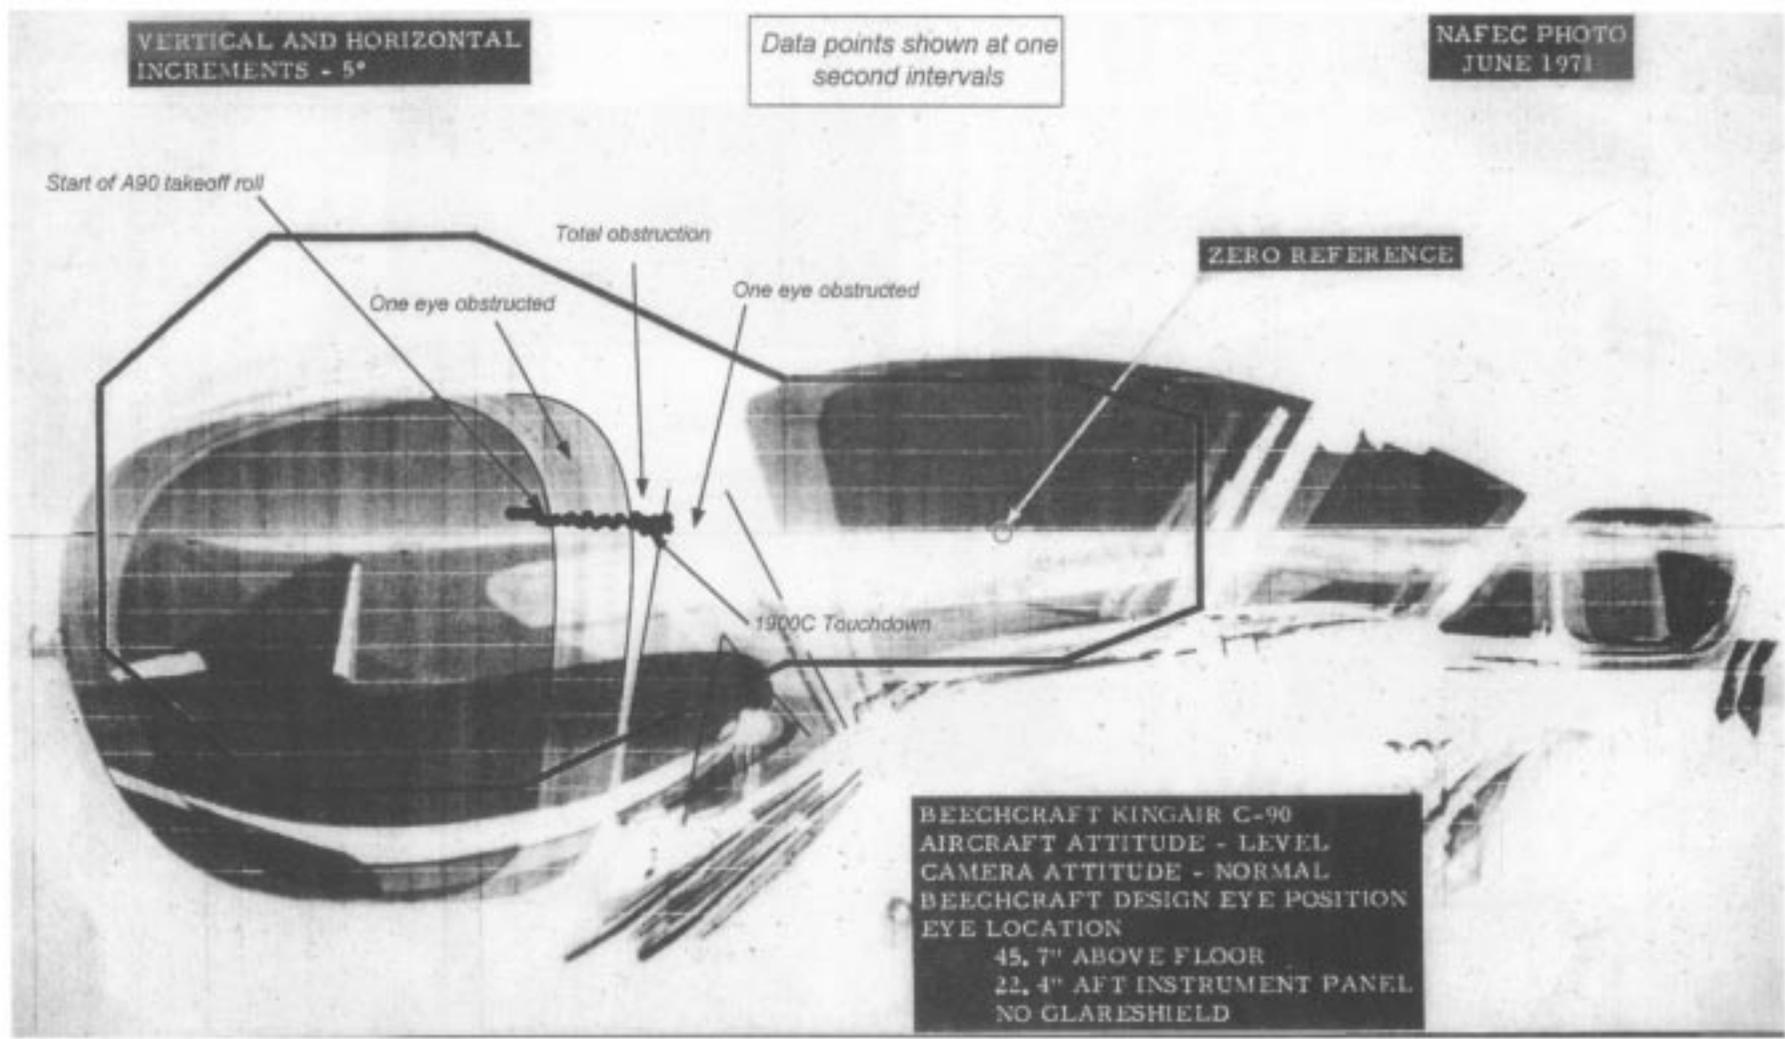
Figure 8.—King Air left seat occupant's view of Beech 1900C.

The VIZPC study also indicates that while the King Air was stationary near the end of runway 04, the left seat occupant's³⁷ view of the Beech 1900C would have been unobstructed at nearly 72° to the left, as viewed through the side window of the King Air. (See figure 8). About 17:00:40, 4 seconds before the King Air began its takeoff roll, the view of the Beech 1900C from the left seat occupant's position would have become partially obstructed at nearly 68° to the left, and fully obstructed at 17:00:54, about 55° to the left, when the King Air would have been accelerating during the roll; this time is immediately before the touchdown of the Beech 1900C. The view of the Beech 1900C from the left seat occupant's position would have been fully obstructed from 17:00:54 until impact at 17:01:09, except for 2 seconds at 17:01:02 when the view would have been partially obstructed.

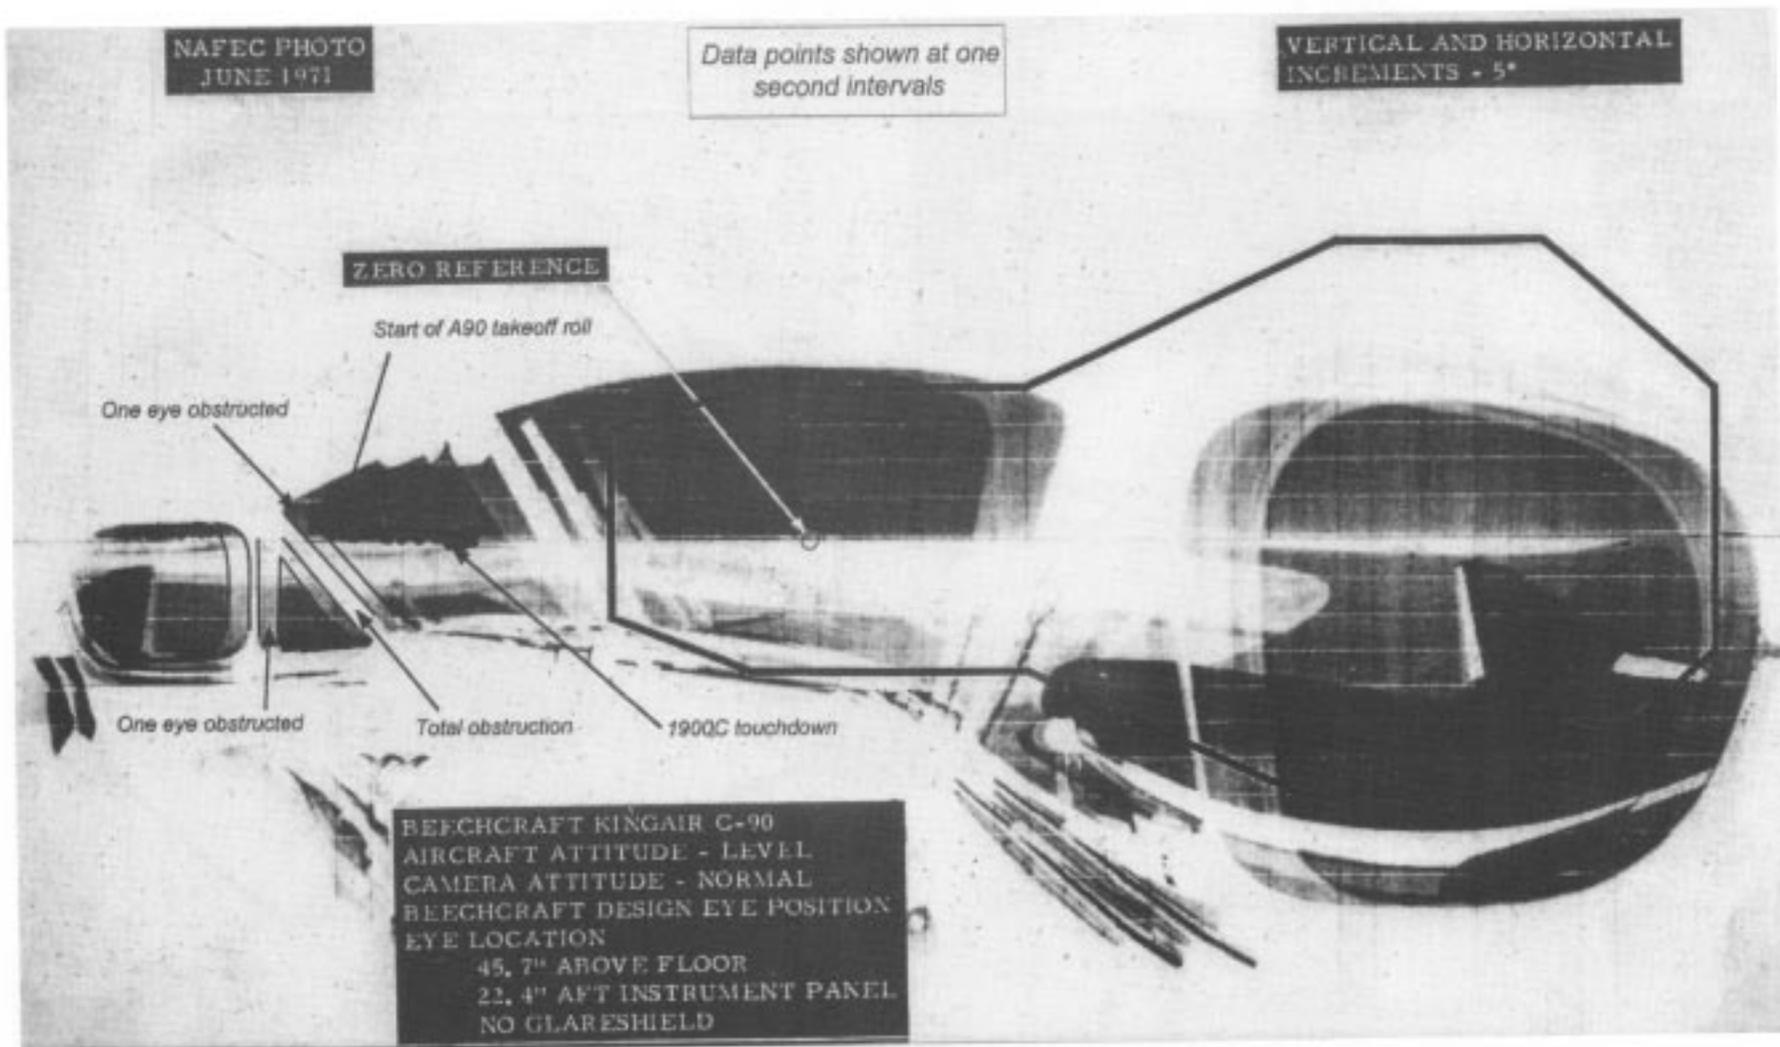
Figure 9.—King Air right seat occupant's view of Beech 1900C.

As shown in figure 9, the King Air right seat occupant's view of the Beech 1900C would have been partially obstructed by the left seat occupant's side posts until just before the start of the King Air's takeoff roll. At 17:00:39, the Beech 1900C would have emerged into clear view in the left front windshield. It was noted that when the right seat occupant's view would have been obstructed, the left seat occupant's view would have been clear, and vice versa. At the start of engine throttle back by the King Air pilot, the Beech 1900C would have been about 50° to the left of the King Air. This position would have been fully obstructed from the King Air left seat occupant's position, but in clear view from the right seat occupant's position.
