**Aviation Safety Council**

**SQ006 Accident Investigation  
Factual Data Collection  
Group Report**

**Survival Factors Group**

**ASC-FRP-01-01-006**

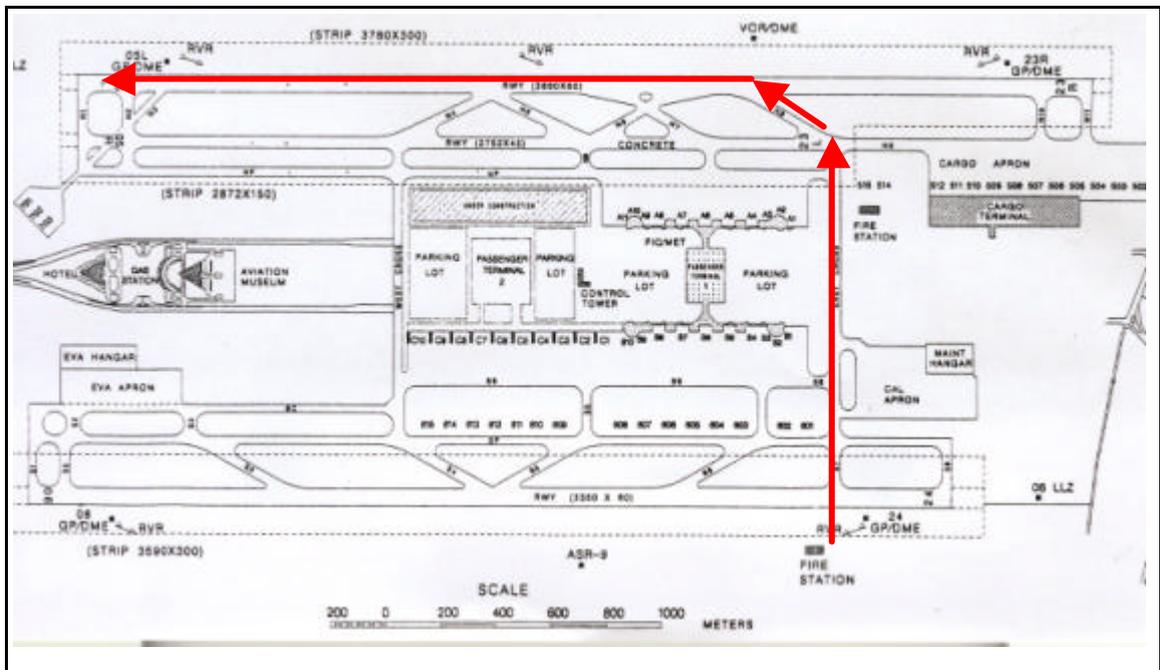
Two fire tenders were involved in the test. Fire tender No.1 loaded with 6000 liters and No.3 with 12000-liter of water. The fire fighters were on standby in their rest area. ATC clearance to cross runway 06/24 was requested from the dispatching office after the alarm sounded. The fire tenders were cleared to cross the active runway by the tower. The route taken by the fire engines is highlighted in the chart below. No. 3 fire tender reached the runway end in 2 minutes 48 seconds followed closely by No. 1 fire tender.
