**INTERSTATE AVIATION COMMITTEE
AVIATION ACCIDENT INVESTIGATION COMMISSION**

**FINAL REPORT
BASED ON THE RESULTS OF THE INVESTIGATION OF THE AVIATION ACCIDENT**

Type of aviation accident	Catastrophe
Aircraft type	Tu-204-100V
State registration identification mark	RA – 64047
Owner	Ilyushin Finance OJSC
Operator	JSC Aviation Company "Red Wings"
Aviation Administration	Interregional territorial Air Transport Authority Central regions of the Federal Air Transport Agency
Scene of the incident	Russia, Vnukovo Airport, coordinates location of the aviation accident: 55° 35.040 N, 37°15.324 E
Date and time	29.12.2012, 12:32 UTC (16:32 Moscow time) time), day

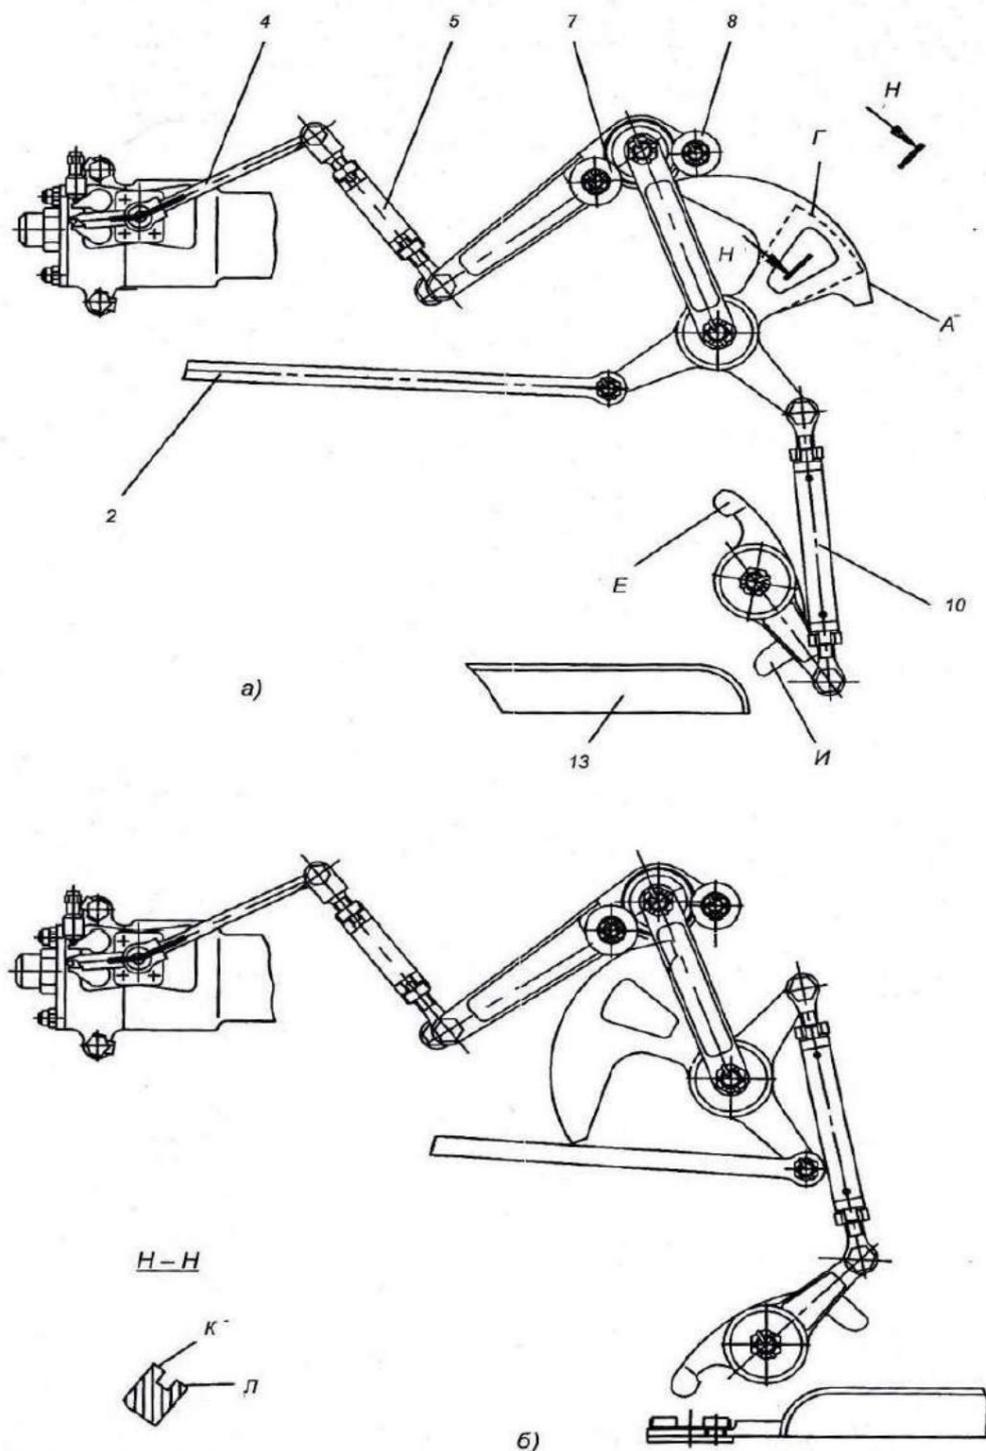
Fig. 2. Diagram of the blocking and control mechanism of the PS-90A engine.
 2, 5, 10 – rod; 4 – lever; 7, 8 – roller; 13 – guide; a – maximum position
 forward thrust; b – position of maximum reverse thrust.

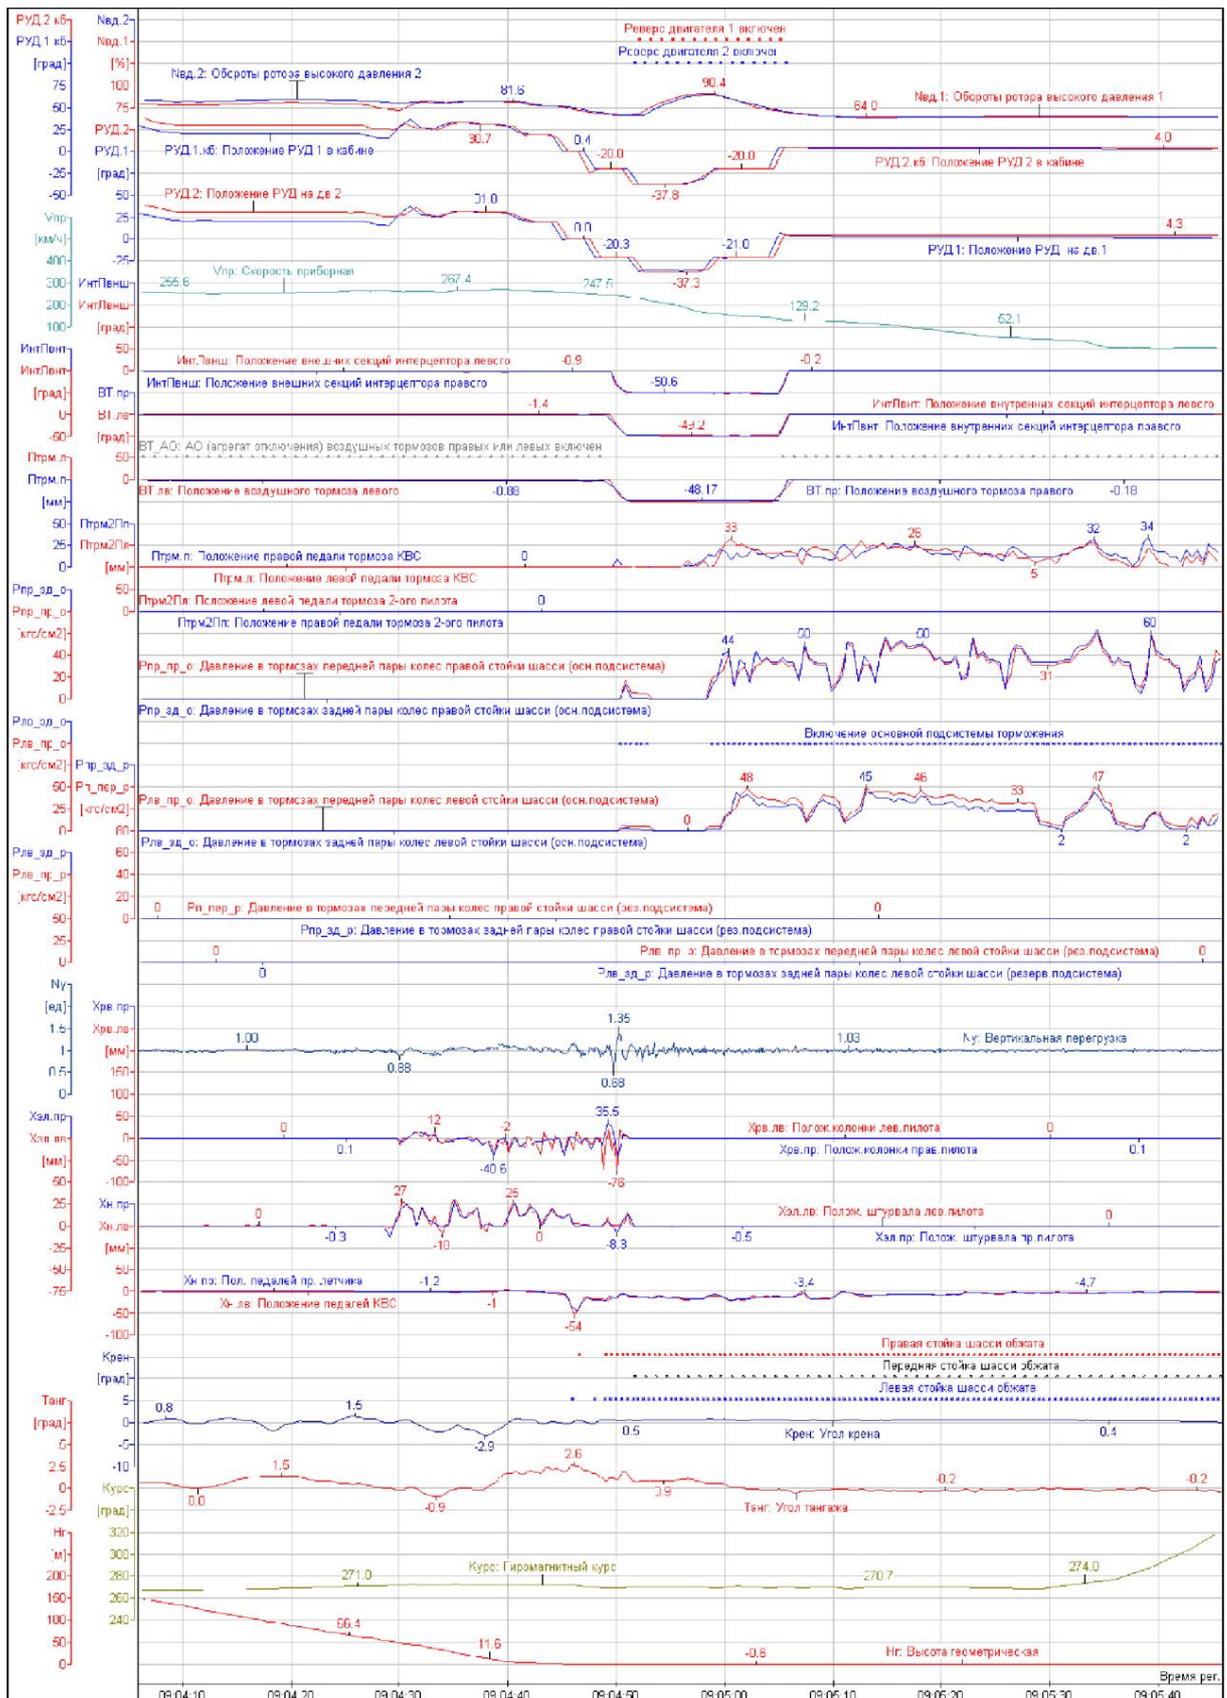
After the report *"(100 meters)"* the PIC command was recorded: *"Landing."* At an altitude of about 60 meters, the A/P9 and AT were switched off. From an altitude of about 20 meters, the PIC began increase the pitch angle to level the aircraft before touching the runway. At altitude 12...15 m the indicated airspeed was ~270 km/h, which was significantly higher RLE recommendations.

Fig. 8. Flight parameters of the Tu-204-100V RA-64047 aircraft on 12/29/2012 (landing at a/p Pardubice).

The plane landed at 09:04:46, at a speed of ~255 km/h, at an angle pitch angle of ~2.5°, practically without roll (Fig. 8). Vertical overload at the moment

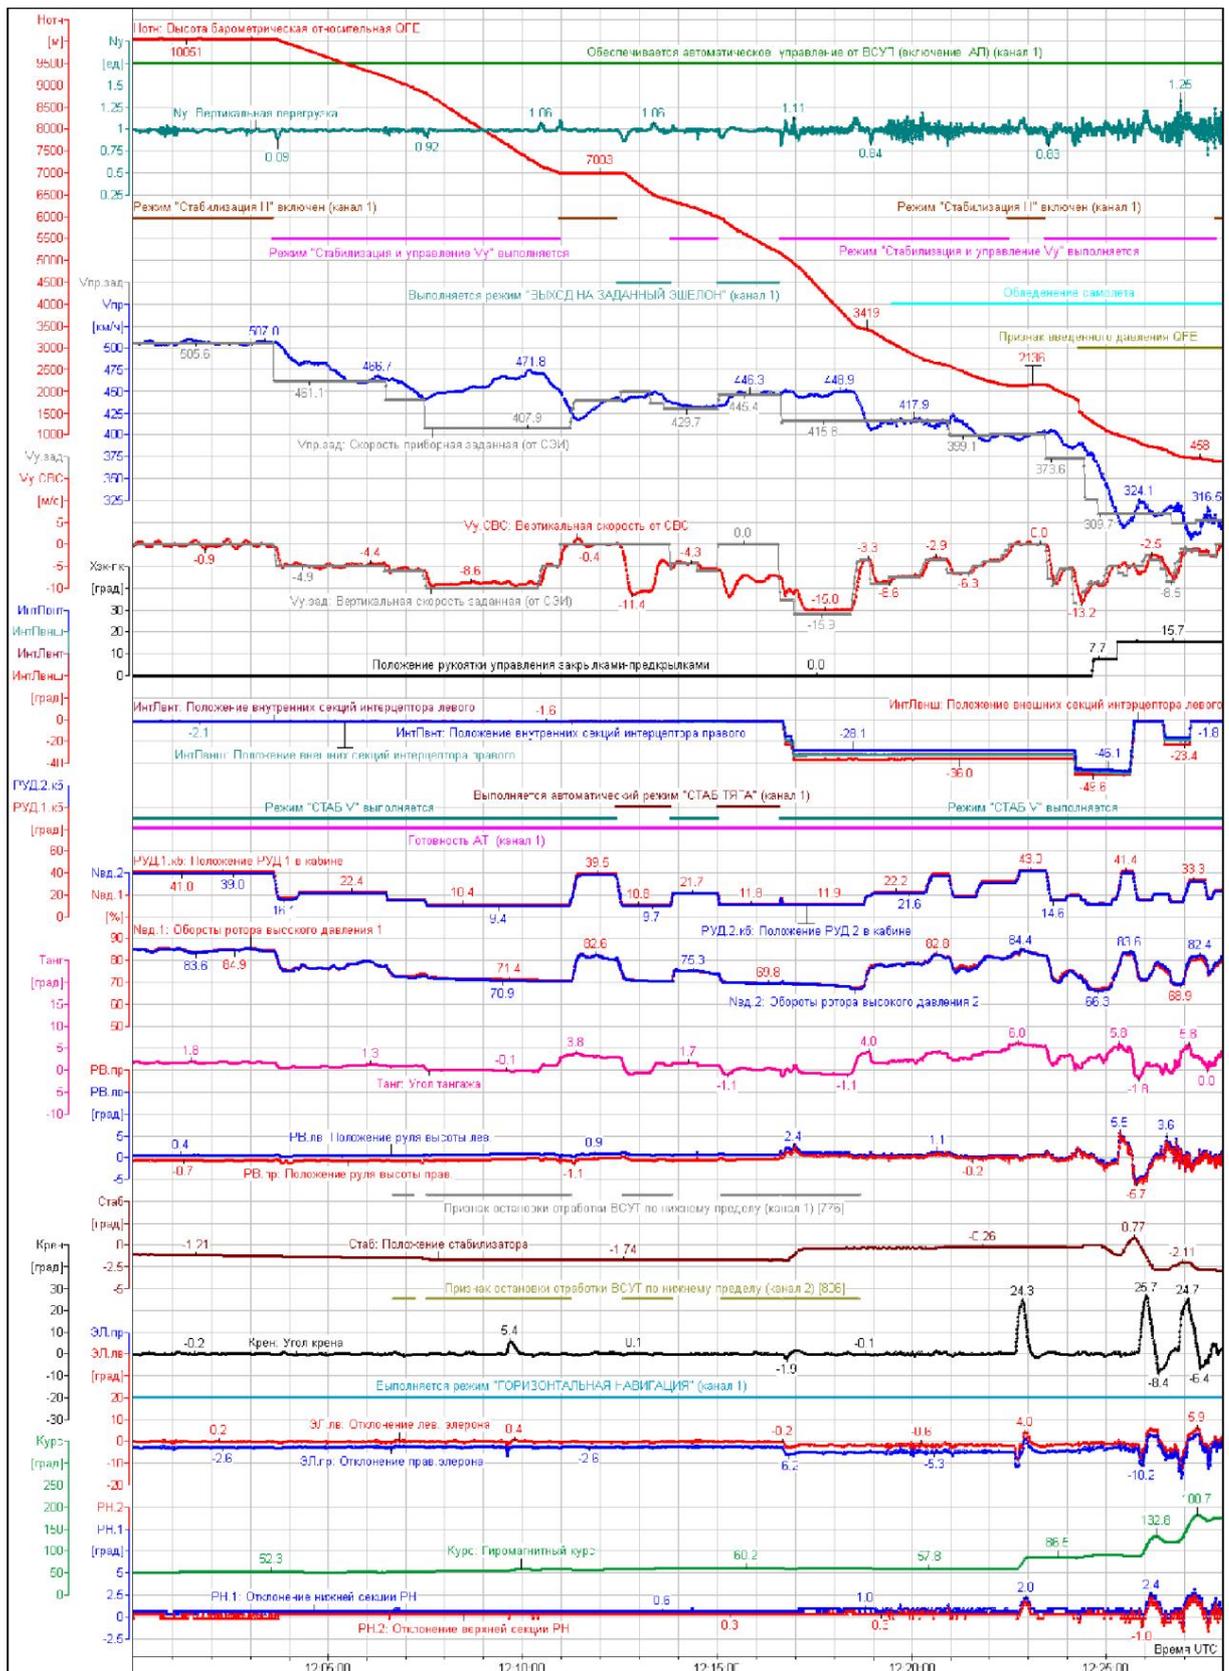
The controller gradually gave permission to descend to levels 270, 250, 230. The descent was carried out automatically with a vertical speed -5...-10 m/s, which corresponded to the specified one. The maximum recorded The indicated airspeed during descent was ~475 km/h (Fig. 9).

Fig. 9. Flight parameters of the Tu-204-100V RA-64047 aircraft on 12/29/2012 (decrease in Vnukovo airport).

Starting from an altitude of 3100 m, the descent was carried out in icing conditions, as evidenced by is evidenced by the appearance at 12:19:30 of a one-time command "Icing of aircraft" (Fig. 9), and also recorded speech information. Approximately one minute before When the icing alarm was triggered, the activation of the engine anti-icing system was registered.

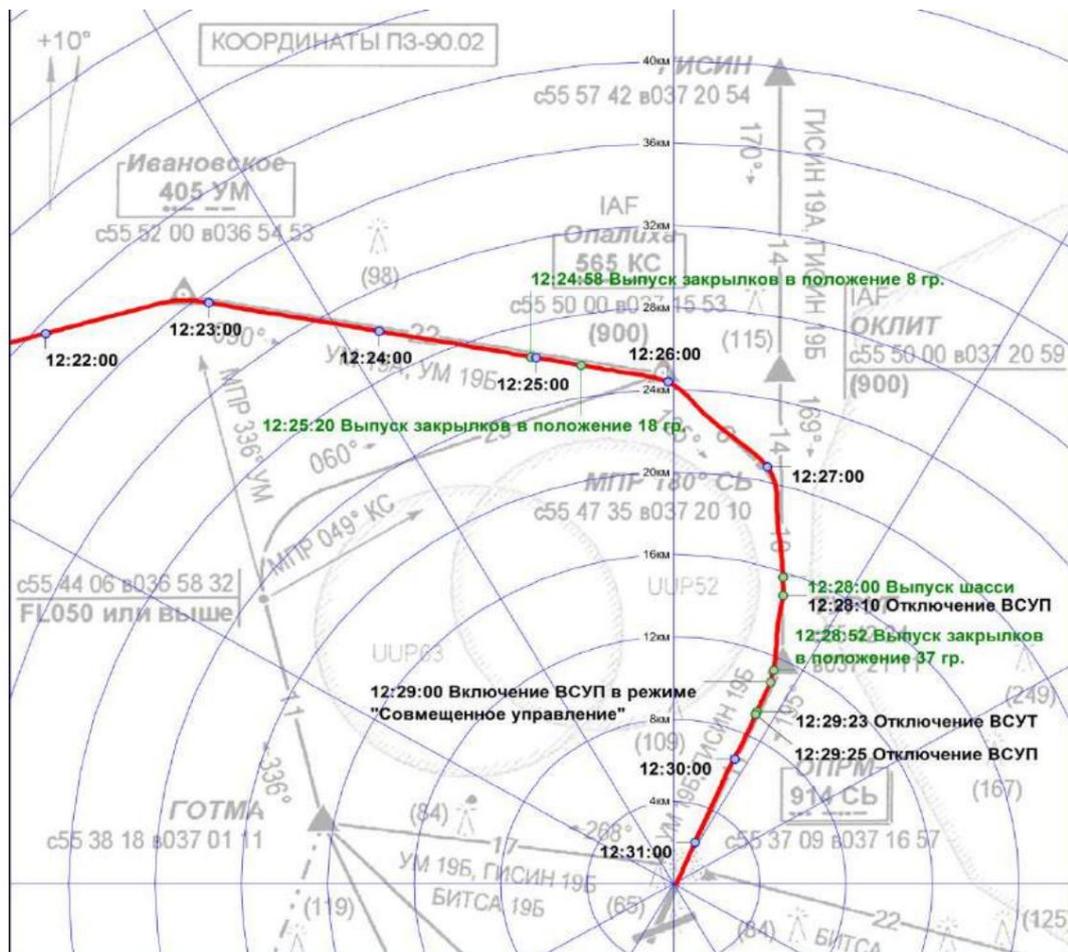
Fig. 10. Flight trajectory of the Tu-204-100B RA-64047 aircraft on December 29, 2012. Final landing approach phase at Vnukovo Airport.

At the moment of releasing the flaps to the 18° position, the aircraft was at a distance about 25 km from the end of runway 19 (Fig. 10), the flight altitude was 980 m, instrument speed – ~305 km/h.

By this time the flight altitude had decreased to 270 m, the indicated airspeed was 250 km/h, the aircraft was at a distance of about 4600 m from the threshold of runway 19 (Fig. 10). The descent was carried out with a vertical speed of about -4...-5 m/s, angle attack (true) was 1.4...1.6, the indicated air speed increased to 250...260 km/h.

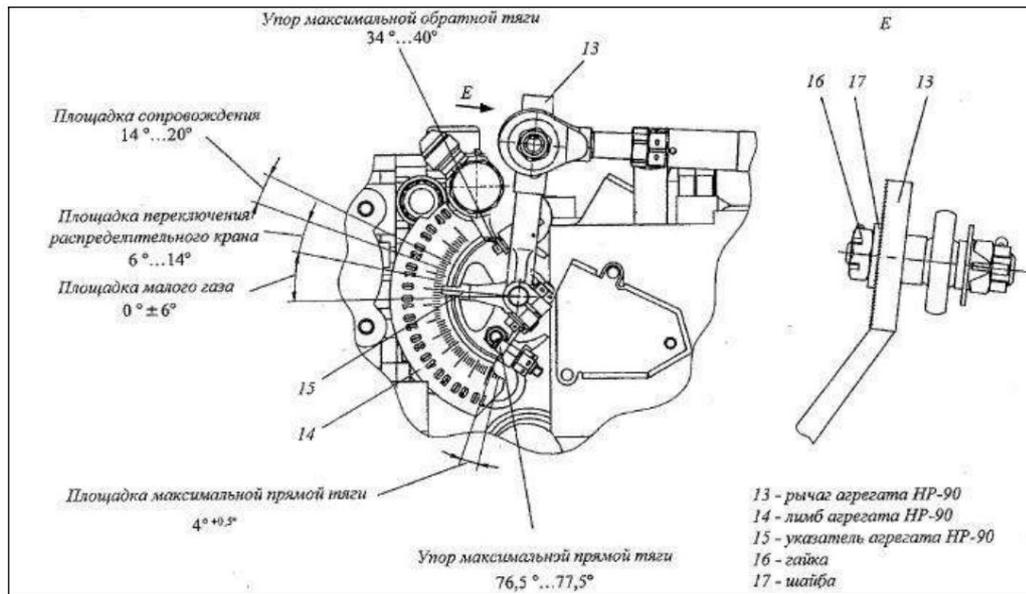
Fig. 14.

When moving the RUR to the intermediate stop, the pointer on the pump limb- the regulator passes through the switching platform of the distribution valve (Fig. 14), after which, in 2...3 seconds, the reversing device flaps are repositioned Reverse thrust mode. To prevent the engine from engaging in reverse in the air the release of the engine reversing devices is blocked in the hydraulic control system reverser in the absence of a signal for simultaneous compression of the main landing gear supports. Signal compression of the main landing gear for the thrust reverser system is formed when at least one of the two limit switches on each support was triggered.

According to the logic of the MUB operation, when the reverse valves are in the straight position the traction, the locking cam, resting against the guide, should not allow movement RUR and, accordingly, the indicator on the limb of the pump-regulator further from the platform accompaniment (Fig. 14.).

During normal operation, the engine modes are set RED. When controlled from the power steering, the engine operating mode is increased occurs in stages (Fig. 17), upon reaching a position more -32° (for example, -33°) according to the indicator on the dial of the regulator pump (Fig. 14), until this value is reached, the operating mode is maintained engine "low throttle".

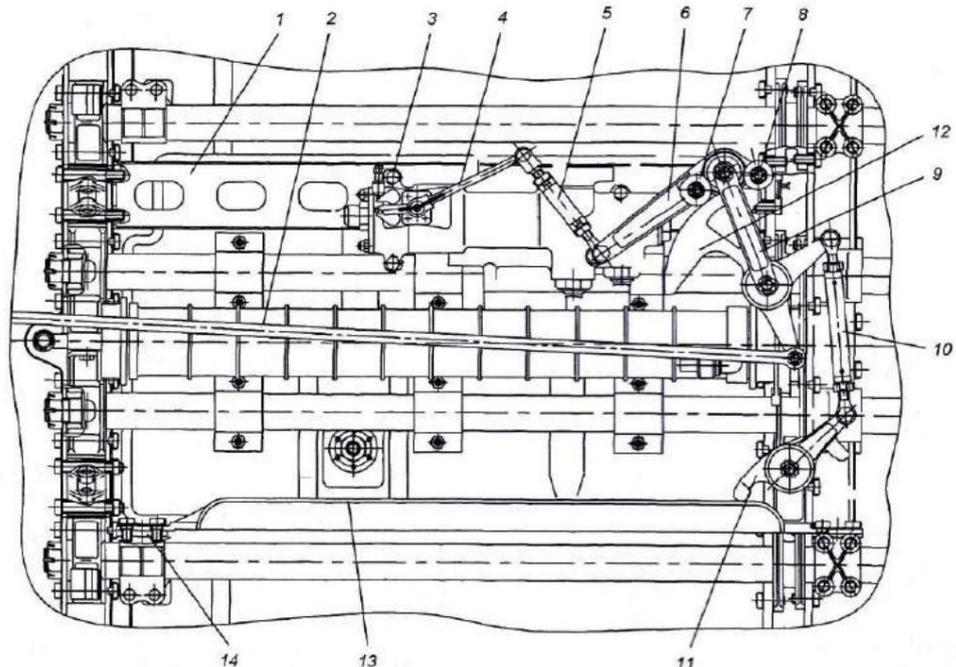
Fig. 15.

Рис. 7.7. Механизм управления и блокировки РУ двигателя ПС-90А
1 - кронштейн; 2, 5, 10 - тяга; 3 - кран КР-90; 4 - рычаг; 6 - переключатель; 7, 8 - ролики; 9 - перемычка; 11 - кулачок блокировки; 12 - кулачок управления; 13 - направляющая; 14 - кронштейн промежуточный

The control and locking mechanism of the reversing device is mechanical system (Fig. 15), which, through a system of levers and rods, provides communication reverser control valve KR-90 with RUR, as well as with the pump throttle valve lever-regulator HP-90. The control and locking mechanism provides, among other things, switching of the KR-90 crane, as well as blocking the RUR from possible switching reversing device, bypassing the "Low Gas" platform on the pump-regulator (this function and was not performed in the accident flight).

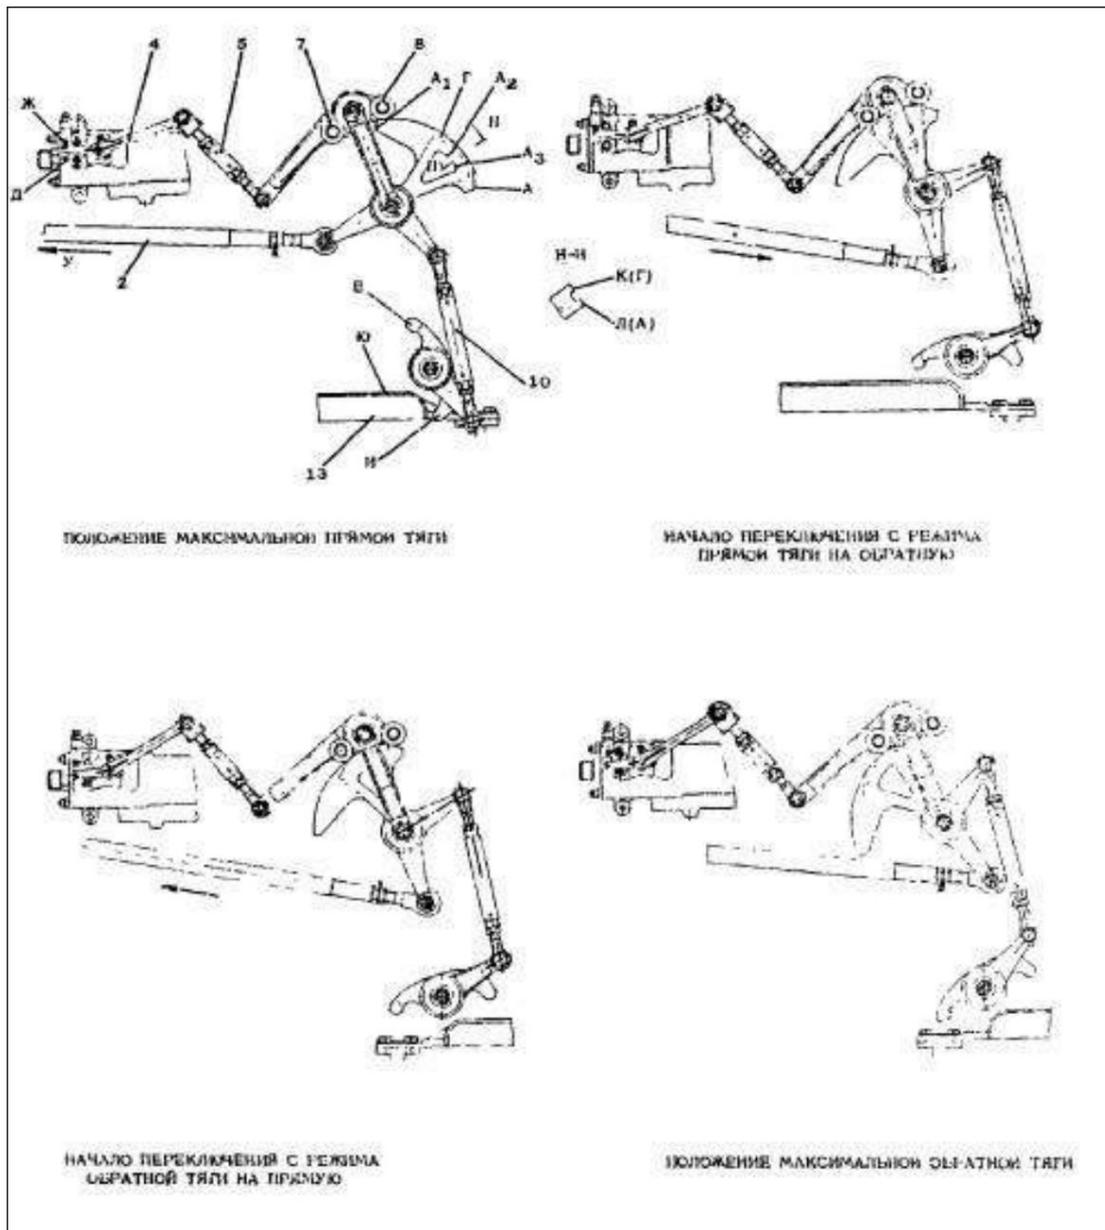
The engine design provides for blocking further movement of the power steering system. (above the intermediate stop) and, accordingly, blocking further movement an indicator on the dial of the regulator pump, the position of which determines the operating mode engine. Design and operating procedure of the control and locking mechanism (CLM) The reversing device at various stages is shown in Fig. 15 and Fig. 16.
