MINISTRY OF JUSTICE OF THE REPUBLIC OF LITHUANIA  
TRANSPORT ACCIDENT AND INCIDENT INVESTIGATION DIVISION

Accident to cargo aircraft  
Boeing 737-400SF, registered EC-MFE,  
operated by Swiftair,  
that occurred on 25 November 2024  
near Vilnius International Airport,  
in Vilnius, the Republic of Lithuania

## **INTERIM REPORT**

No. (A-24/23) 1A-242  
20 December 2024

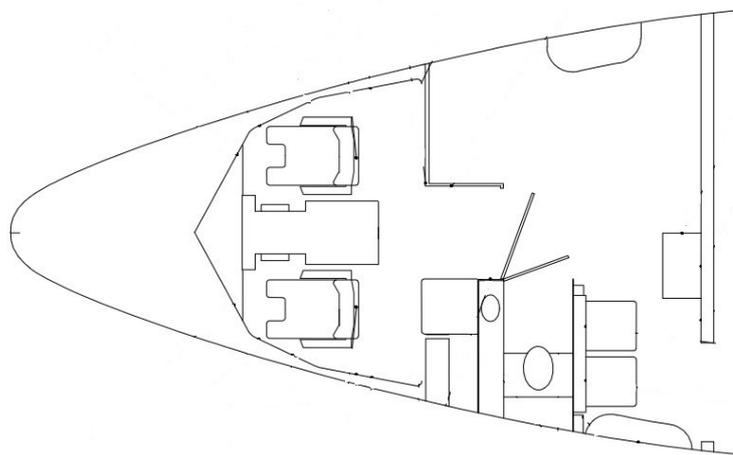
Figure 11. Flight deck and cabin layout & seating diagram (Operator / TAID)

The captain was seated on the left-hand pilot's seat, the co-pilot occupied the right-hand pilot's seat (Figure 11). The two passengers were seated on the left-hand side of the forward cabin next to each other on two aft facing cabin attendant seats close to door 1L.
