*Accident  
which occurred  
on 30 January 2000  
in the sea near Abidjan Airport  
to the Airbus 310-304  
registered 5Y-BEN  
operated by Kenya Airways*

**REPORT**

**5y-n000130**

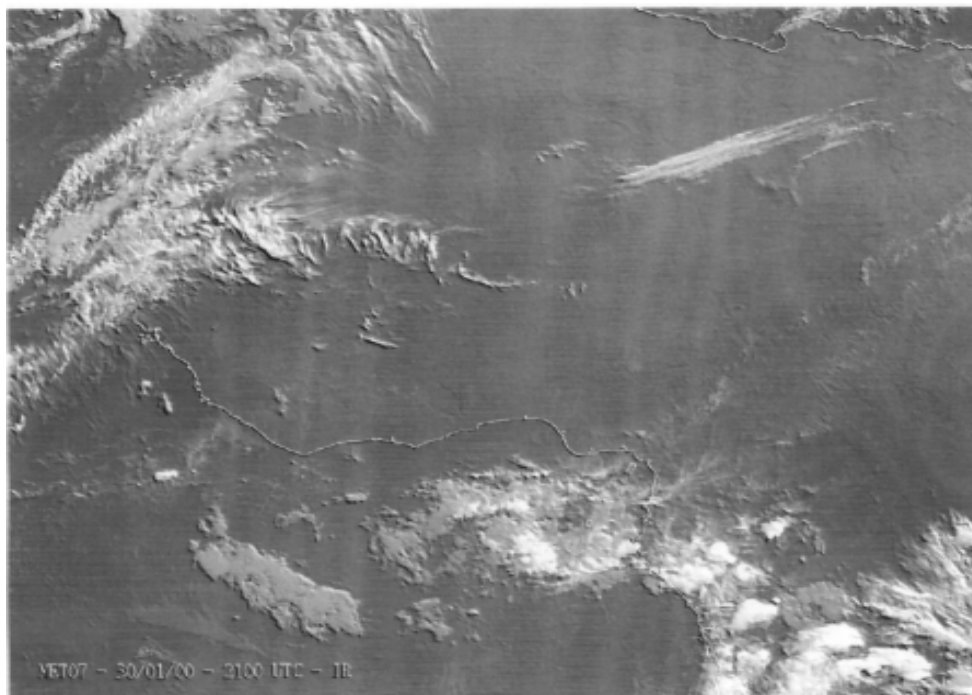
From 20 h 00 to 24 h 00, the sky was clear with few clouds, 2/8 of stratocumulus with its base at between 350 and 400 meters. The horizontal visibility was good, equal to or over 8 km. There was an absence of any rain or storm activity or any other meteorological phenomena at that time.

A satellite photo, below, shows the situation at 21 h 30 on 30 January 2000.

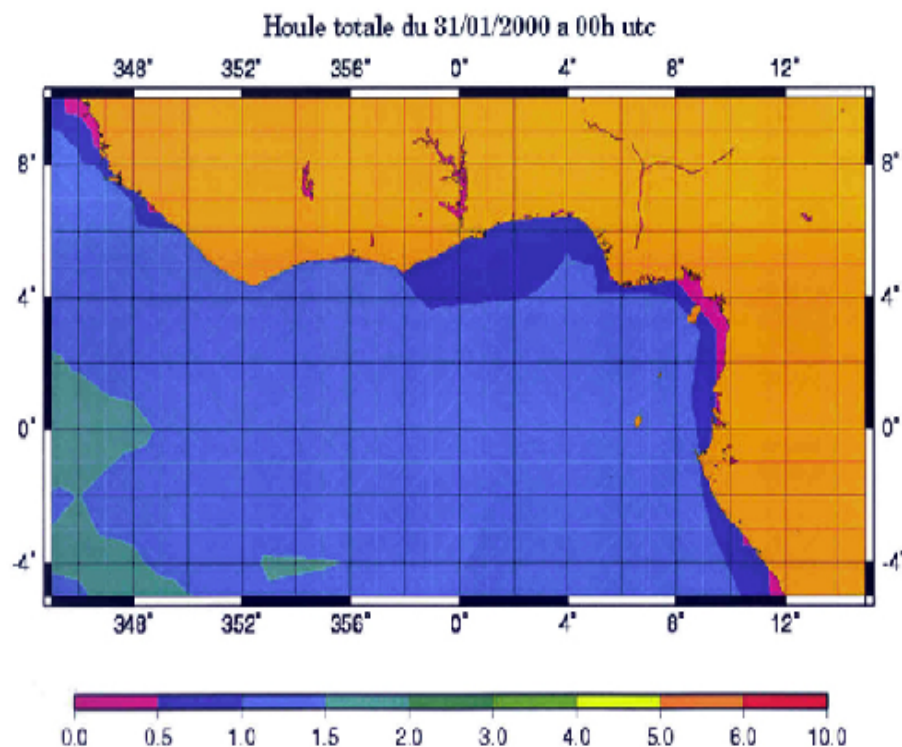
The situation was identical to that of the continental region around Abidjan. The storm activity was centered 2 degrees latitude north and east and 2 degrees longitude west, more than 200 kilometers from the coast near Abidjan.

The satellite photo below shows the situation of the tide on 31 January 2000 at 00 h 00.

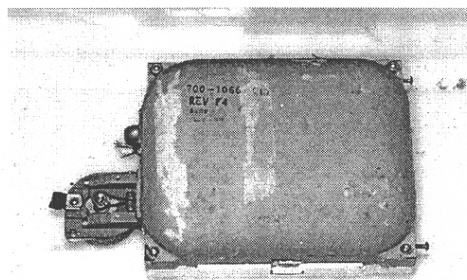
*Figure 2: Memory module*

The recorder was transported in water to minimize oxidation. It was found to exhibit slight impact damage to the outer casing and face plate (Figure 1). The recorder was rinsed with fresh water and disassembled in order to remove the tape medium. The internal crash protected memory module and the tape medium were found to be in pristine condition (Figures 2 and 3). There was no corrosion damage to the recording.

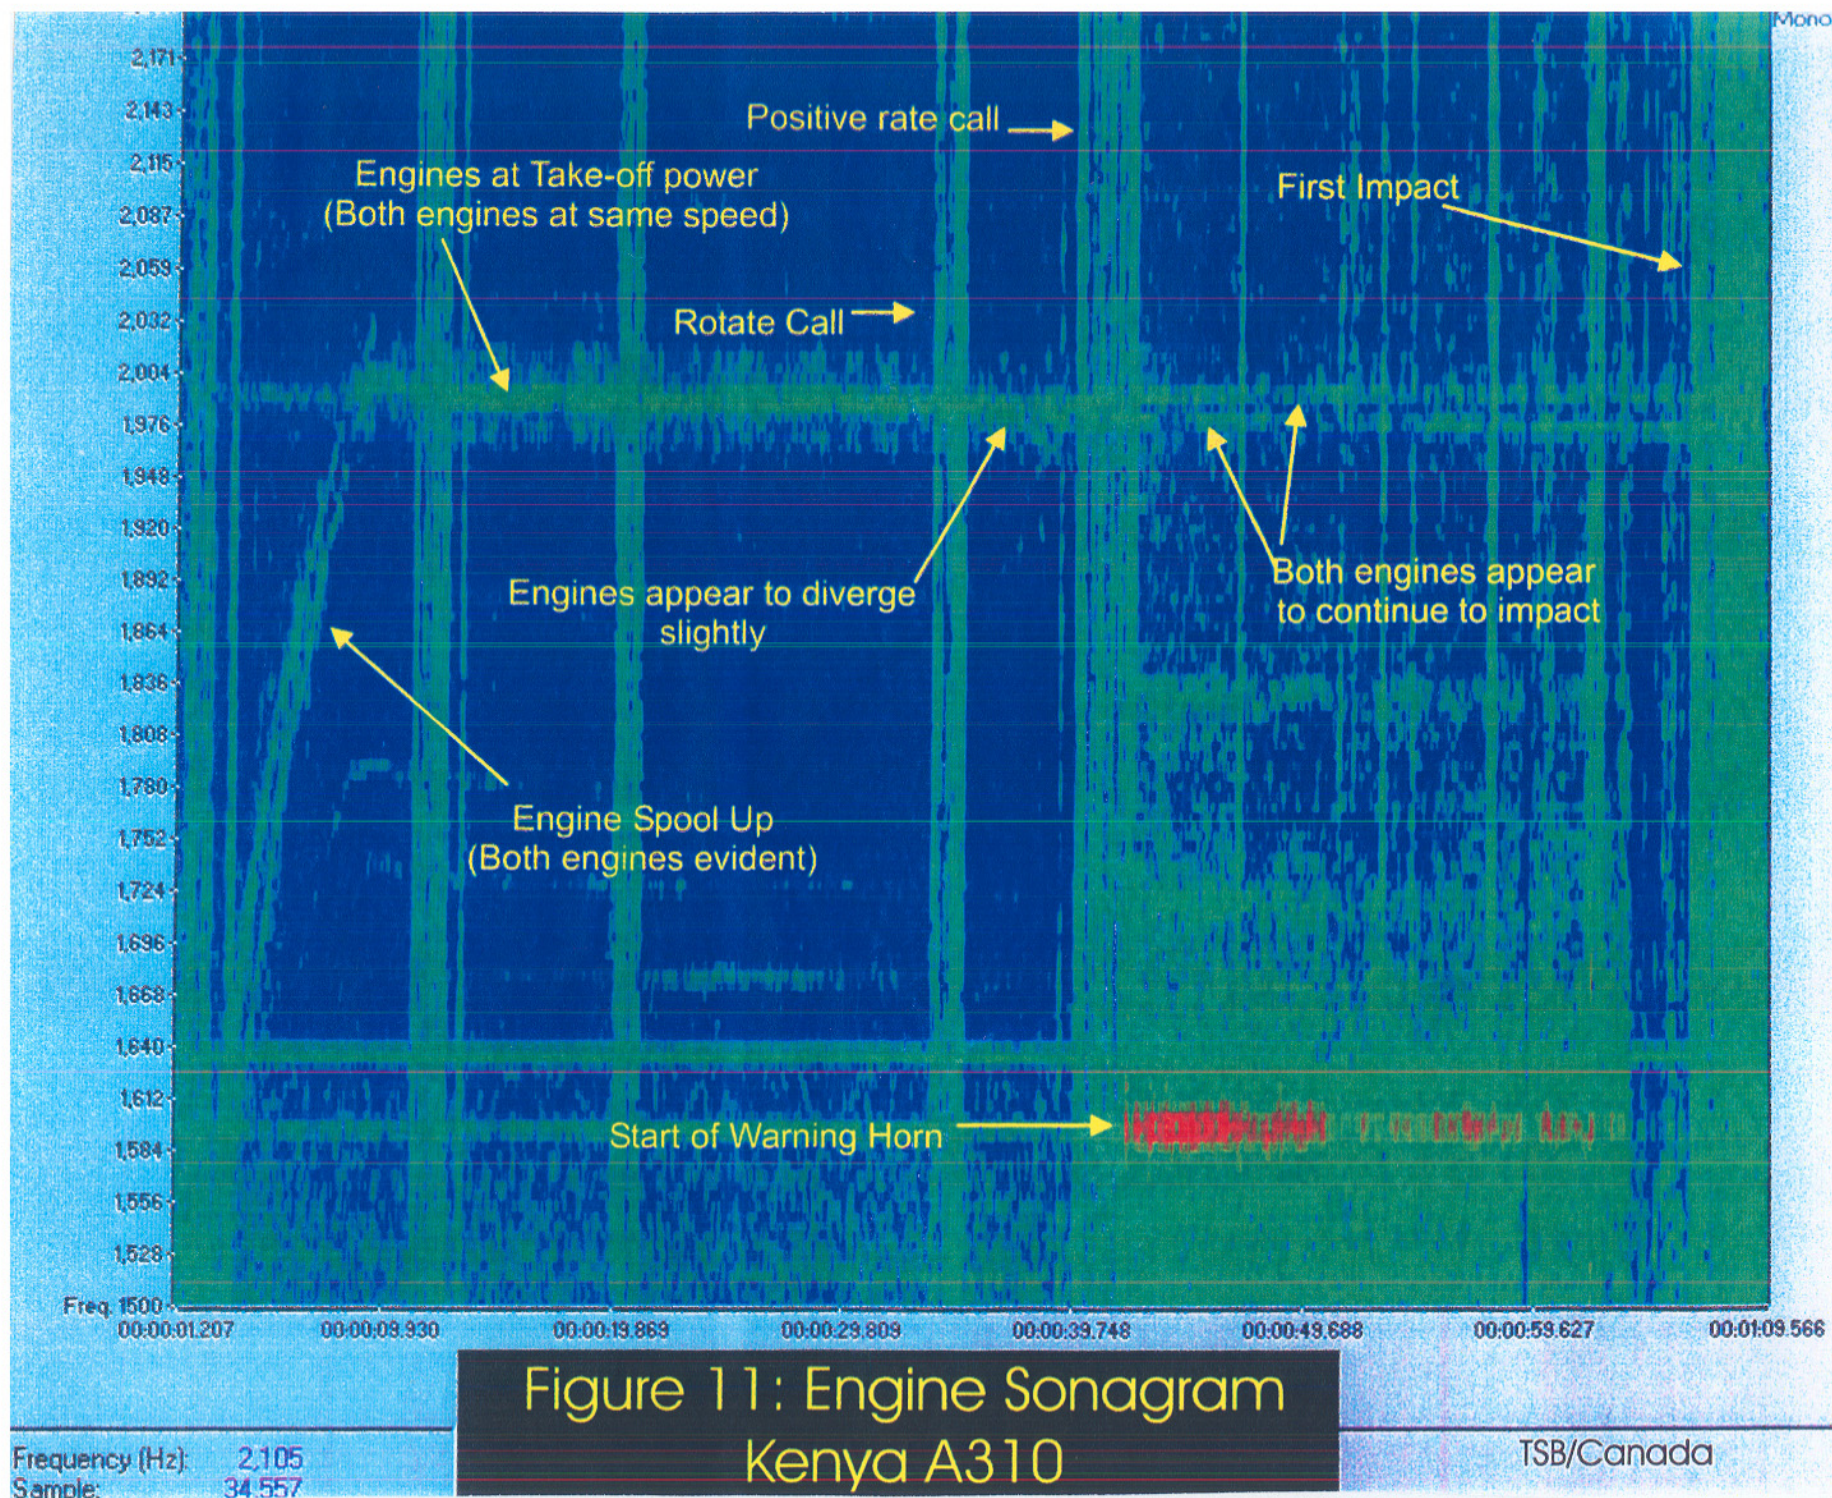
Figure 12: Auto Altitude Call Outs

The auto altitude call outs recorded during the final 16 seconds of the take-off were plotted as a function of time from the start of engine spool-up (Appendix C, Figure 12). A mathematical smoothing algorithm was applied to the data, which was then differentiated to provide an indication of the vertical rate of climb. The CVR recording indicated that there was a change from a positive to a negative rate of climb at some point following the stall warning activation. The derived vertical rate suggests that the rate of descent exceeded 1,000 feet/min, and that a recovery was possibly initiated, as suggested by an apparent reduction in the rate of descent, during the final 10 seconds of the flight.
