NATIONAL TRANSPORTATION SAFETY BOARD

AIRCRAFT ACCIDENT REPORT

**COLLISION OF
AERONAVES DE MEXICO, S.A.
McDONNELL DOUGLAS DC-9-32, XA-JED
AND PIPER PA-28-181, N4891F
CERRITOS, CALIFORNIA
AUGUST 31, 1986**

NTSB/AAR-87/07

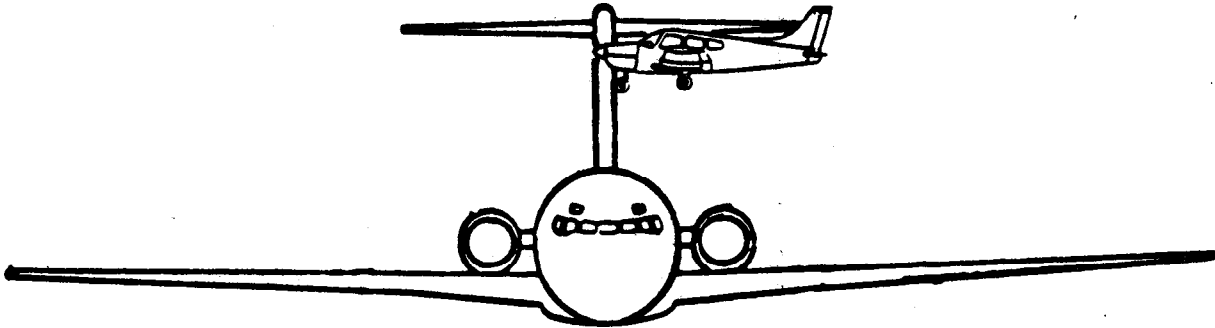
Figure 6.--Collision geometry as viewed from above the DC-9.

The damaged areas on the DC-9 vertical and horizontal stabilizers contained propeller slice marks, paint transfer marks Rom the nose wheel area and vertical stabilizer of the Piper, and embedded pieces from the cabin roof area of the Piper. **The** location and angles of these marks and damage on the **DC-9**, when matched to their respective locations on an intact Piper PA-28, showed that the front of the Piper had struck the left side of the DC-9 vertical stabilizer and that the impact angle was perpendicular to the longitudinal axis of each airplane. (See figure 6.) The impact angle was generally consistent with the flight tracks of the airplanes shown on the radar data plots.

Estimated positions of aircraft at impact, based on the propeller damage and scratch marks on the DC-9 Vertical and Horizontal Stabilizers.

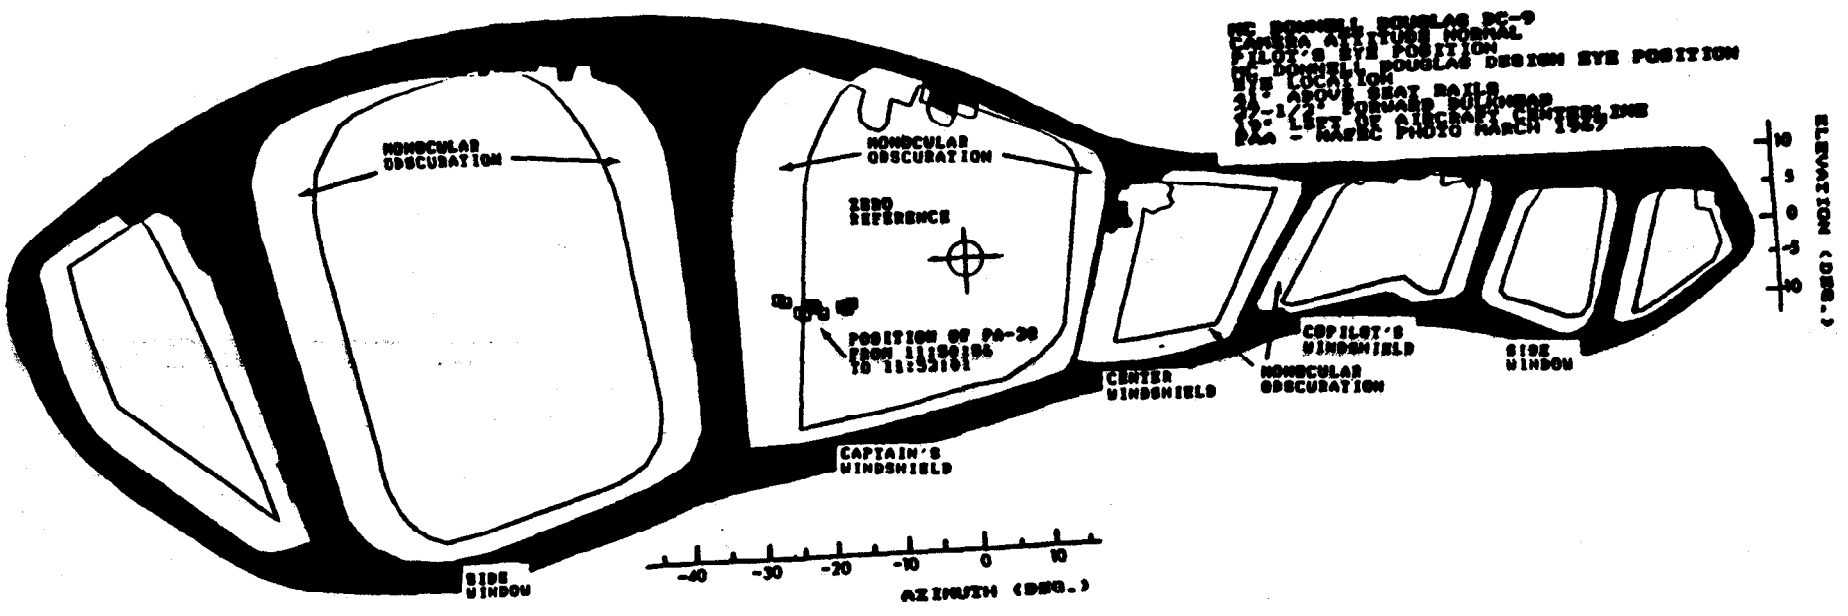
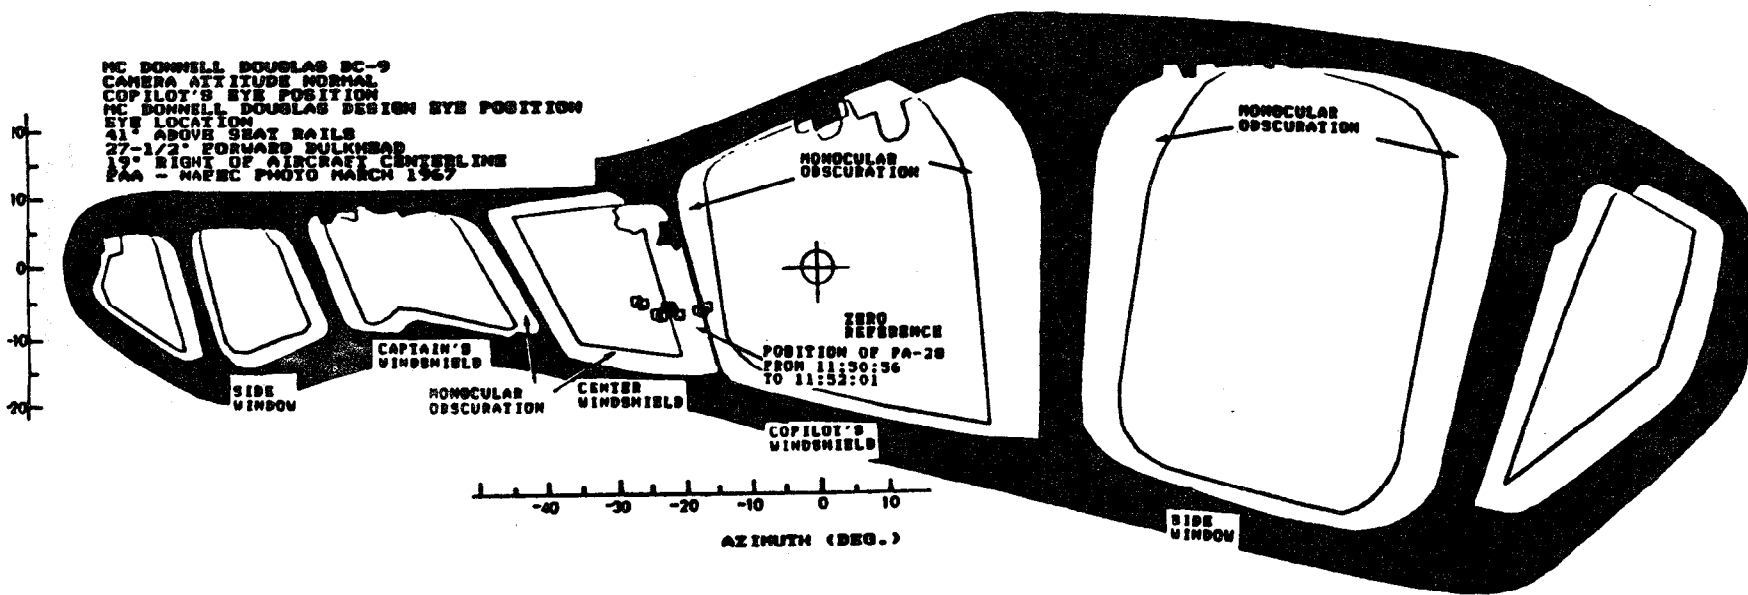
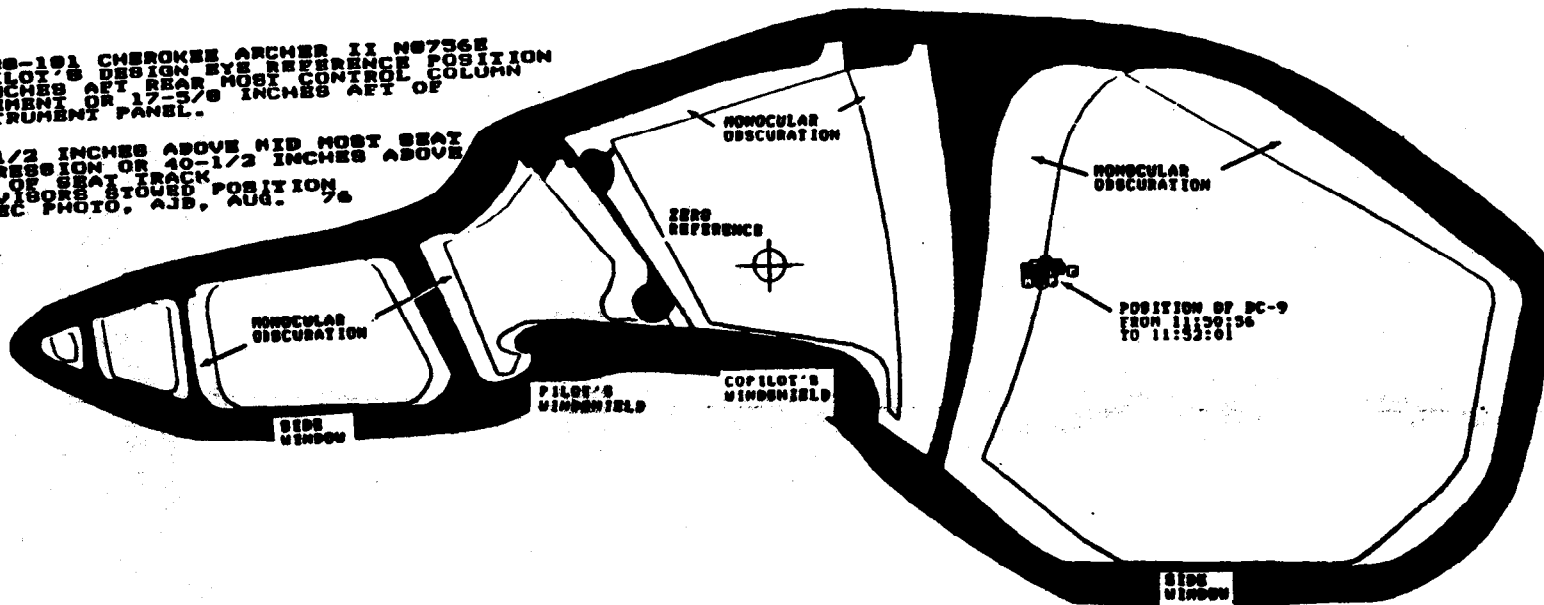
APPENDIX E
COCKPIT VISIBILITY STUDIES

A visibility study was conducted to determine the physical limitations to visibility from the pilot and copilot seats of the DC-932 and from the Piper PA-28-181. To accomplish this, the time histories of both airplanes' flightpaths and attitudes, as contained in the radar track plot, and the performance information on flight 498's FDR were combined with binocular photographs 6/ of the respective cockpits. The viewing angles for each airplane were then calculated and plotted at 5-second intervals in relation to the design eye reference (DER) points for each airplane's windshields (appendix E). The study showed that between 1150:56 and 1152:01, the Piper was about 15° to 30° left of the DER point on the captain's windshield and between 15° to 30° left of the DER point on the first officer's windshield. For the first officer, assuming that he did not move, the Piper airplane was located on the airplane's center windshield and in an area where, for about 50 percent of the time, he could see it with both eyes. Assuming the captain did not move, the Piper was located primarily in an area where he could see it with both eyes.
