**PB90-910406
NTSB/AAR-90/06**

AIRCRAFT ACCIDENT REPORT

**UNITED AIRLINES FLIGHT 232
McDONNELL DOUGLAS DC-10-10
SIOUX GATEWAY AIRPORT
SIOUX CITY, IOWA
JULY 19, 1989**

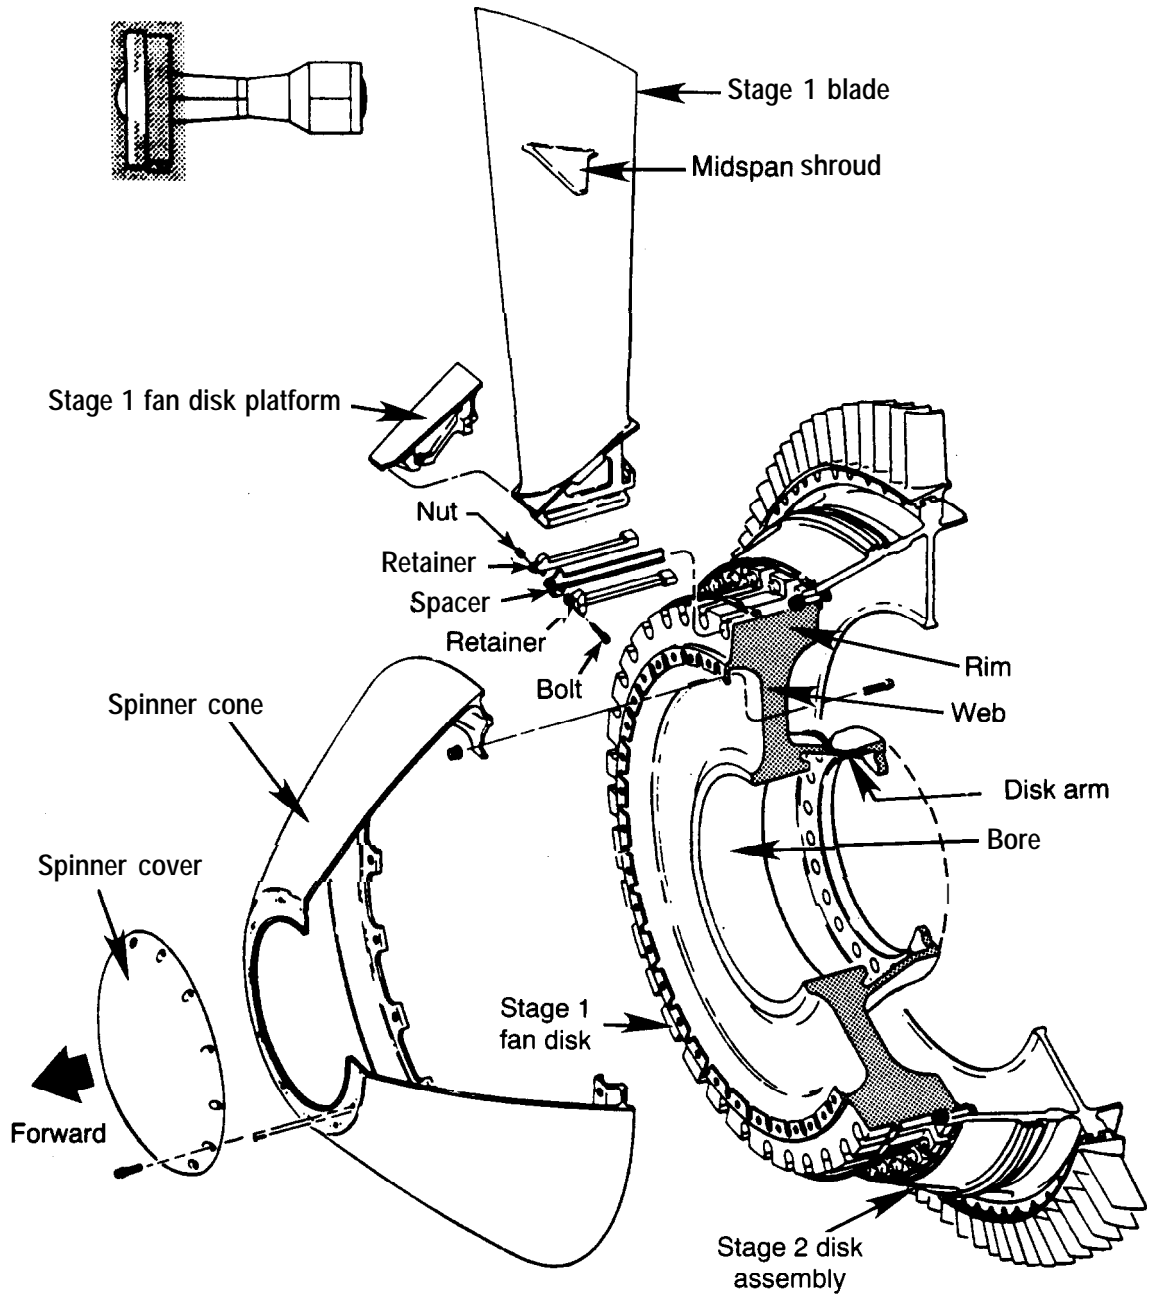
Figure 16. --Fan rotor assembly.

Figure 16 shows a drawing of a **CF6-6** engine fan rotor assembly, most of which departed the No. 2 engine of the accident airplane in flight. The assembly consists of the large stage 1 disk and attached fan blades and retainers, the smaller stage 2 disk and attached blades, the spinner cone and cover, and various mounting and balancing hardware. A cutaway view of the engine in the area of the stage 1 disk is shown in figure 17.
