I am truly honoured to have been given the opportunity to head the Investigation into the Accident at Kozhikode on 07 August 2020 involving B737-800 aircraft VT-AXH operated by M/s Air India Express Limited.

SYNOPSIS

Air-India Express Limited B737-800 aircraft VT-AXH was operating a quick return flight on sector Kozhikode-Dubai-Kozhikode under 'Vande Bharat Mission' to repatriate passengers who were stranded overseas due to closure of airspace and flight operations owing to the Covid-19 pandemic. The aircraft departed from Kozhikode for Dubai at 10:19 IST (04:49 UTC) on 07 August 2020 and landed at Dubai at 08:11 UTC. The flight was uneventful. There was no change of crew and no defect was reported on the first sector. The aircraft departed from Dubai for Kozhikode at 10:00 UTC as flight AXB 1344 carrying 184 passengers and six crew members.

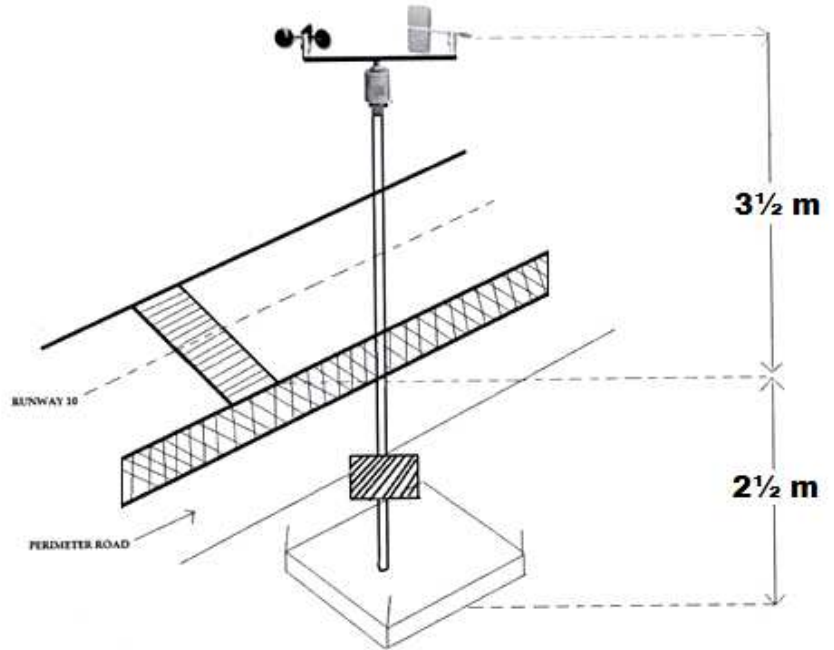
Figure 13: Anemometer installation for Runway 10

As per CAR issued by DGCA (CAR Section 9 - Air Space and Air Traffic Management, Series M, Part I, Issue II, 24 March, 2017, Rev. 2, 08 November, 2018) and ICAO Annex 3, the height of the Anemometer for reporting surface wind and directions shall be 10 m (+/- 1 m). However, the height of anemometer for Runway 10 is 6 m and it is installed on a platform 2.5 m below the runway surface. Hence, the effective height of the Anemometer above the runway surface for runway 10 is just 3.5 m. The same is depicted in the figure 13.

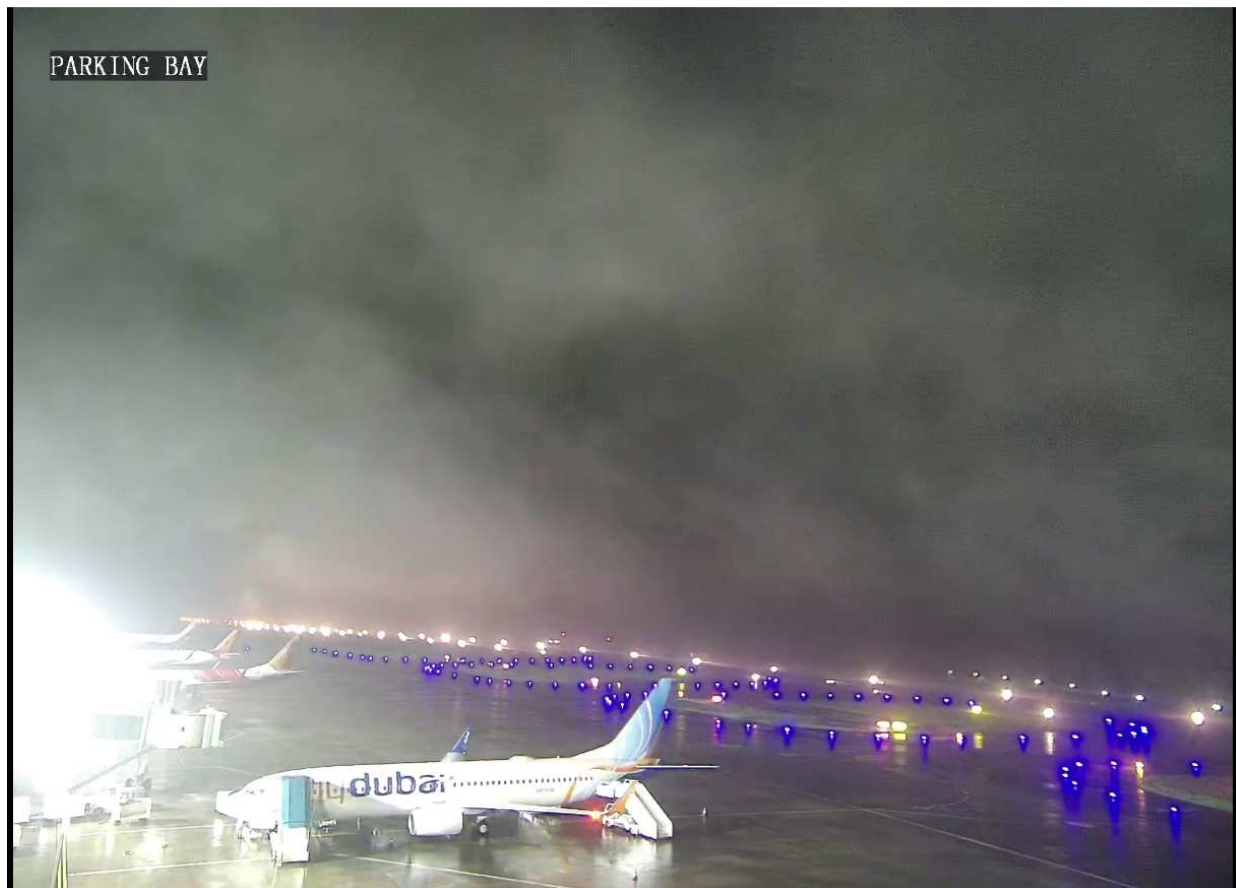
Figure 20: Screenshot from CCTV footage at 19:22 IST

The above figure shows low clouds in the direction of Runway 28 approach. The aircraft had made a missed approach on Runway 28 at around this time.

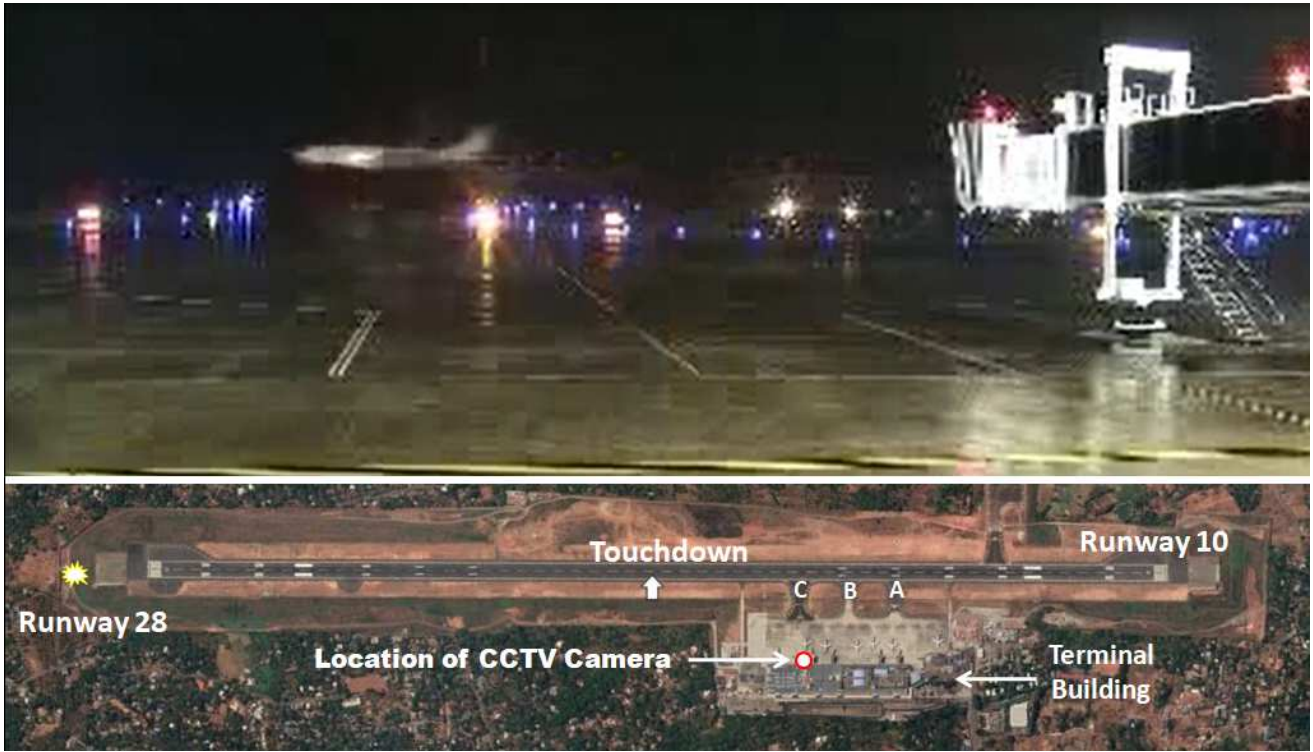
Figure 21: The Screen Shot from CCTV Installed in Front of Taxiway 'C'

The above figure shows the aircraft while crossing Taxiway 'C', and still floating. The location of camera and final touchdown point is also shown.

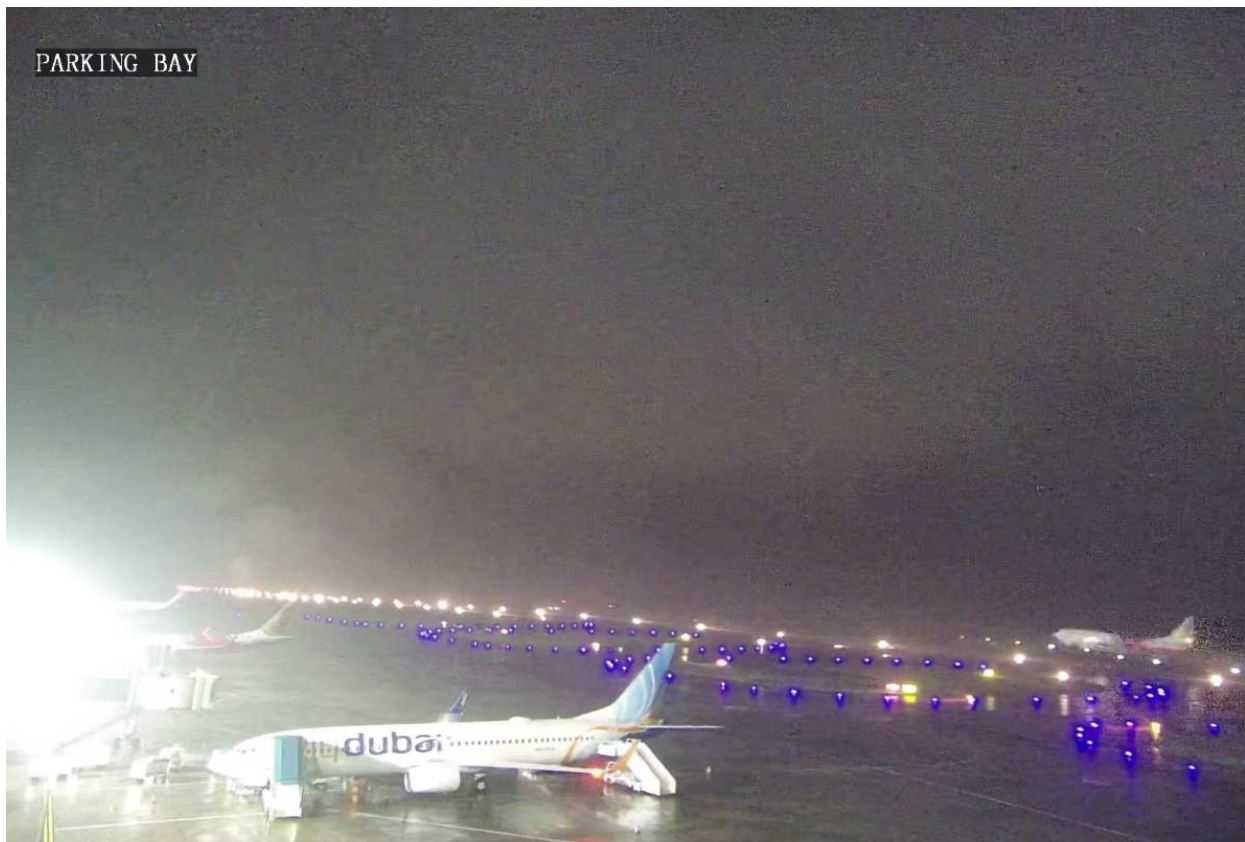
Figure 22: Screenshot from CCTV footage showing VT-AXH landing

The above figure shows visibility conditions at the time of landing on Runway 10. VT-AXH is also seen in the frame.

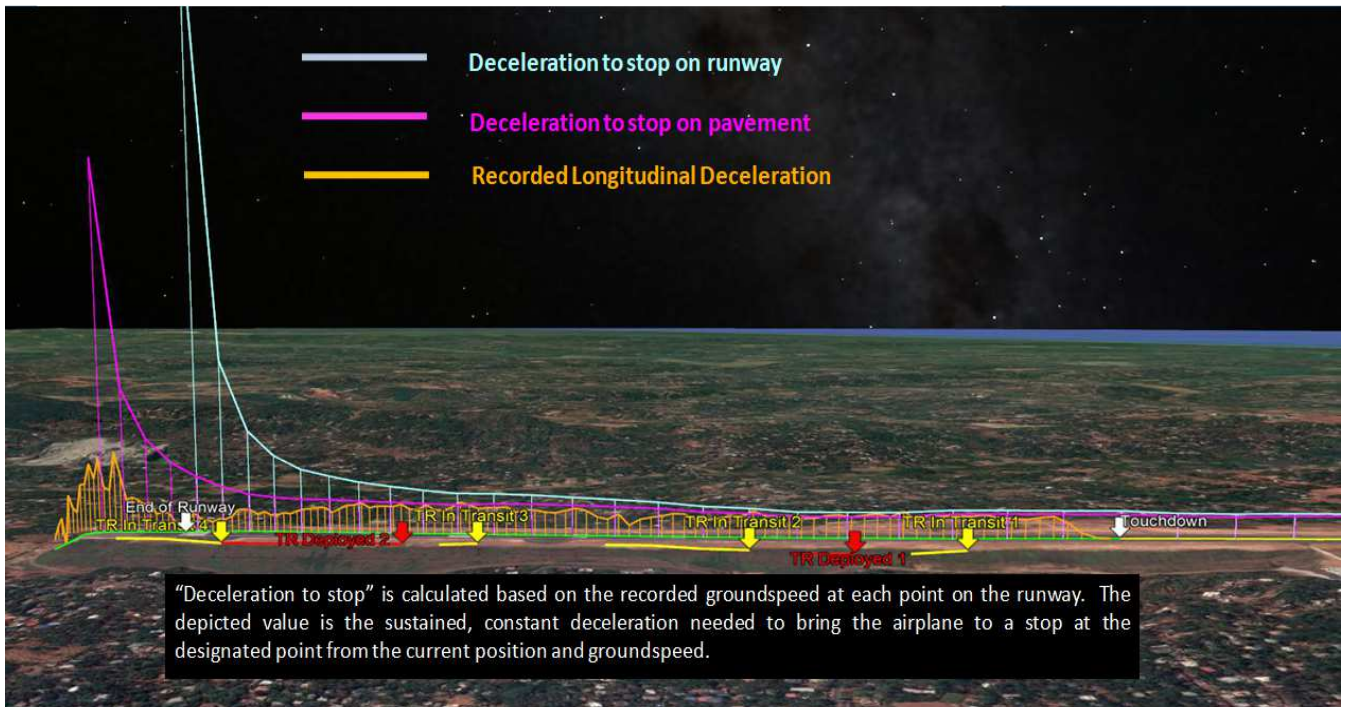
Figure 25: Deceleration to Stop

From 7100 ft till the end of the runway, the average μ_{airplane} increased to approximately 0.14. At the time when the aircraft crossed the end of the runway, longitudinal deceleration increased rapidly, along with the calculated μ_{airplane} . However, this was not sufficient to stop the aircraft and it plummeted down the table top runway embankment.

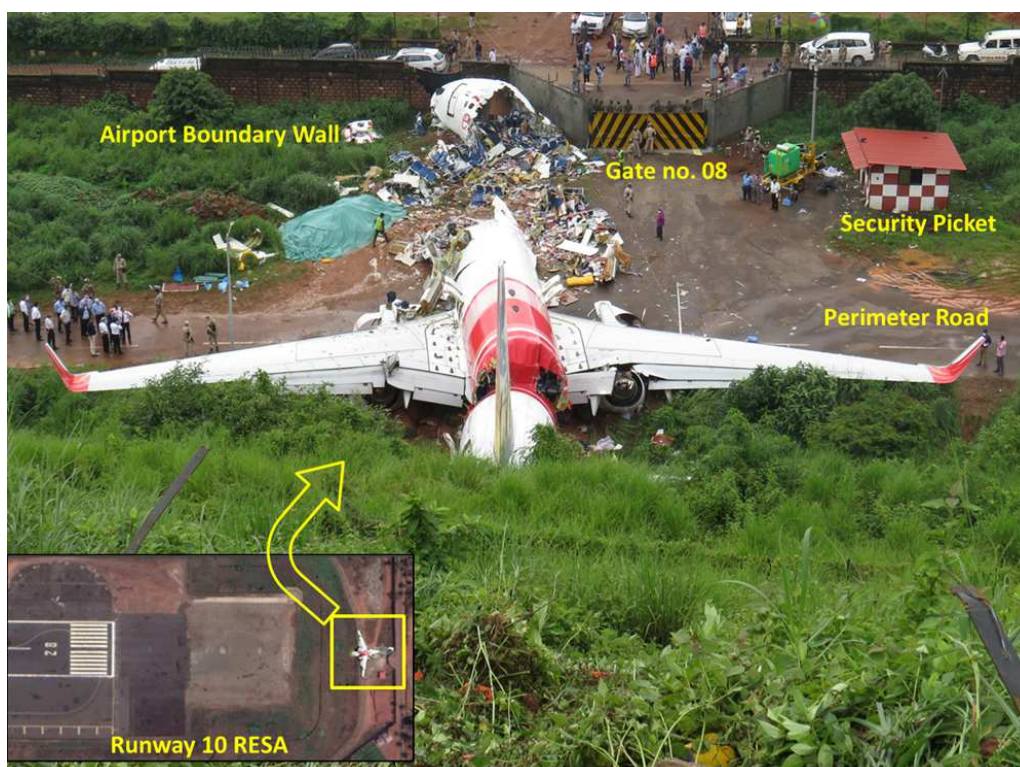
Figure 27: Layout of Wreckage.

Immediately thereafter the aircraft pitched nose down before the DFDR stopped recording. The aircraft went down and impacted the perimeter road at an angle of about 30° nose down. The fuselage separated into three sections on impacting the perimeter road. The forward section of the aircraft came to rest on a heading of 080 degrees magnetic, 74 ft forward of the centre section. The centre

section was on a heading of 110 degrees magnetic and the aft section on a heading of 120 degrees magnetic.

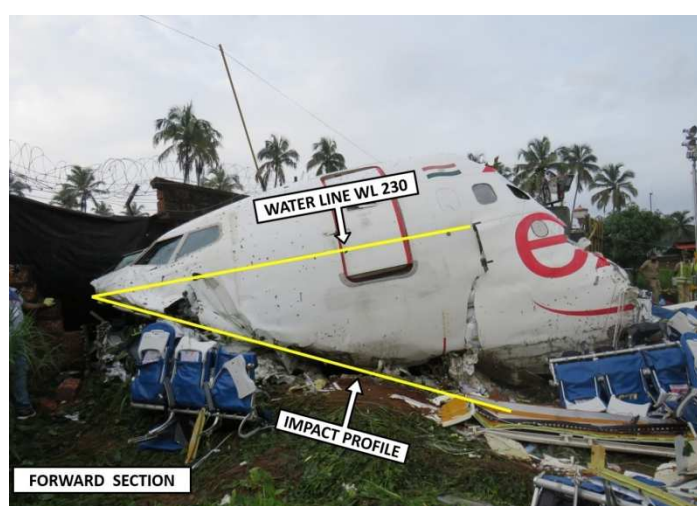
Figure 28: Forward Section Impact Profile.

The initial impact separated the forward section from the centre section, it moved forward in the direction of the perimeter wall next to Gate No. 08. Impact and separation dissipated a part of the total energy and the rest was consumed by friction with road/soft ground and impact with the perimeter wall.

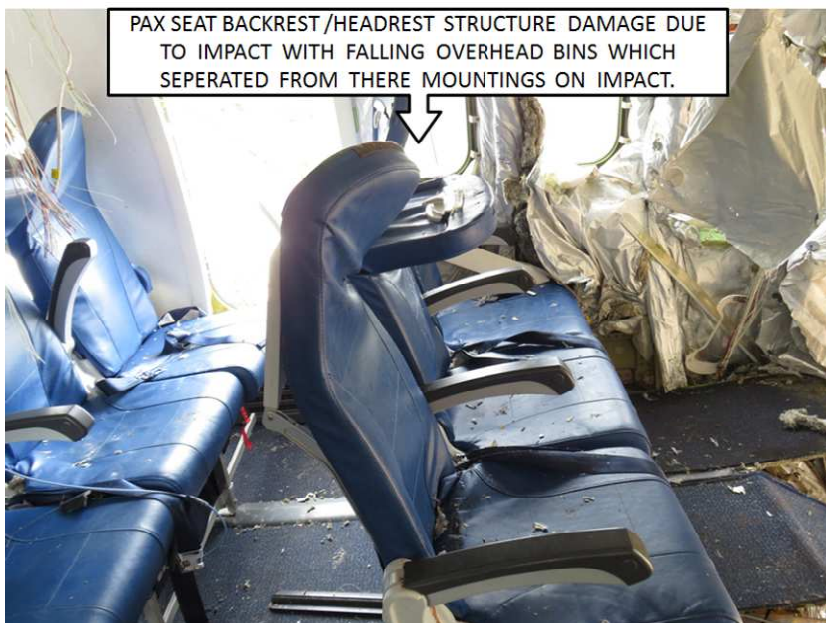
Figure 30: Passenger Seats with damaged Headrests

floor crumpled and separated. Attached cabin equipment including seats, overhead bins, passenger service units and side wall panels fragmented and were scattered over an area of approximately 300 square yards forward of the centre section. The passenger seat headrests were bent forward due to impact with the loaded overhead bins that separated and fell down with a forward momentum.

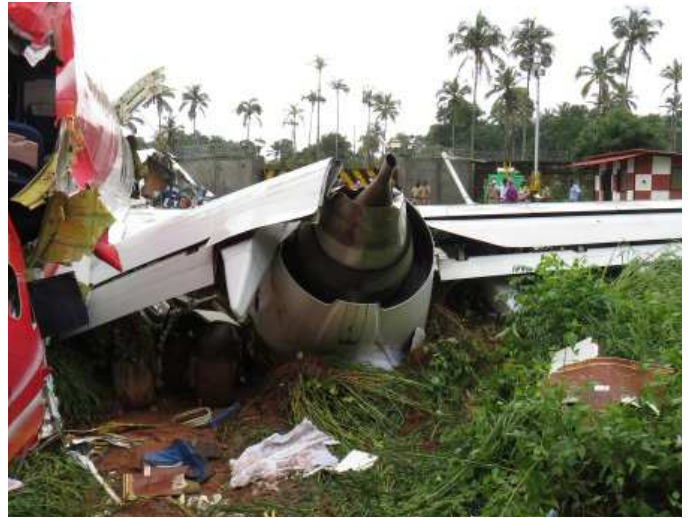
Figure 37: Right Engine

Engines ingested lot of debris, mud and a portion of the air-intake which had crushed on impact. The pieces from crushed section got stuck beneath the fan blade tips. This along with the ingested debris resulted in the arresting of engine rotation. Nacelles of both the engines were also destroyed.

Both Engines had the thrust reverser actuators retracted, and the translating cowls of both were in the stowed position, indicating that the thrust reversers were stowed before impact. This information conforms to the recorded DFDR data. There was no evidence of pre-impact anomalies noticed during the examination.

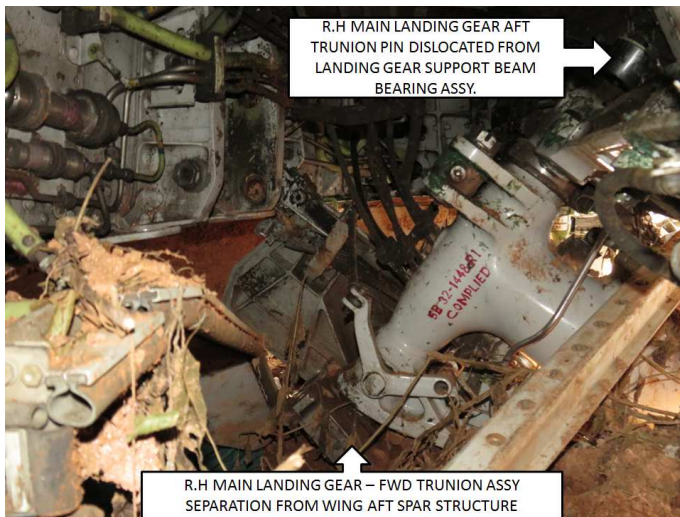
Figure 40: Right Main Landing Gear Separation

The right main landing gear folded back under the right inboard flap. It separated from forward trunnion pin assembly and side beam hangar fitting with a dislocation from the aft trunnion pin. It did not separate cleanly and was covered by debris and partially submerged in water. The DFDR indicated that the right main landing gear was down and locked before impact.

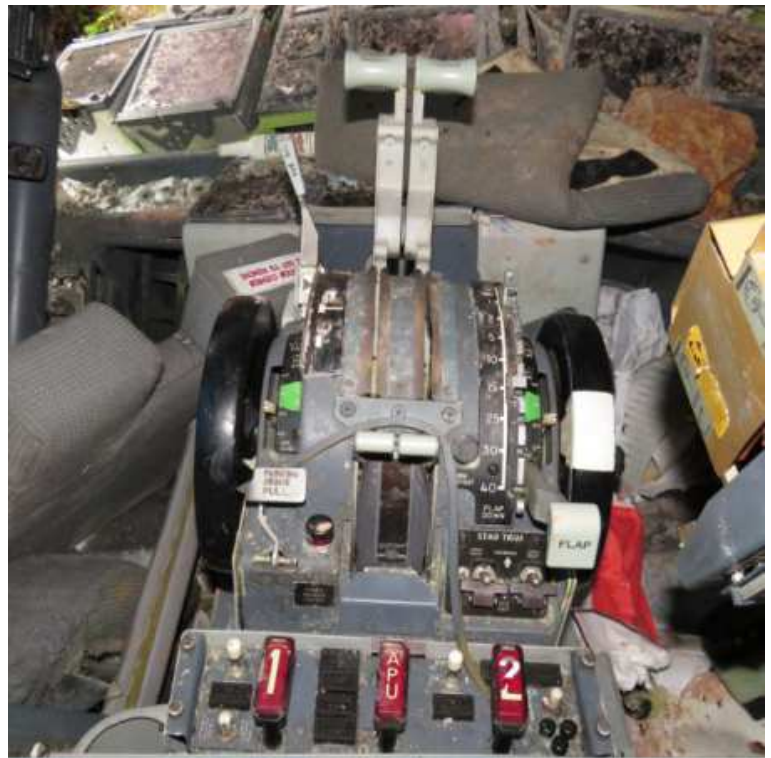
Figure 43: Control Stand

The throttle lever position did not correspond to the last recorded position in the DFDR data before impact. The Engine Throttle Levers were found jammed at the full forward position with the stop plate bent forward. This was attributed to impact damage sustained by the Thrust Lever Resolver Assemblies and Control Rods causing it to move back thereby forcing the throttle lever forward with such a force that it resulted in bending the stop plate. Both the throttle levers were jammed and could not be moved.

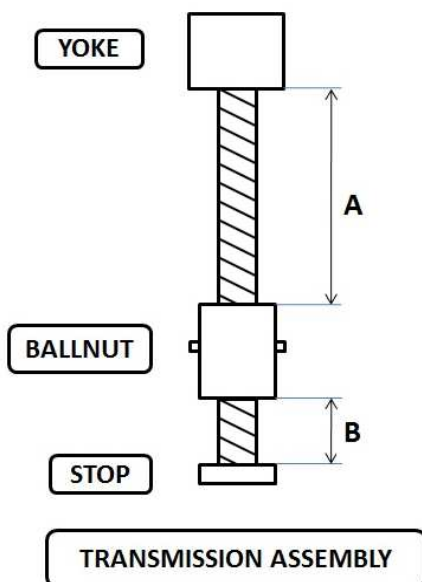
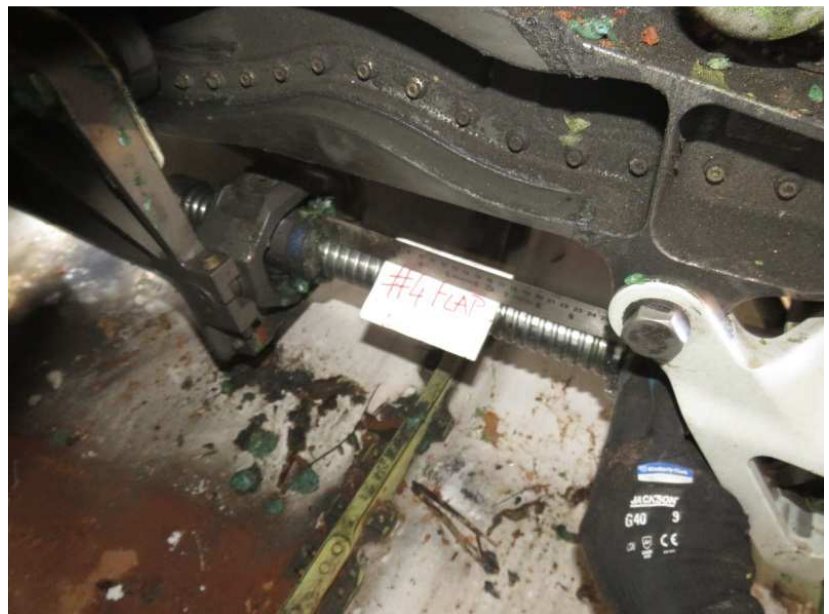
Figure 46: Trailing Edge Flap Jack Screw Measurement

The Flap lever was found to be at Flap 40 selection and free to move without any frictional load. This position did not corroborate with the Flap 30 selection last recorded in the DFDR. The actual Flap position was confirmed by physically measuring the flap jack screw length which is shown in the following figure and table. The measured length corresponds to the Flap 30 selection as in DFDR.

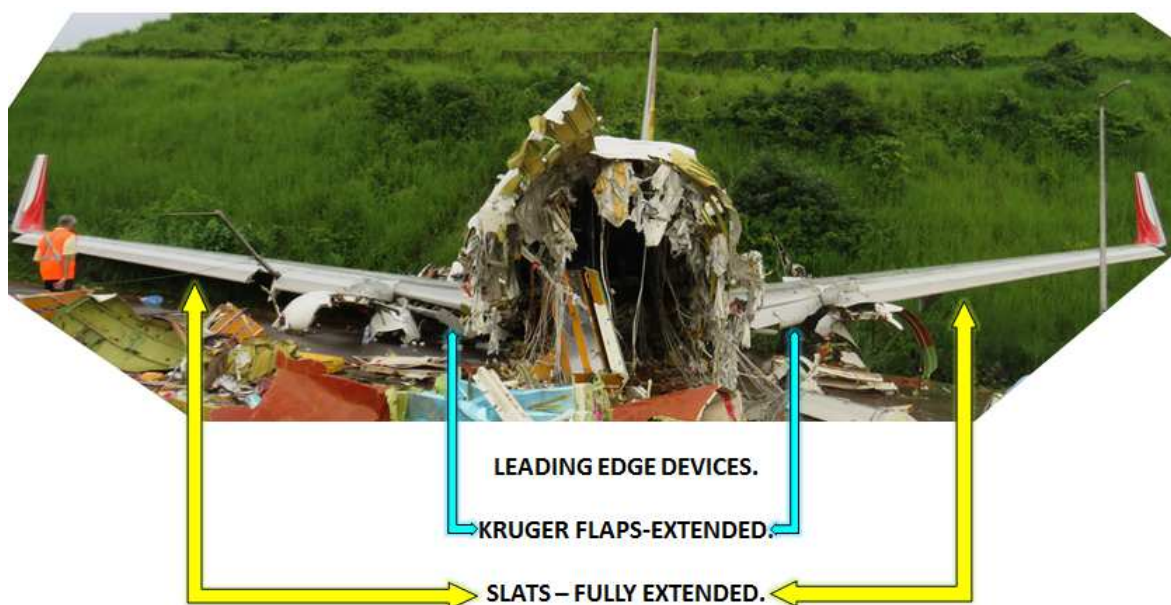
Figure 47: Leading Edge Devices

Leading edge flaps were found to be in extended position and slats were found to be in “full extend” position. The kruger flaps were damaged and leading edge slat #5 on the right wing impacted a light pole resulting in separation of a 30 inch piece from the outboard end.

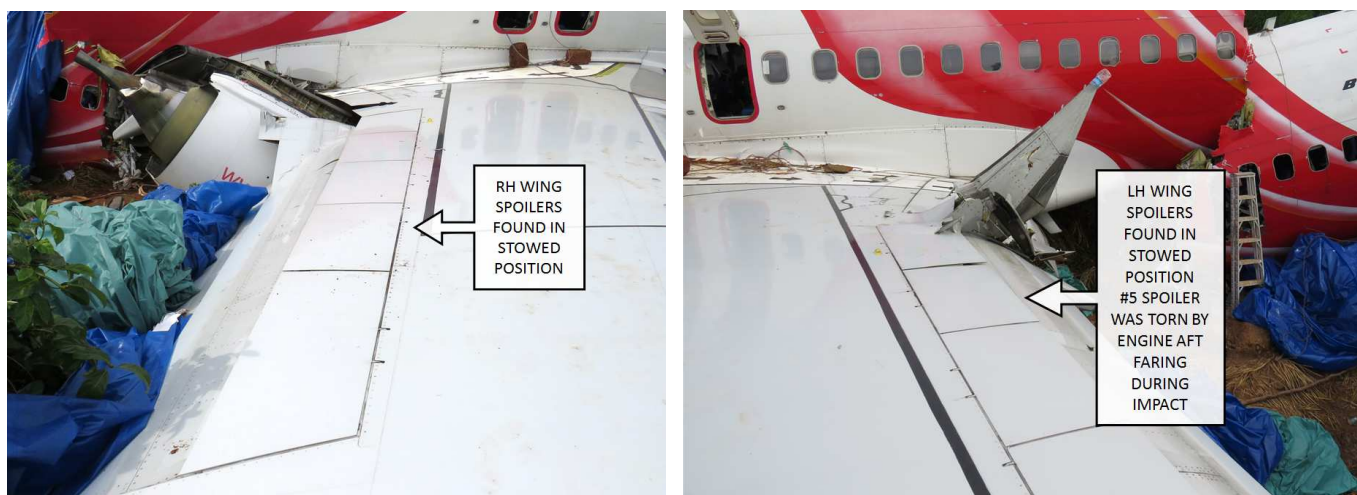
Figure 49: Spoilers

Physically all spoilers were found in the stowed position, corresponding to the recorded position in the DFDR before impact.

Flight spoiler # 5 was hit by the LH Engine Aft fairing which broke apart during Engine separation. The spoilers were stowed and pressurised at this point, as indicated by the damage pattern on the spoiler.

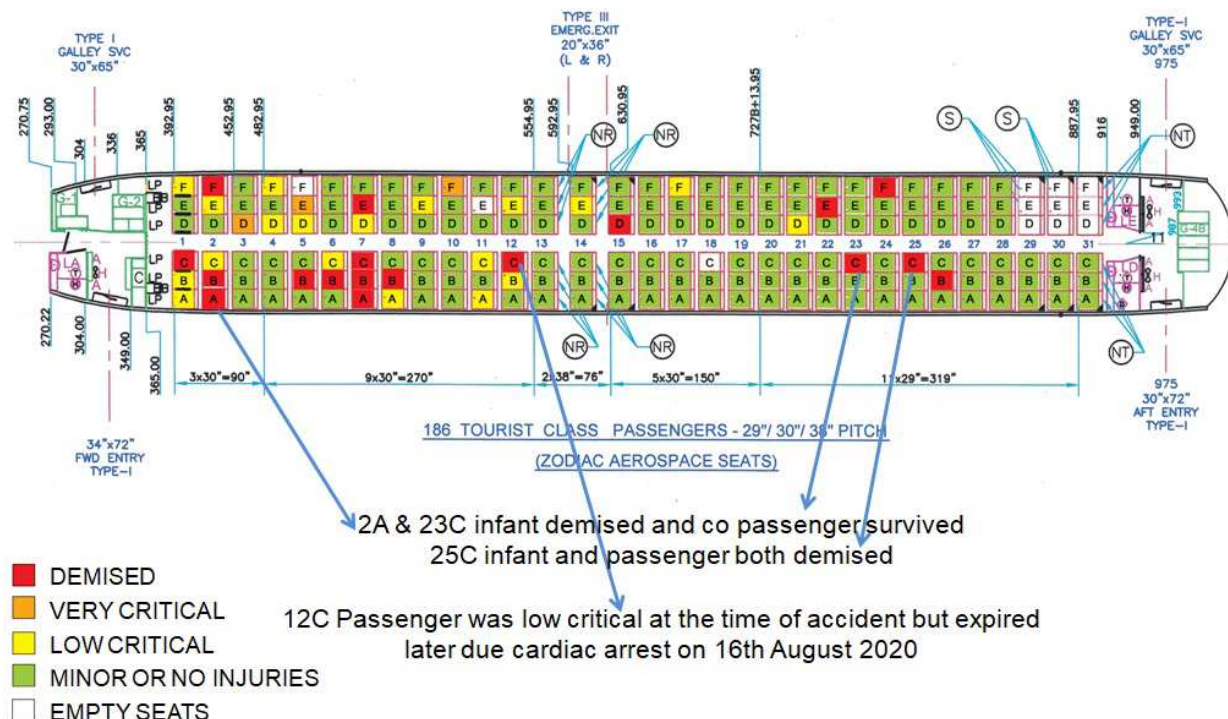
Figure 51: Fatalities and Injuries to passengers depicted on Seat Layout

fatal musculoskeletal injuries and head injuries except passengers on 3C, INF/3C, 3E 5A, 8F and 9E (six passengers) who sustained minor injuries. Also, the rows 22 to 26 suffered extensive damage due to the fact that the aircraft split up around this location. 05 out of 30 passengers seated in the area suffered fatal injuries and one suffered serious injuries. Remaining 24 passengers suffered minor injuries.

The injury pattern analysis of the deceased passengers reveals that, these 19 passengers were distributed in two clusters, each in the vicinity the aircraft fuselage breaks i.e. from row numbers 2 to 10 and 22 to 26. Figure 51 depicts the injuries to the passengers as per seat layout.

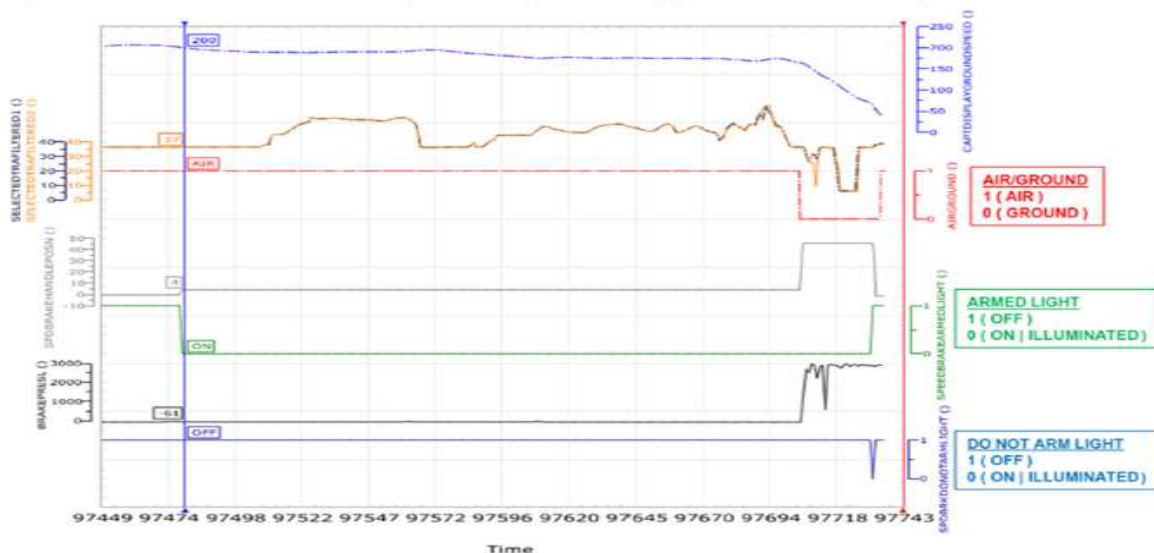
Figure 59: SBDNA and SBA Lights Graph (above 70 Kts)

It can be seen from the Figure 59 that the SBA light was recorded to illuminate when the speed brake lever was set to ARM on approach. The SBA light remained illuminated until after the aircraft landed and decelerated below 70kt ground speed. Based on this observation, it can be inferred that multiple wheels (at least one even number wheel and one odd number wheel) were sensed to rotate greater than 60 knots within four seconds of landing and remained that way during deceleration through 70 knots of the PIC side recorded ground speed.

The behaviour of the SBDNA light as seen in the figure 59 indicates that SBDNA light was recorded on the DFDR to be OFF on the event flight until the aircraft was below 70 knots groundspeed. The recorded state of the SBDNA light indicates that the paired wheel spin determinations (Greater than 60 knots sensed on one or both wheels within the pairings) were in agreement following touchdown and while above 70 knots groundspeed during the landing deceleration.

From the recorded behaviour of the SBDNA and SBA lights, for Ground Speed above 70 knots, it can be concluded that multiple wheels were sensed to be spinning greater than 60 knots and that there was no disagreement between the paired wheel speed determinations for the majority of the landing roll. Due to a four second time delay in the SBA and SBDNA logic after touchdown, no conclusions about wheel speed during the first four seconds after landing can be drawn from the behaviour of the lights.

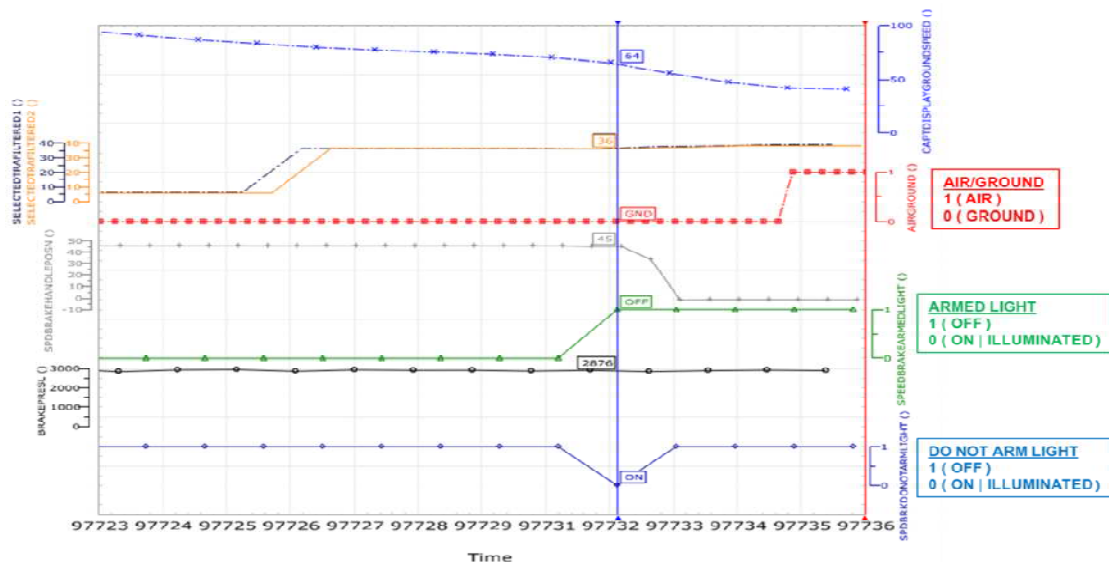
Figure 60: SBDNA and SBA Lights Graph (below 70 Kt)

The SBDNA light was recorded to be illuminated for one FDR data frame with the aircraft position: Latitude 11.13327, Longitude 75.969257. The aircraft recorded ground speed was 66 knots at the time and the recorded position is approximately 105 feet beyond the runway hard surface. Below 70 Kt ground speed The SBDNA light would have illuminated in a scenario where there is disagreement between the sensed wheel speeds (i.e. Wheel speed greater than 60 knots sensed on one wheel of a pair, with both wheels on the opposite pair sensed at less than 60 knots).

This scenario is considered likely reason for SBDNA light behaviour as the aircraft was on a soft surface and ground speed was approaching 60 Kt at the time the SBDNA light was recorded. The speed brake lever was stowed shortly after the SBDNA light was recorded. The SBDNA light was turned OFF after the speed brake lever was stowed consistent with expected system behaviour.

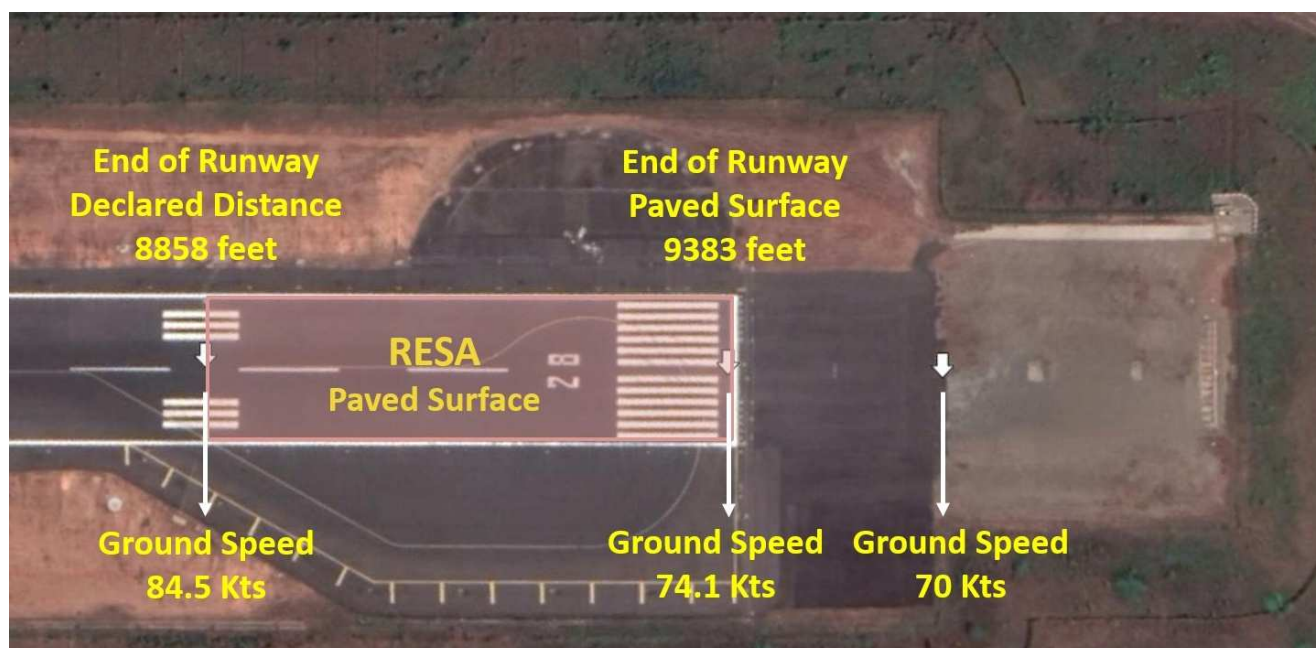
Figure 62: Ground Speed of the Aircraft with reference to RESA

During the visit of Investigation Team it was observed that concrete slabs on which the frangible light fittings and ILS localizer antenna are installed, are protruding above the ground which would adversely affect the aircraft deceleration. In addition, wild vegetation was also seen growing on the soft ground portion of RESA. The poor maintenance of Soft Ground portion of RESA will adversely affect the desired deceleration of the aircraft.

The Soft Ground portion of RESA provided an average longitudinal deceleration of -0.40 G with peaks of up to -0.64 G as calculated from the DFDR data. However, it was not enough to stop the aircraft as the aircraft crossed the declared end of runway 10 at a ground speed of 84.5 kt and entered the soft ground portion of RESA at a ground speed of 70 Kt. (Figure 62)
