FINAL REPORT

COL-16-37-GIA

Fuel Exhaustion

AVRO 146-RJ85, Reg. CP 2933

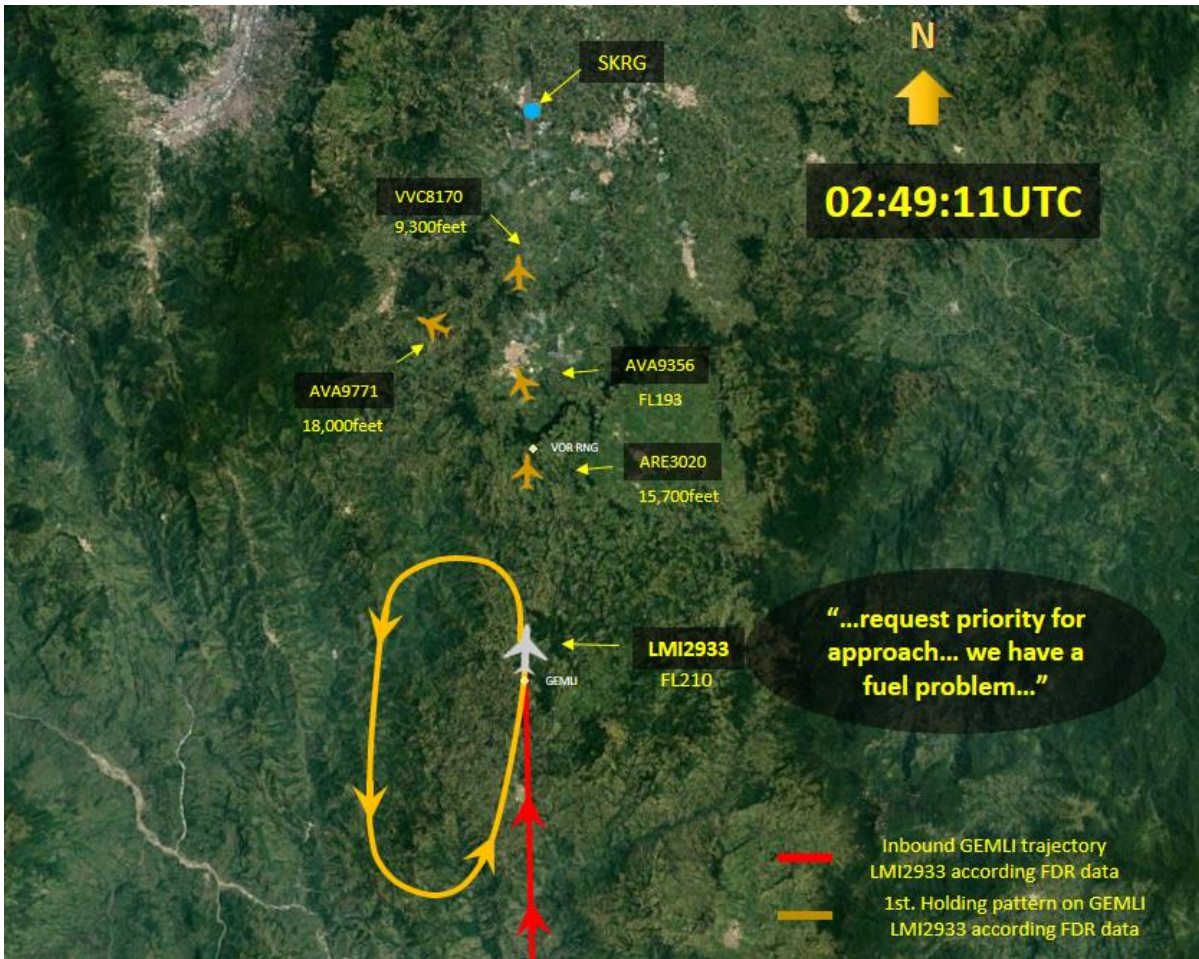
Figure 3. CP 2933 Second inbound leg to GEMLI - 02:49:11

Later, at 02:49:11, CP 2933 made its first circuit in the holding pattern and while on his second inbound leg to GEMLI¹¹, the crew of flight CP 2933 requested priority due to a fuel problem:

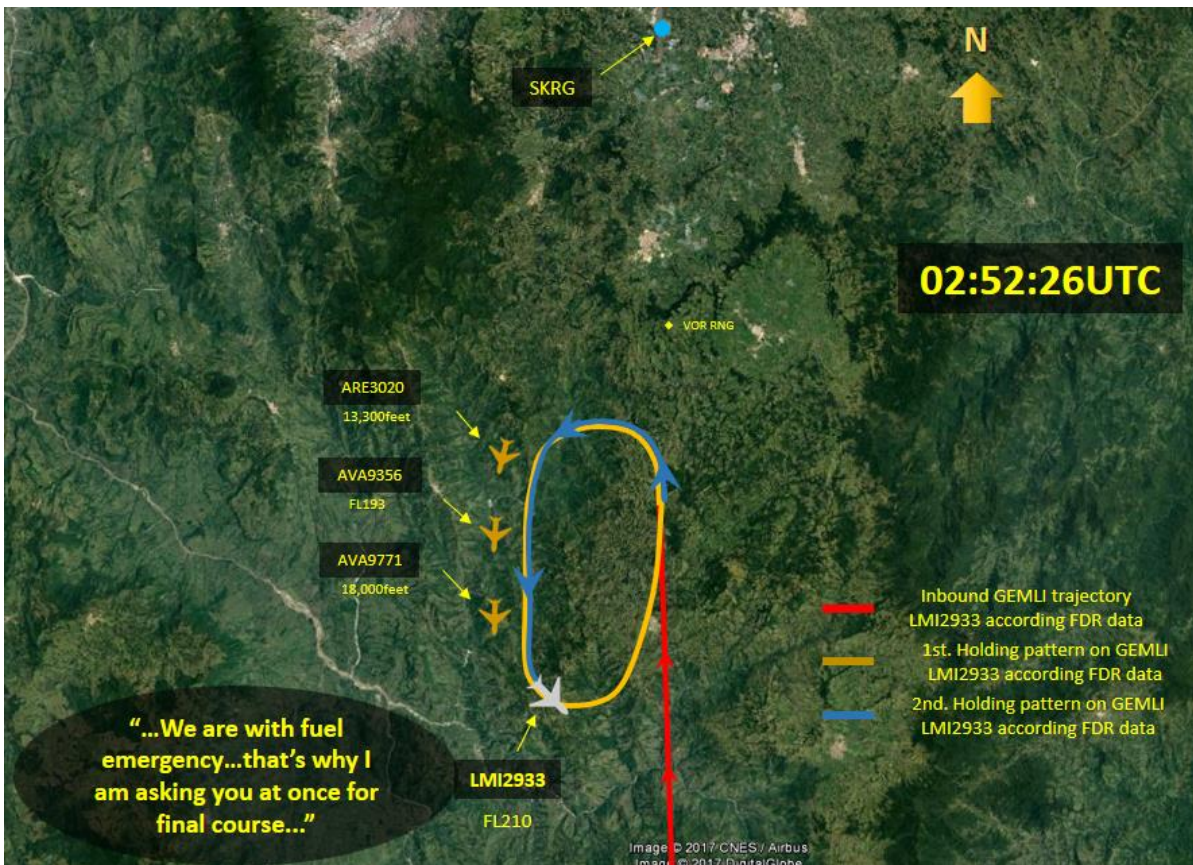
Figure 4. CP 2933 Third inbound turn to GEMLI - 02:52:26

02:52:05	LMI 2933	LMI 2933 request inbound vectors...
02:52:18	MDE APP	Stand-by - I have an aircraft below...below you on approach, additionally, they are doing a runway inspection. How much time do you have to remain on your approach LMI 2933?
02:52:26	LMI 2933	We are with fuel emergency...that's why I am asking you at once for final course
02:52:45	LMI 2933	Request immediate descent LMI 2933

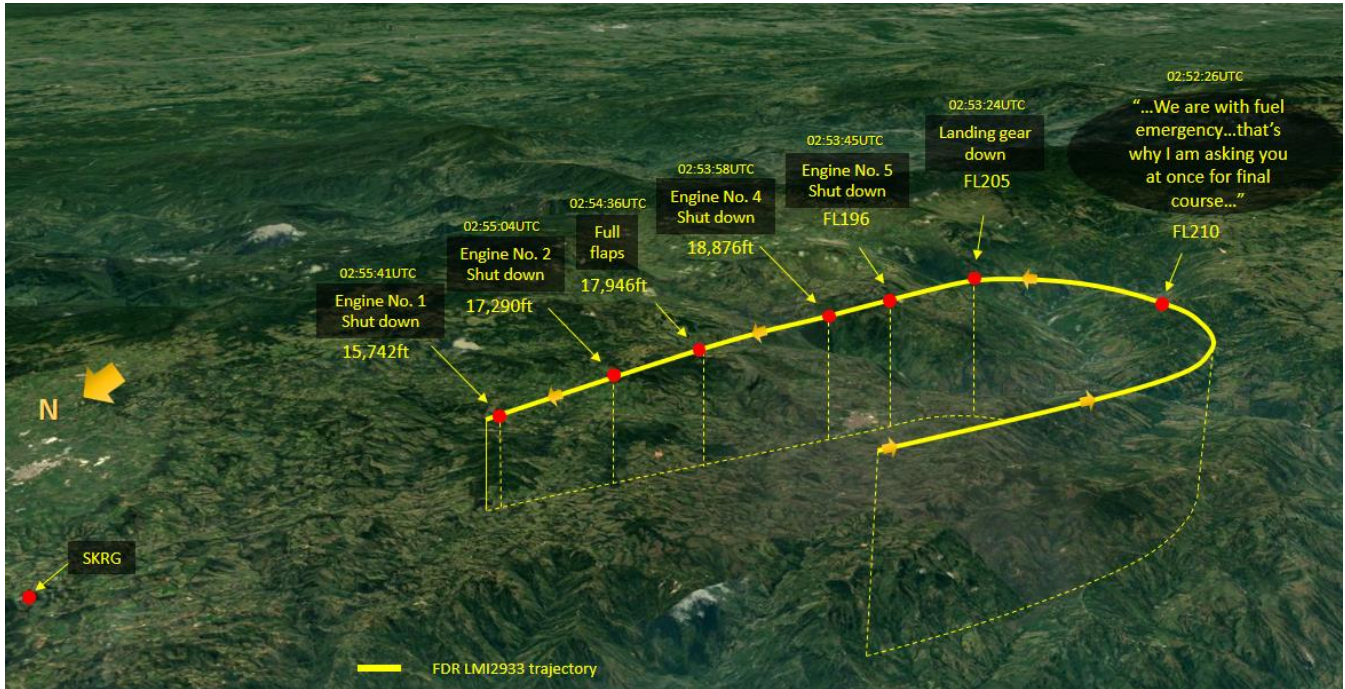
Figure 5. CP 2933 Last sequence of events until 02:55:48 when the FDR stopped recording

The aircraft was 15.5 nm south of Rionegro RWY 01 threshold, and 5.4 nm south of the accident site (which had an elevation of 8.516 feet).

Radar traces indicated that "C mode" was lost at 02:55:55 at which time only the aircraft's primary radar signal was displayed.

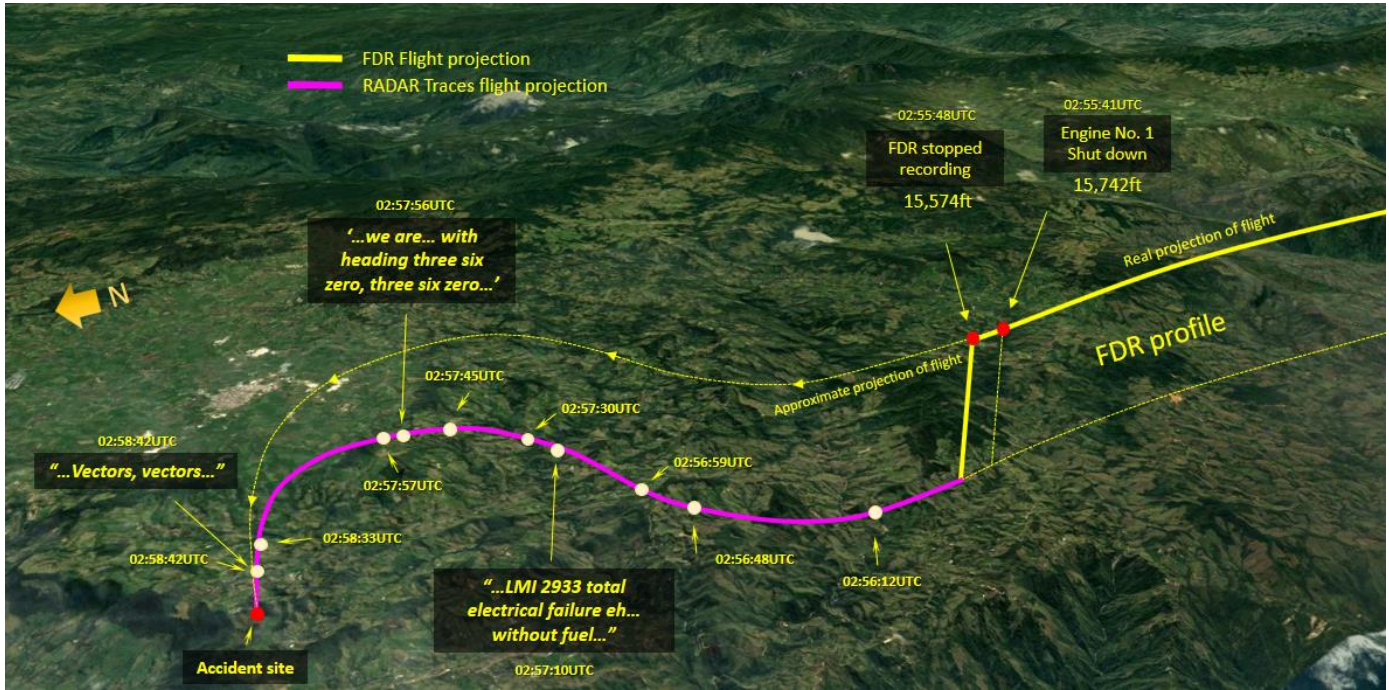
Figure 6. Approximate projection of CP 2933 according to Radar Traces

02:57:10	LMI 2933	... LMI 2933 total electrical failure eh... without fuel...
02:57:29	MDE APP	Runway is cleared and operable, rain over the station LMI 2933 firefighters alerted
02:57:40	LMI 2933	...illegible... Lima Mike India (back ground voice "vectors tell her") vectors... vectors to the runway
02:57:46	MDE APP	lost radar signal, I don't have you - report heading now.
02:57:56	LMI 2933	we are... with heading three six zero, three six zero.
02:58:01	MDE APP	With heading...turn left zero one zero should proceed to the Rionegro VOR localizer, one mile ahead of the VOR, at the moment you are correct, I confirm turn left heading three five zero.
02:58:18	LMI 2933	Left three five zero ...
02:58:20	MDE APP	Yes correct you are zero point one mile from Rionegro VOR
02:58:30	ATC a LMI 2933	I don't have your altitude Lima Mike India

02:58:38	LMI 2933 a ATC	Nine thousand feet...
02:58:42	LMI 2933 a ATC	Vectors, vectors
02:58:47	ATC a LMI 2933	You are eight point two miles from the runway

Despite repeated calls by ATC, no further responses were received from CP 2933.

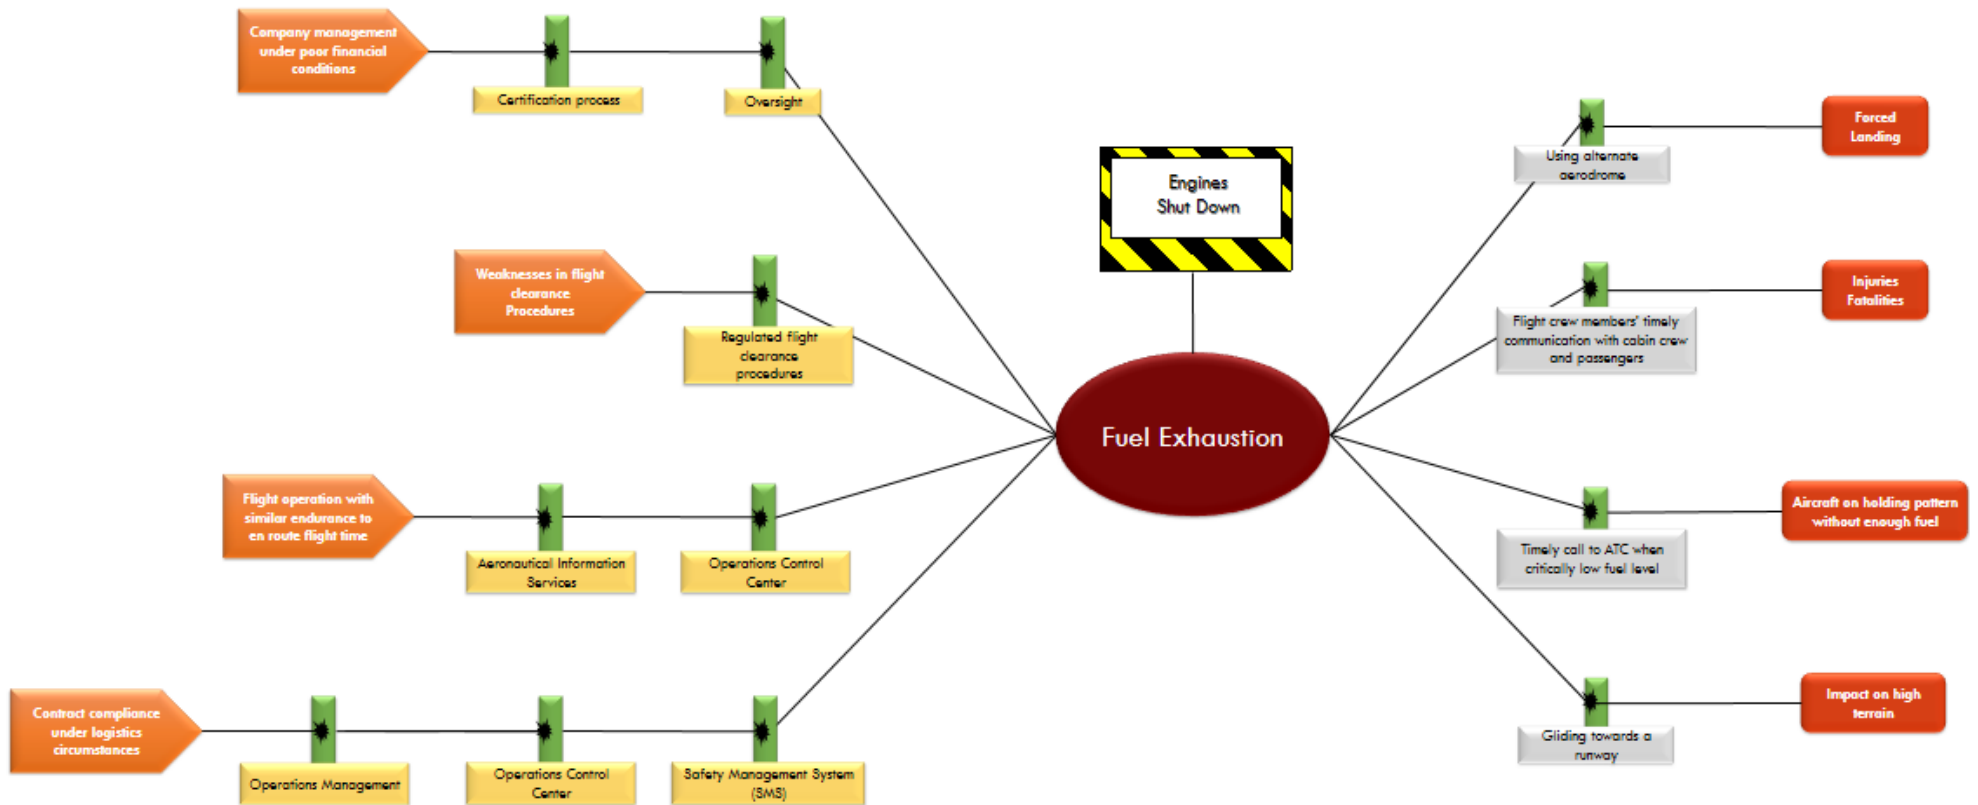
Figure 21. Bow-tie diagram applied to accident CP 2933

In order to establish the accident causes, this tool is useful to identify systemic threats as well as preventive controls, and estimate the operation of preventive controls in a given situation.

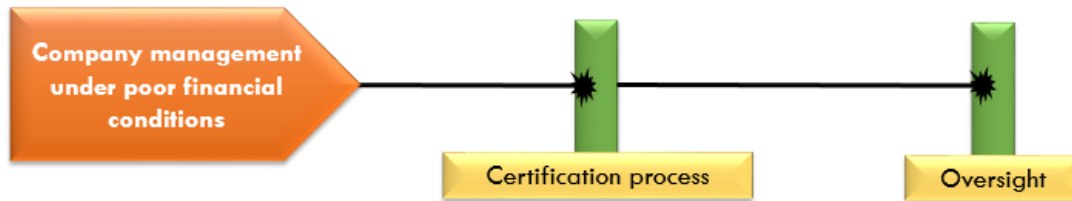
2.10.1.1 Company Management under poor financial conditions

The first identified threat corresponds to a latent operation of the company with a deficient economic situation that was evident in the later statements of the personnel and in some documents that supported the delay in the payments to the personnel of the company. This precarious situation which was latent in the organization, maintained preventive controls (defenses) that at the time had no impact to correct economic performance.

As part of the company's certification process, the company's verification had to be strengthened as an effective control not to allow the performance of multiple positions within the organization by the same individual; likewise, within the SMS manual, attention to risk management was not considered a main factor which in this case was absent in the financial side.

This threat directs the company to operate under standardized deviations that are directly related to an economic saving that, in turn, leads to neglecting another effective control, oversight, a defense so as not to materialize a threat of an event. A sample of this was a finding spotted a year ago related to inadequate fuel management by SAFA. There, the organizational symptoms of a lack of company oversight and effective compliance with the oversight plan of the Aeronautical Authority were evident.

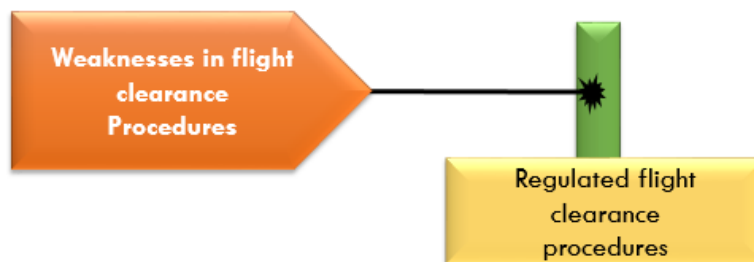
2.10.1.2 Weaknesses in flight authorization procedures

Another latent threat was related to the weakness in flight authorization procedures. Effective control for this weakness was directly related to the verification of the operating conditions of a Non-Regular flight (Charter), according to the regulations applicable in the Colombian

Regulation, RAC 3.6.3.5.6. It was evident that although the request was processed in accordance with the provisions of the regulations, the procedure presented weaknesses since an exhaustive study of the documentation provided by the company for its scheduled flight was not carried out, nor were the necessary concepts included. Strengthen flight clearance procedures and manage properly risk during the operation.

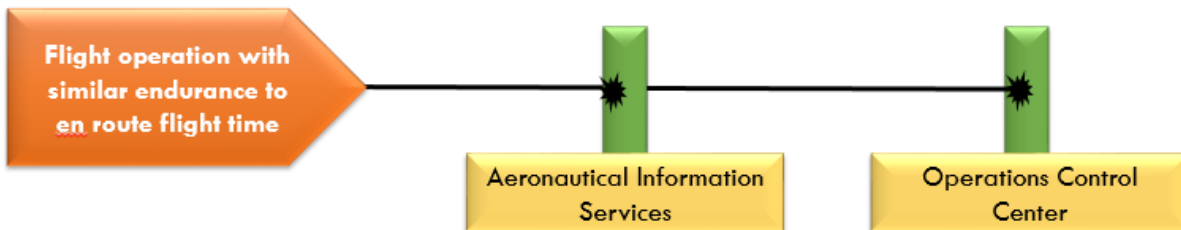
2.10.1.3 Flight operation with similar endurance to en-route flight time

The crew scheduled a flight similar endurance to en-route flight time. The effective controls to not materialize the threat constituted first, in the filter made by the ARO / AIS Aeronautical Information Service during the presentation of the flight plan, to which apparently objections were made, and which was finally accepted as they were not considered by the company. The control of the operations constituted the last barrier to not allow the evolution of the threat; however, there were weaknesses in the control of flights, prioritizing compliance with the contract and generating permissiveness on the part of the company by not evaluating the risk and executing a flight under those circumstances.

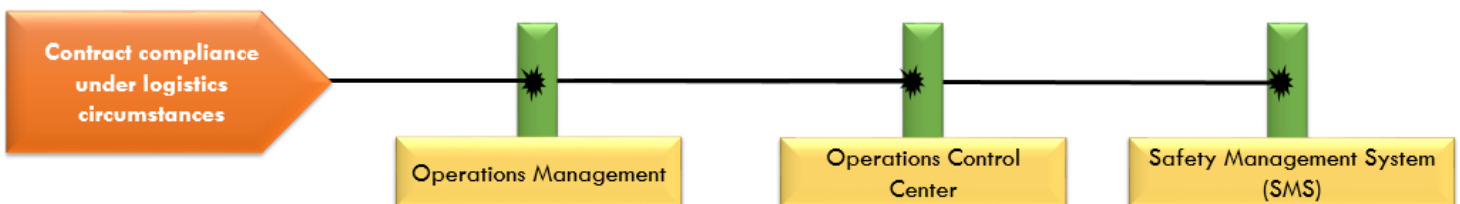
2.10.1.4 Contract compliance under logistics circumstances

The contract between the company and the soccer team was intended to carry out two flights; one between Sao Paulo (Brazil) and Medellin (Colombia) on November 28, 2016 at 2:00 p.m., and another flight on December 2, 2016 at 07:30 hrs.

Faced with the impossibility of carrying out the flight from Brazil, last-minute logistics arrangements were made by the company, which constituted a threat by neglecting organizational aspects of the operation for the fulfillment of the contract.

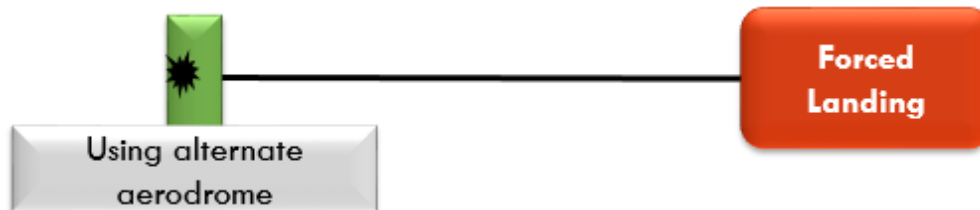
2.10.2.1 Use of an alternate aerodrome

In the event of an imminent exhaustion of fuel, the mitigation measure consisted in proceeding to an alternate aerodrome that would allow the refueling of the aircraft. This obstinate attitude of continuing the flight to the destination, even with a fuel system warning, 40 minutes before the accident, did not allow to prevent or mitigate the consequence of a forced landing given the conditions of a night flight, heavy traffic and the over flight on a mountainous terrain.

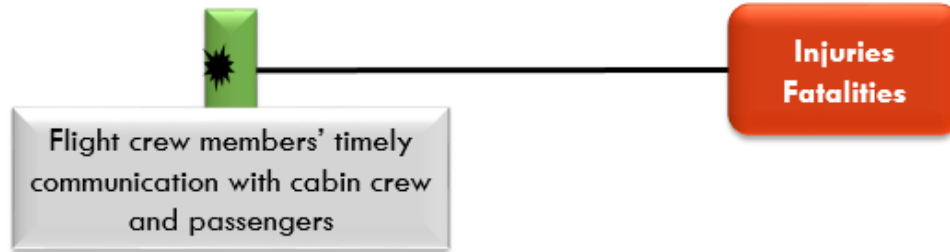
2.10.2.1.1 Flight crew members' timely communication with cabin crew and passenger communication during fuel exhaustion

Another preventive measure to mitigate the consequence of a hazard was the timely communication of the crew to the passengers about exhaustion fuel situation and shutdown of the engines in flight. This measure which was not carried out prevented the execution of emergency procedures in the passenger cabin before the imminent event during the flight.

The situation of not preparing the cabin before an emergency situation on the part of the crew was a previously identified symptom in the flight checklist process by one of the crew members, to whom an annotation had been made that was directly related to the preparation of the aircraft in emergencies: "... take the necessary time to prepare the aircraft in an emergency situation...".

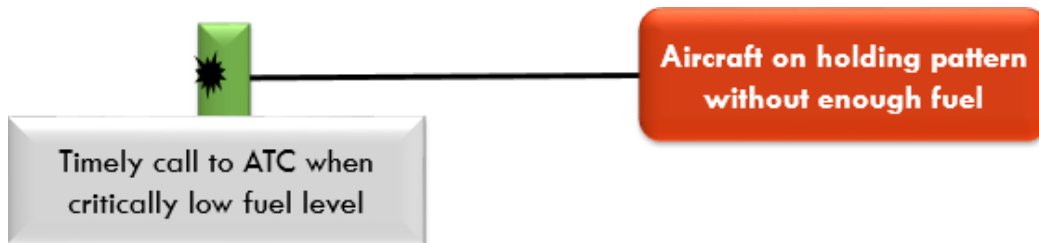
2.10.2.2 Timely calls to the ATC in the precarious situation of low fuel level

A further defense before the imminent exhaustion of fuel in flight corresponded to the timely communication of the crew to the ATC of the situation on board. Timely communication could have allowed rapid management of the ATC so as not to maintain the approach to SKRG, however, as was evident in the investigation, on multiple occasions the crew was instructed to carry a holding pattern at RNG VOR, and the Flight crew of LMI2933 acknowledged instructions without letting the ATC know of the critical condition of low fuel level.

This situation of not making timely calls, led to the aircraft performing a holding pattern maneuver at GEMLI without sufficient fuel.

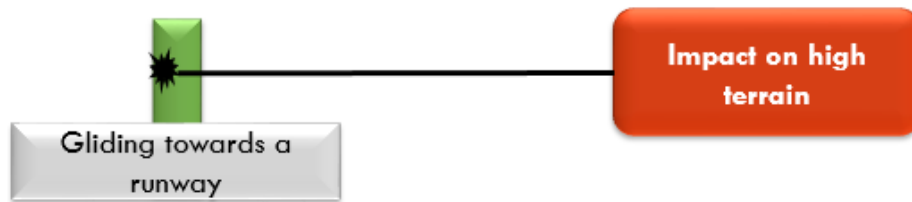
2.10.2.3 Gliding towards a runway

When the engines shut down in flight, the last mitigation measure was to carry out a gliding maneuver of the aircraft to the SKRG airport. If appropriate procedures and safety-based decision-making had been carried out, as a last measure, the aircraft's gliding could have been a mitigation measure to avoid the consequence of an impact on ground. However, the early and unnecessary configuration of the aircraft, the traffic of other aircraft in the descent area, the environmental conditions such as flying in a mountainous terrain, at night and with inoperability of the instruments due to a lack of power supply led to the generation of a chaotic environment in the cockpit when the impact against the ground was inevitable.
