# **The Aircraft Accident Investigation Board of the Islamic Republic of Iran**

## **Flight PS752 Accident Investigation**

# **Final Report**

### **Crash of Ukraine International Airlines Flight PS752**

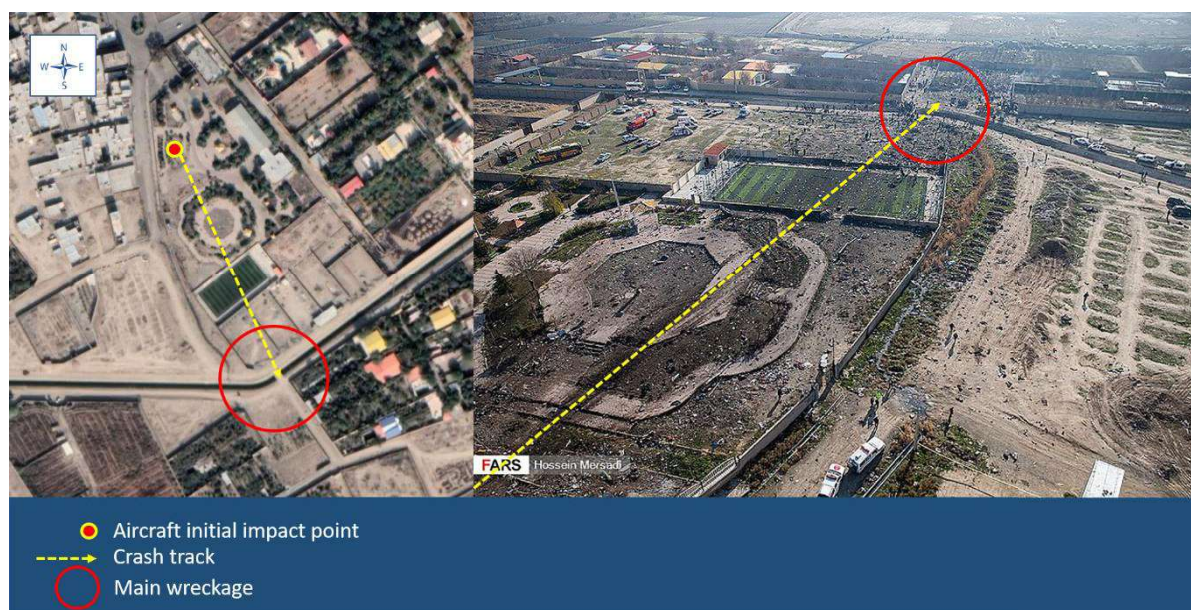
After losing altitude and passing by a residential area, called Khalajabad, the aircraft initial impact point was with a gazebo in a recreational park, called Lale. The aircraft fuselage, subsequently, impacted the ground, disintegrating completely after passing a football pitch, which in turn damaged the surrounding agricultural farms and gardens. Following the initial impact, other impacts were observed along the track at the accident site, wrecking the fuselage and spreading across the entire track. (Figure 3)

Figure 3- Accident site scheme

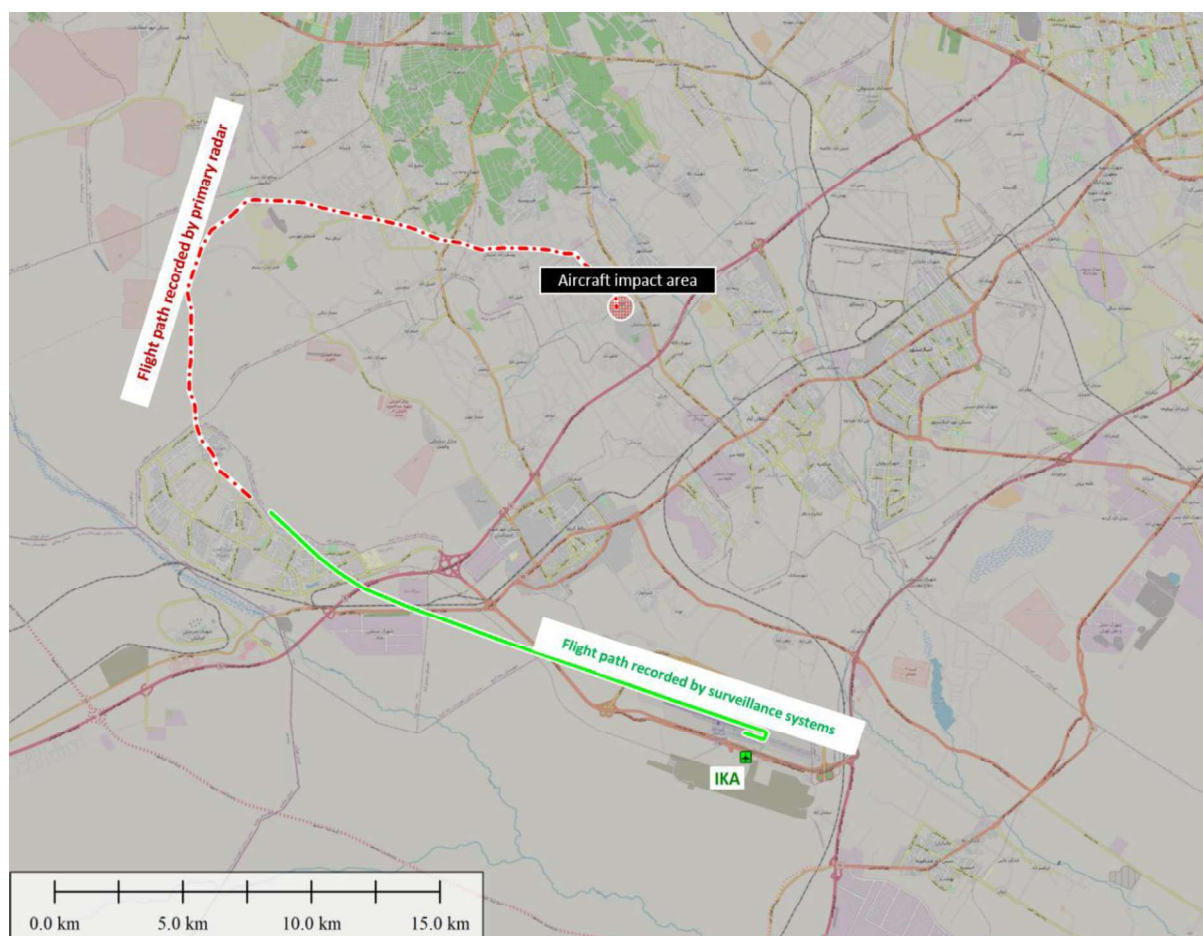
After takeoff, the aircraft continued flying on the planned path, but at position  $35^{\circ}29'29.79''\text{N}$   $50^{\circ}57'13.43''\text{E}$ , the ATC transponder signals and FDR recording terminated, shortly afterwards the aircraft began turning to the right and losing height<sup>2</sup>. While already on fire (based on observations of eyewitnesses and recorded videos), the aircraft crashed into the ground at position  $35^{\circ}33'45.63''\text{N}$   $51^{\circ}6'11.21''\text{E}$  and exploded. Figure 6 depicts the flight trajectory.

Figure 6- Flight PS752 trajectory

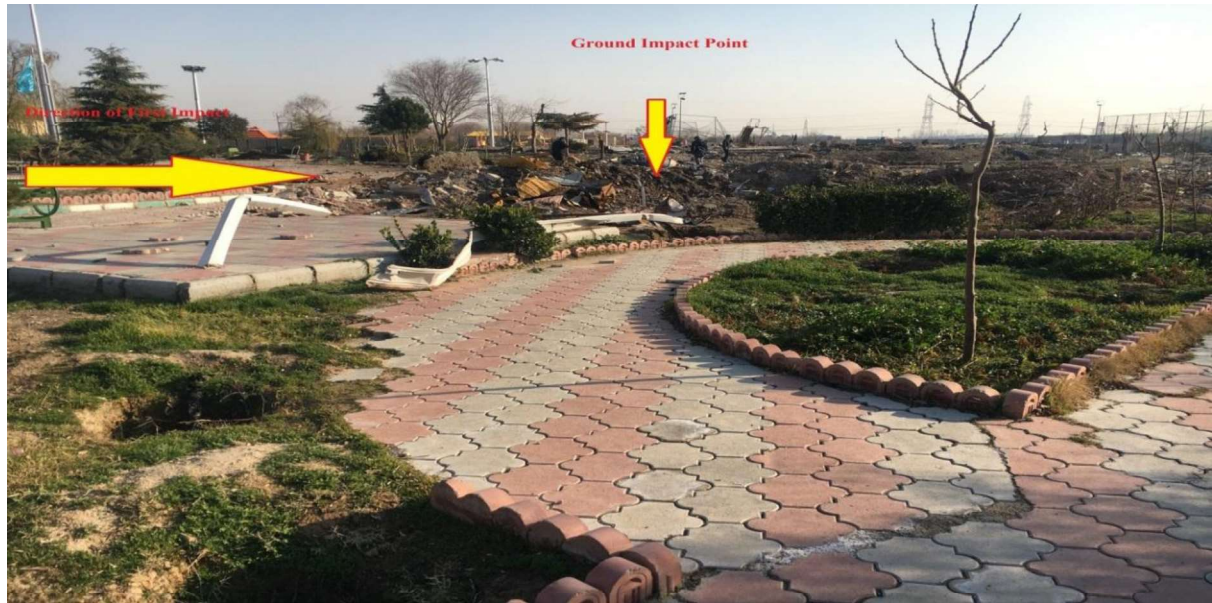
Shortly after the transponder stopped transmitting signals, the aircraft heading was changed to the right and after turning, headed toward the airport. The aircraft lost its altitude gradually and after passing by Khalaj Abad residential area impacted a gazebo roof in a recreation park with the position  $35^{\circ}33'45.4''\text{N}51^{\circ}06'11.3''\text{E}$  and then hit the ground (Figure 7).

*Figure 7- The first ground impact of the aircraft*

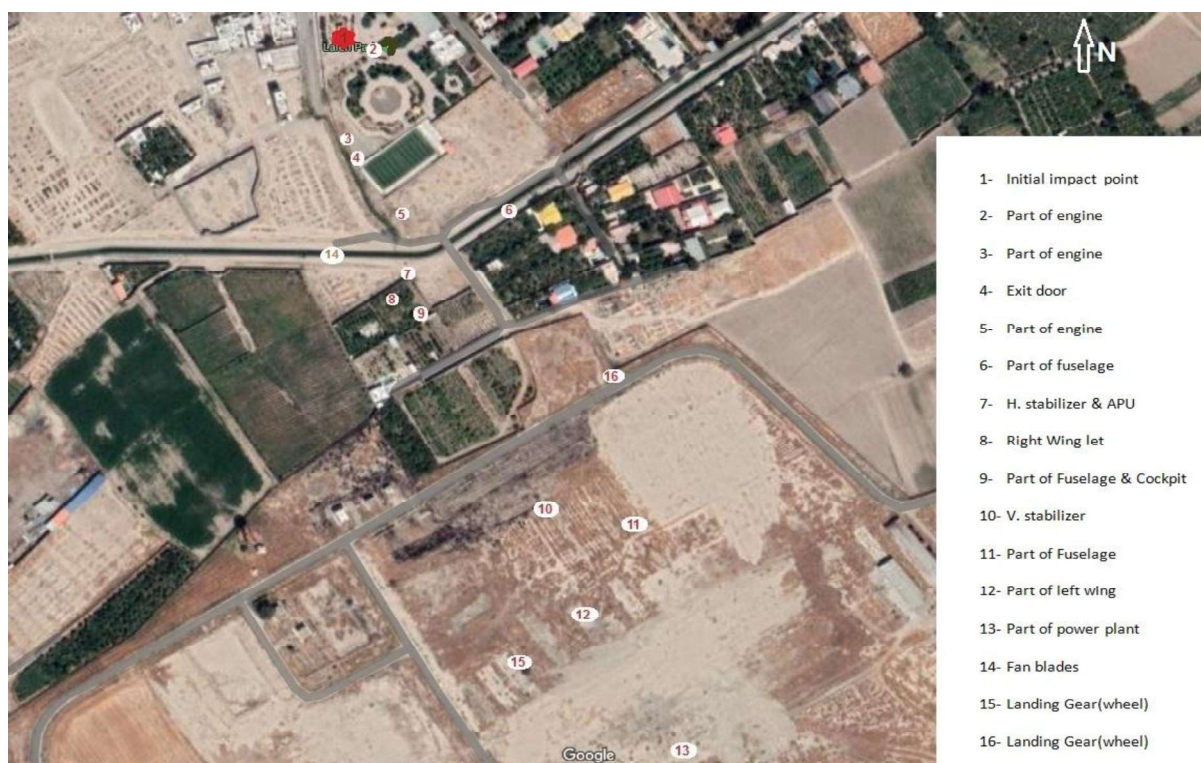
The impact with the ground created a large hole in the park, then the fuselage distanced from the ground and went on to a soccer pitch, hit its fences, passed by a water canal, again hit walls of private gardens and disintegrated completely as shown in Figure 8. The evidence and pieces gathered from the aircraft at the main accident site showed that the aircraft still maintained its relative integrity before impacting the ground. Interviews with eyewitnesses along the flight path confirmed this as well.

Figure 8- An overview of the aircraft parts distribution

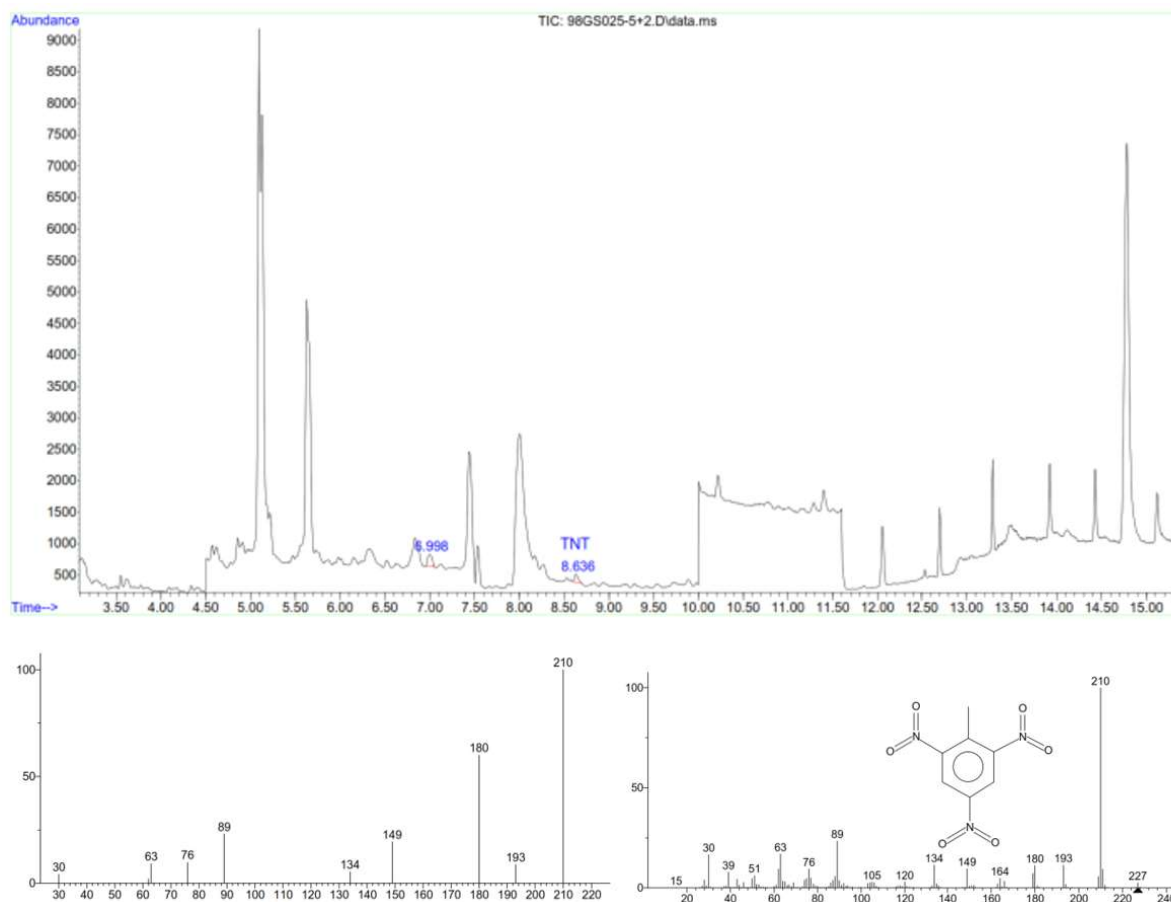
Based on the results yielded through GC/Mass chemical analysis, the existence of Trinitrotoluene (TNT) explosives with a chemical formula C<sub>7</sub>H<sub>5</sub>N<sub>3</sub>O<sub>6</sub> was confirmed in the aircraft wing skin, which was found before the crash site. (Figure 27)

Figure 28- Gas chromatography–mass spectrometry; GC-MS, of aircraft wing skin piece

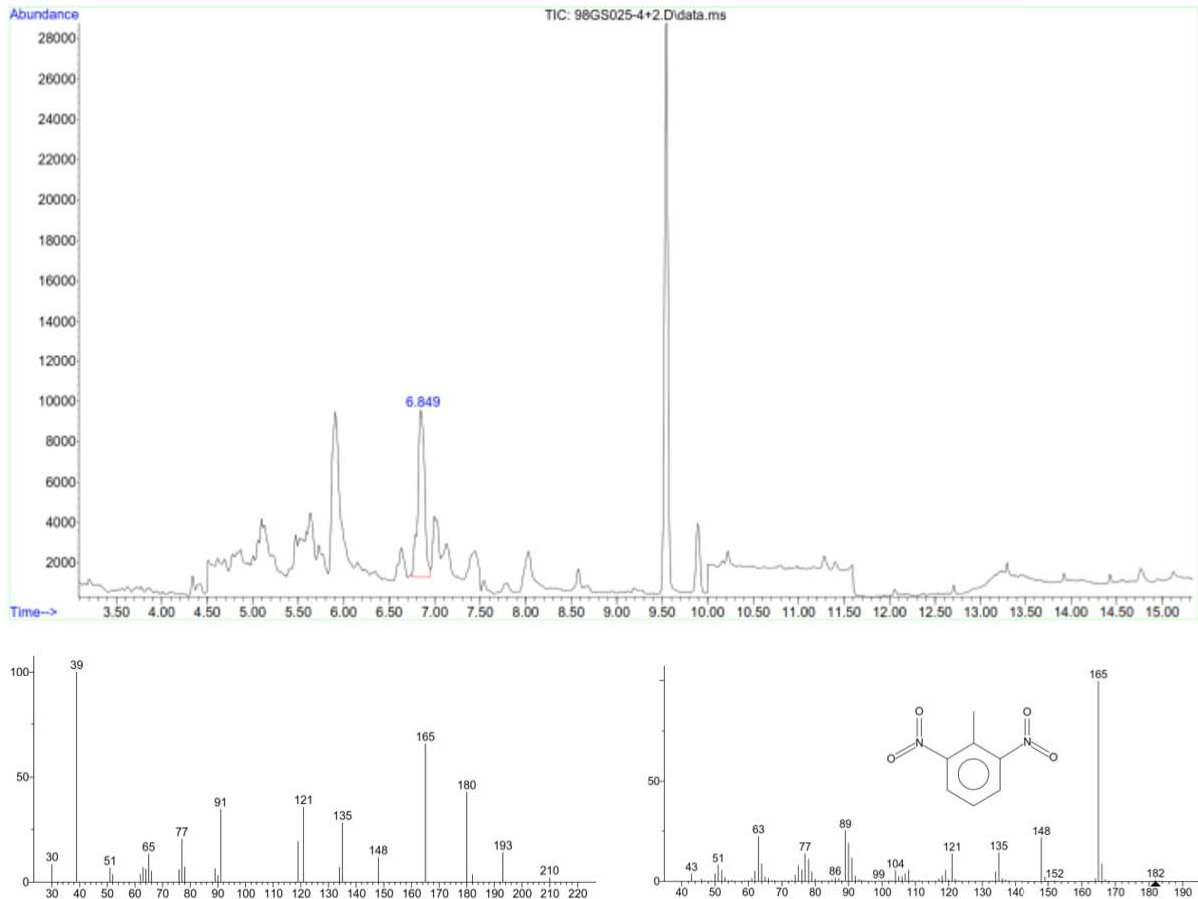
By sampling the air conditioning system and the two ELT pieces of the aircraft (Figure 29) and performing gas-chromatographic-mass spectrometry on each of the parts, the presence of negligible amounts of Dinitrotoluene (DNT) with the chemical formula  $C_7H_6N_2O_4$  was proven.

Figure 30- The GC-MS of the ELT and heat exchanger

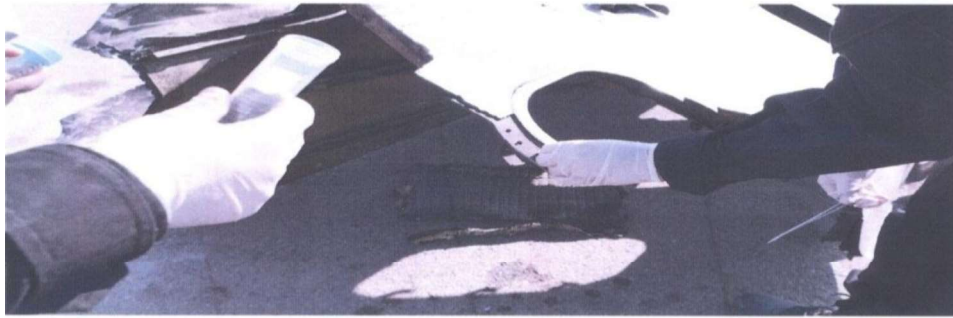
According to the spectrometry obtained from the interior part of the aircraft cabin window (as shown in Figure 31), the presence of explosive Trinitrotoluene (TNT) was detected (Figure 32).

Figure 31- The interior of part of the aircraft cabin window pieces on which the explosive test was done

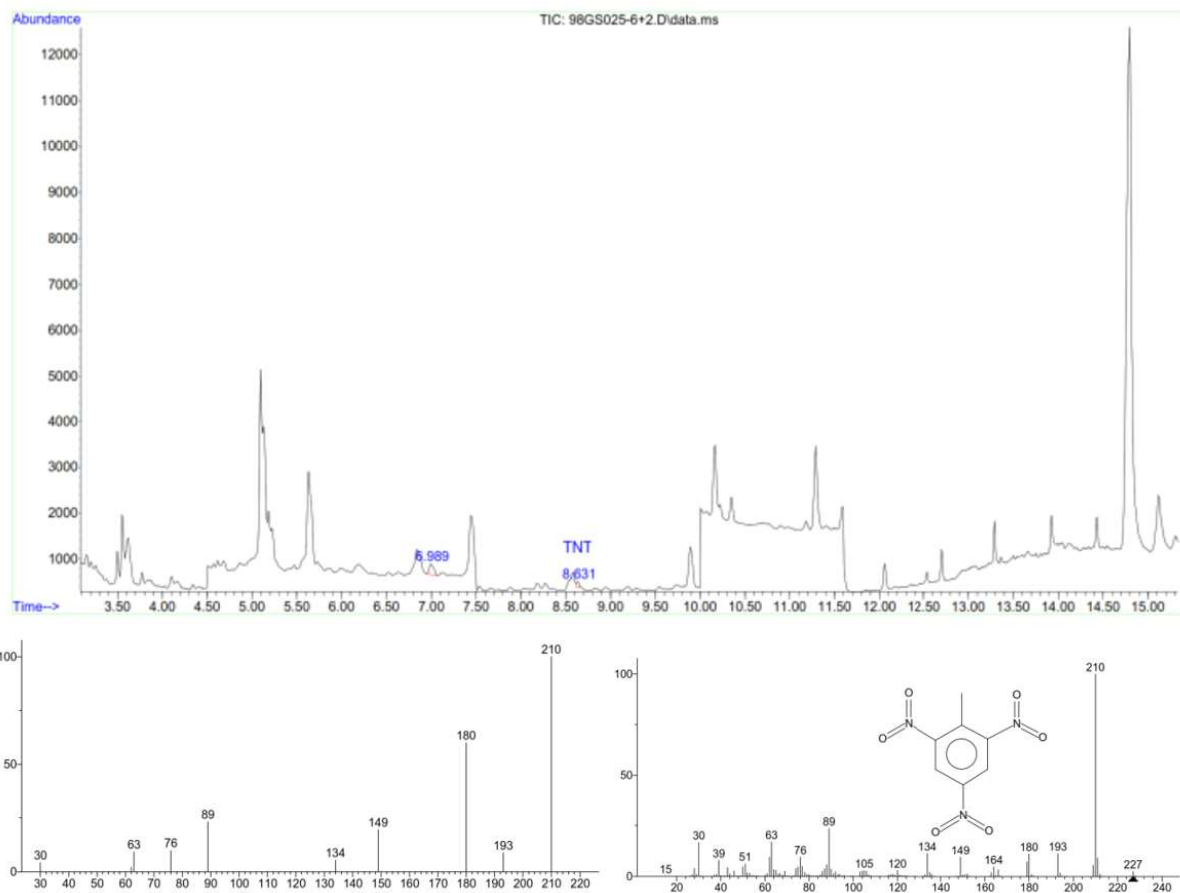
Figure 32- The GC/Mass test result from the interior of part of the aircraft cabin window Pieces

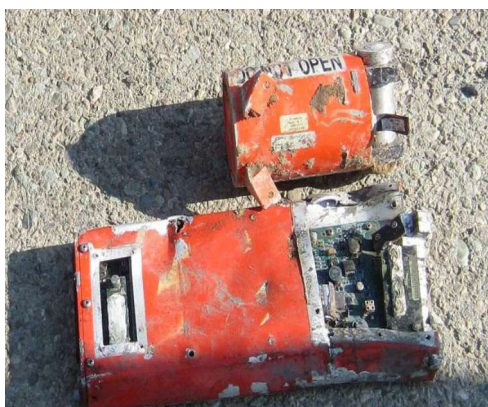
Damage to CVR had been more serious, whose main memory (CSMU) was detached due to the impact severity. The condition of these recorders indicated that the CVR and FDR had not been exposed to the fire in the aircraft, and after the ground impact, they were damaged or exposed to fire. (Figure 35 and Figure 36)

Figure 36- CVR physical appearance after the crash

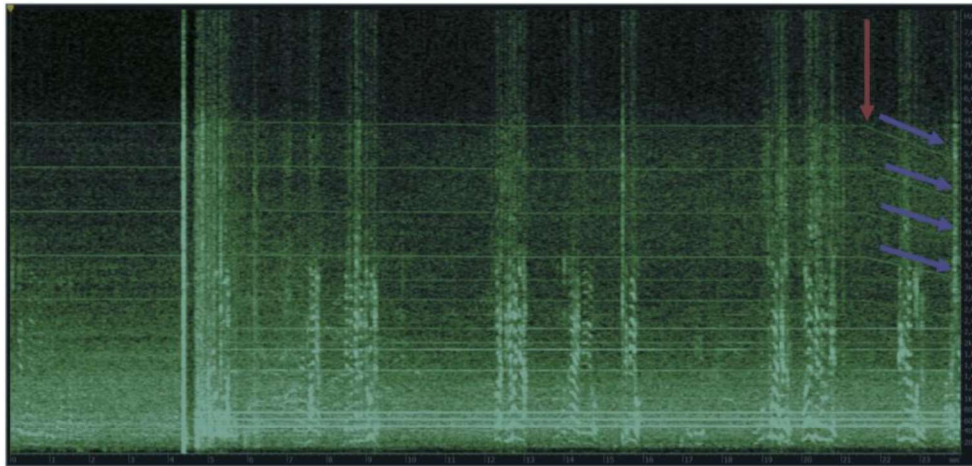
A drop of frequencies began 2.445s before the end of CVR recording.

Figure 40- Drop of frequencies recorded in CVR. Photo:BEA

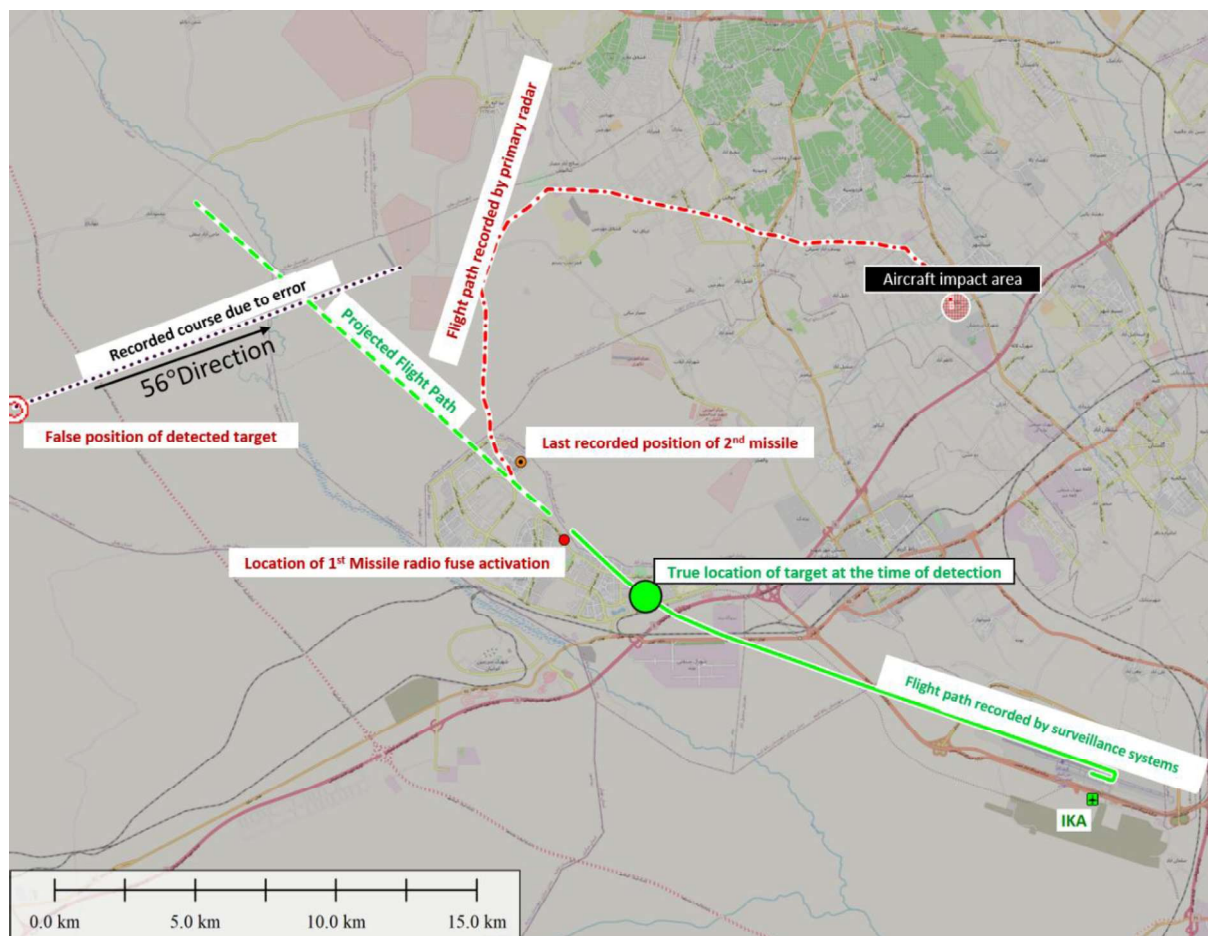
At 06:15:22, the last communication between the second missile and the defense system was recorded in a place close to the aircraft route. After that, the defense system showed a message indicating the strike had failed, with the aircraft clearing from the radar lock-on after some time.

Figure 41- The location of key events in missile launch

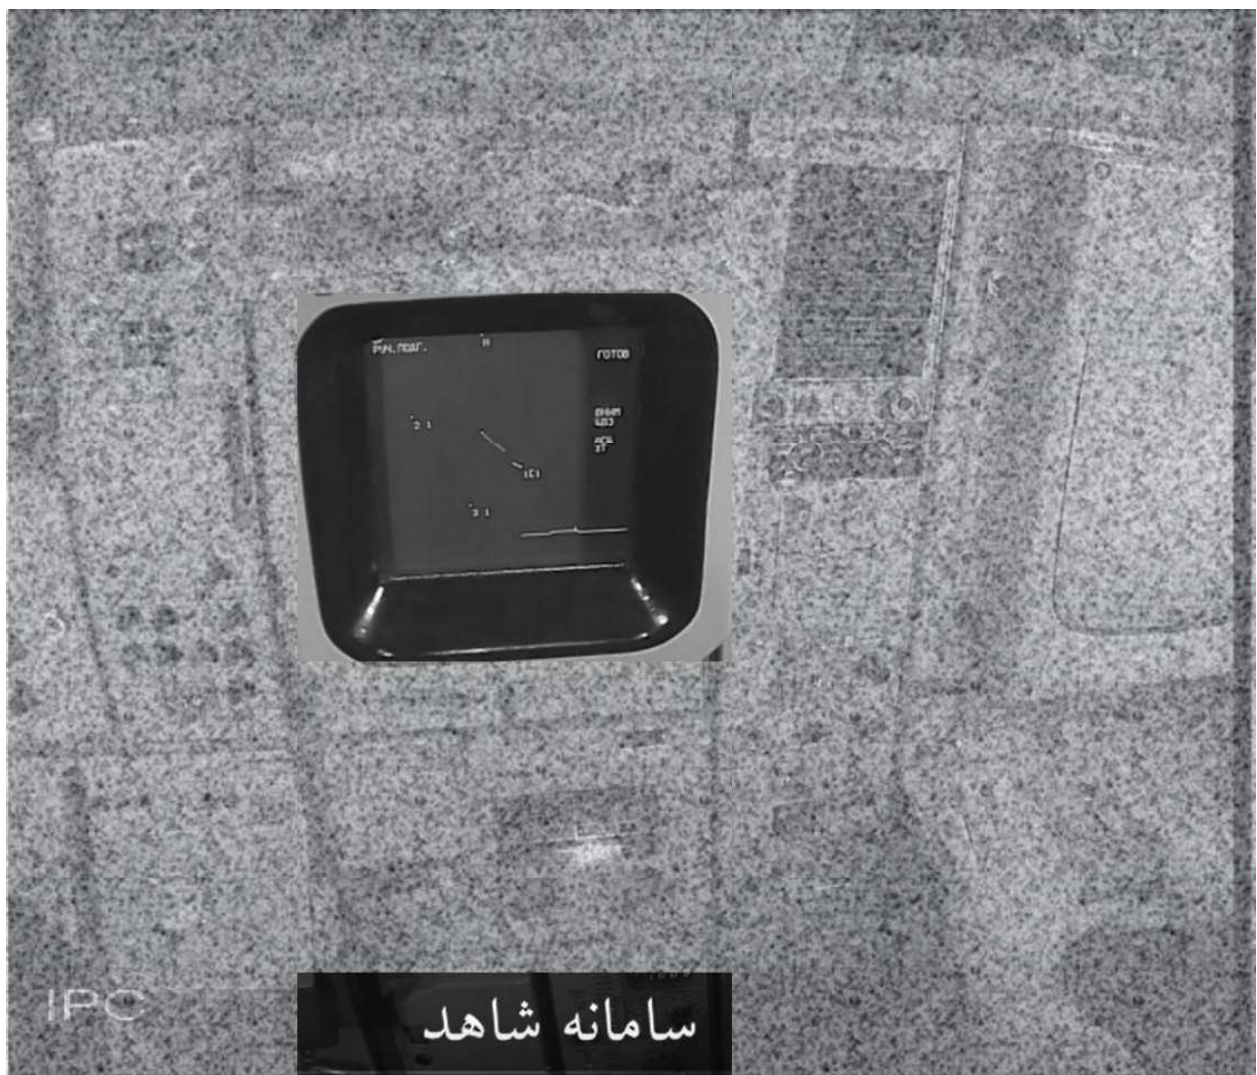
The simulation also indicated that the aircraft flight operation did not play a role in the occurrence of the error made by the air defense unit operator. In the two times of simulation, the reference unit operators detected the aircraft from the IKA direction (Figure 54), while the main unit operators detected it approaching from the western area (Figure 55).

Figure 54- The target direction in the reference ADU in the simulation with correct North alignment

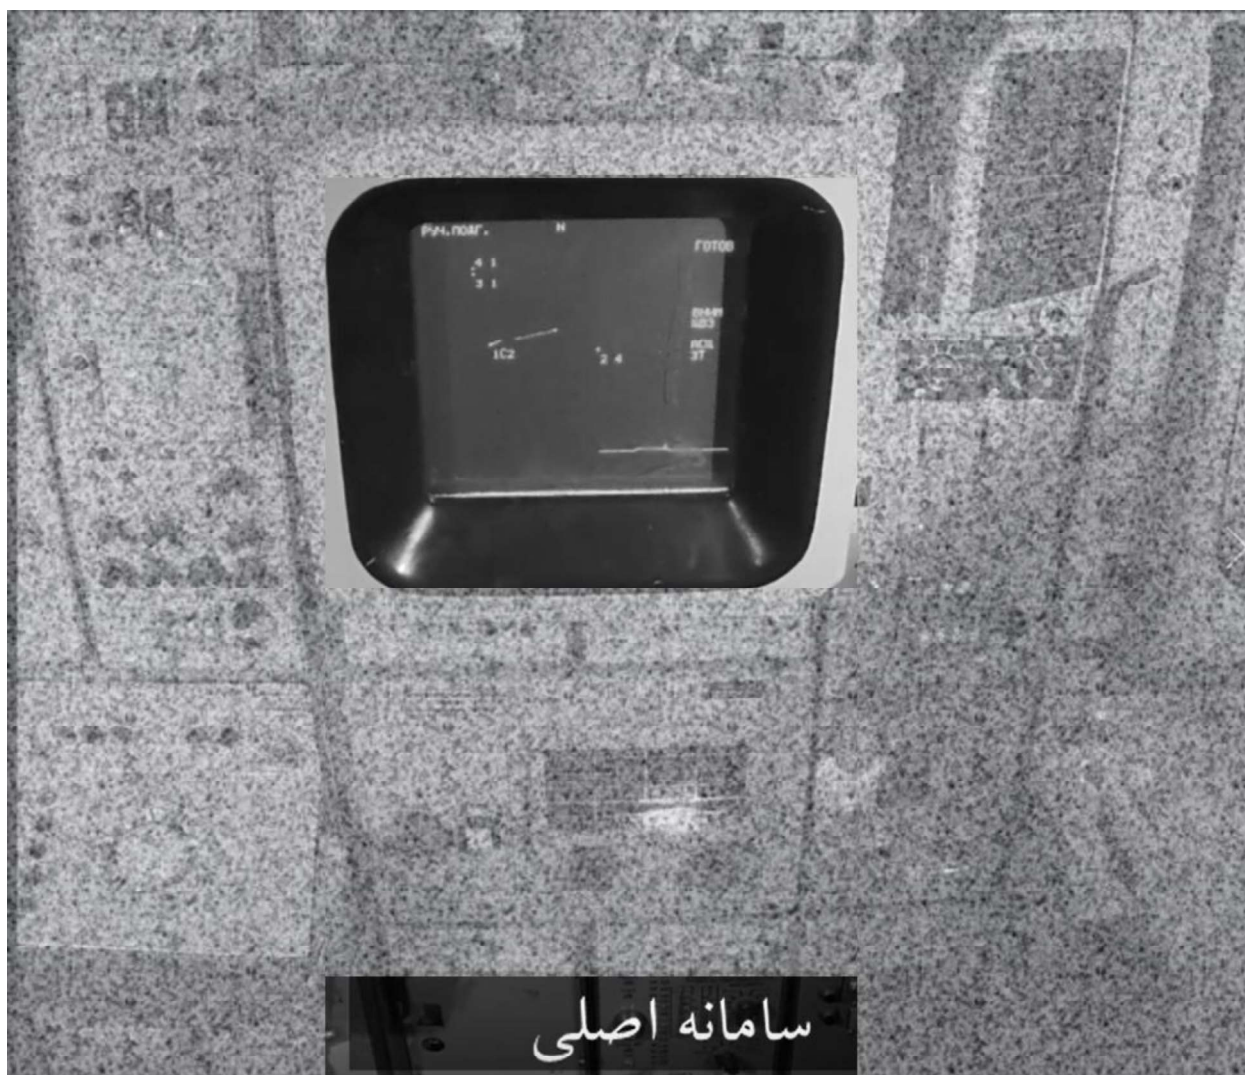
Figure 55- The target direction in the ADU in the simulation with repeated north alignment error

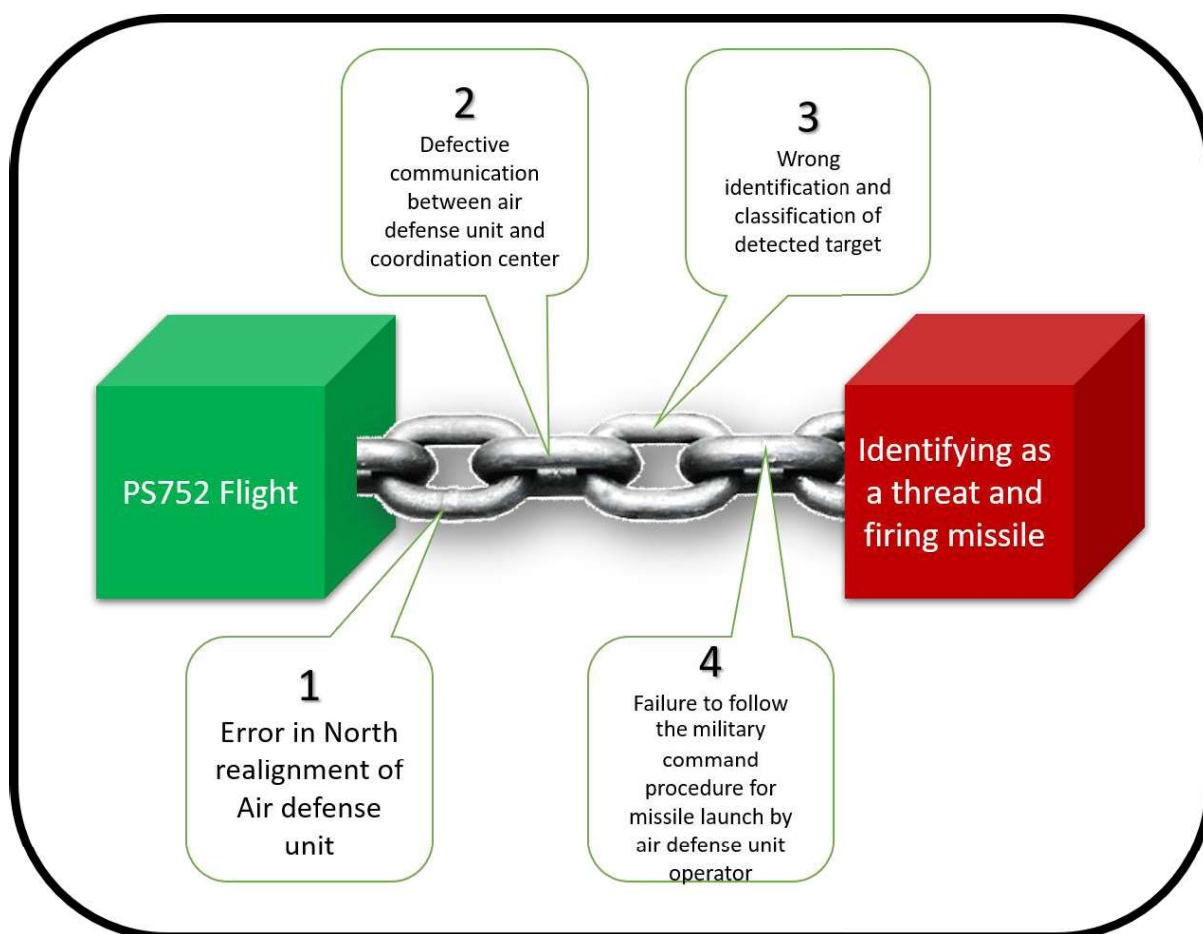
The target specifications were announced to the command center, but the message was never relayed. Without receiving a go-ahead or response from the command center, he came to identify the target as a hostile one and fired missile at the aircraft against the procedure planned.

Figure 56- The chain of events leading to firing missile at PS752

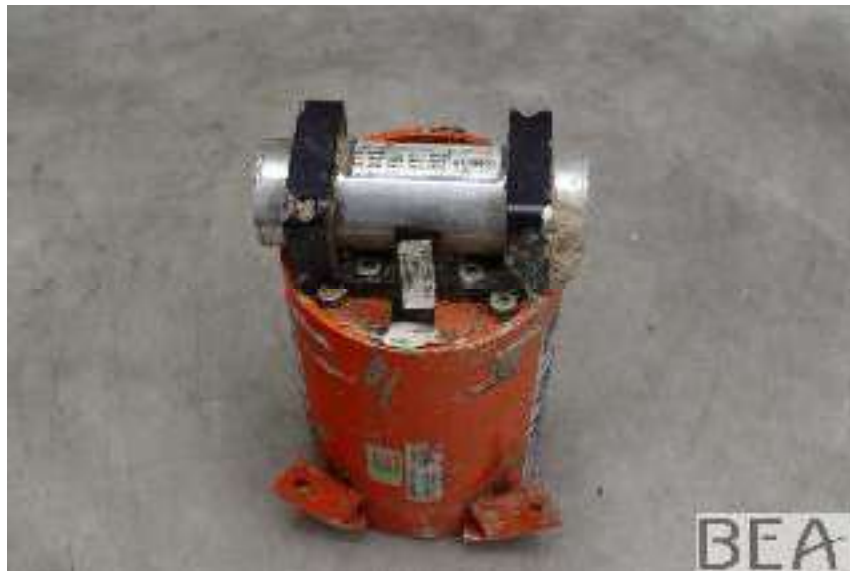
Figure 1: CSMU and flex cable

The CVR was visually inspected. The CSMU was not connected to the chassis. The CSMU showed some traces of impact but no evidence of fire. The ULB beacon was still attached to the CSMU. The flex cable was found torn off.

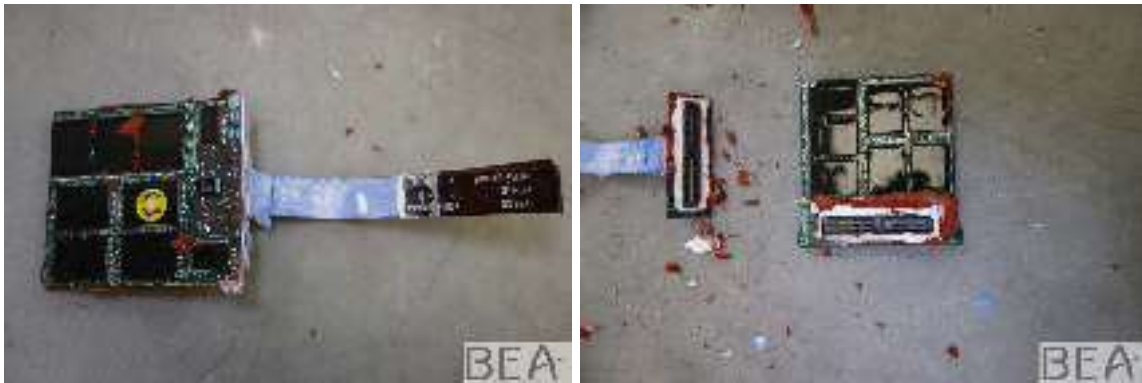
Figure 4: CVR memory board

The memory board is protected by a RTV silicon. This protection was removed to allow visual inspection of the board. The damaged flex cable was removed from the memory board.

The memory board was visually inspected under magnification. It was in good condition. The temperature indicator color showed that the memory board was not exposed to heat.

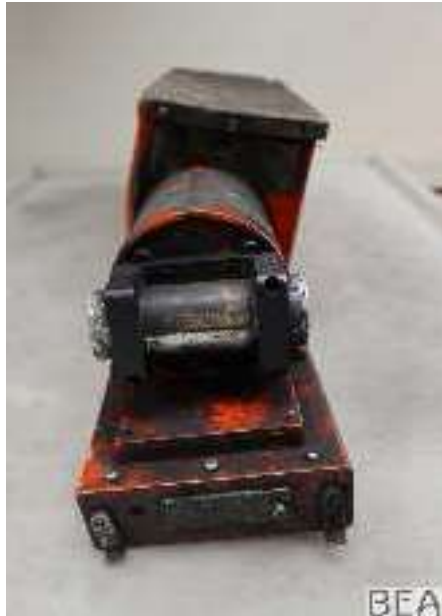
*Figure 7: FDR chassis and CSMU*

The FDR was visually inspected. The CSMU was still attached to the chassis. The flex cable was partially linked to the chassis. There were traces of fire and soot. The chassis was bent.

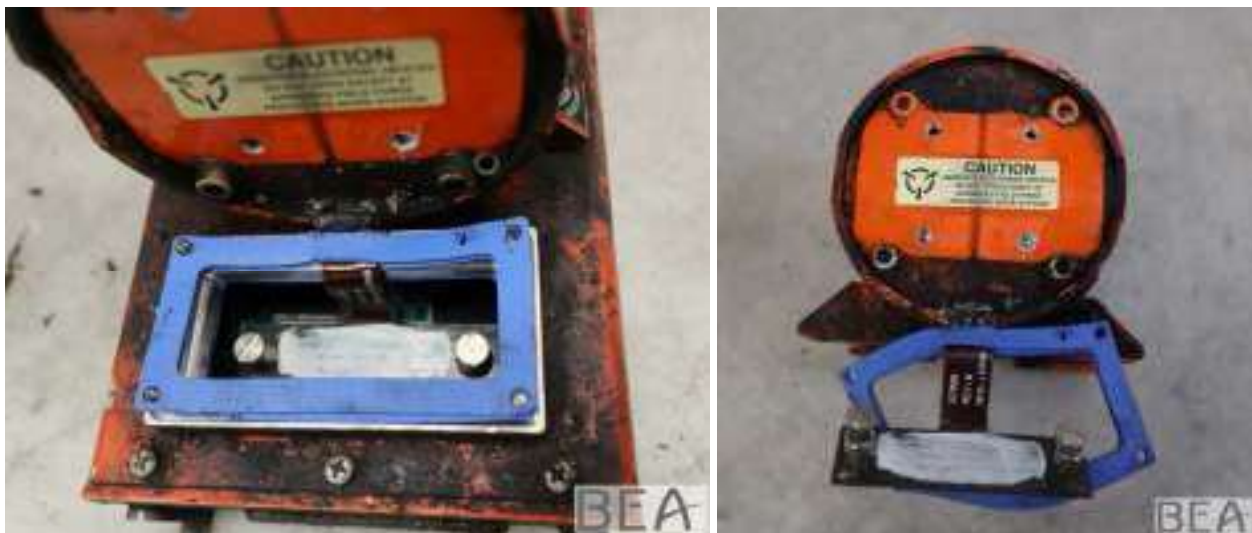
Figure 9: Separation of the FDR CSMU from the chassis

The screws of the flex cable cover were removed. The CSMU connector was disconnected from the chassis interface. The screws attaching the CSMU to the chassis were removed, two out of 4 were found loose. The CSMU was separated from the chassis.

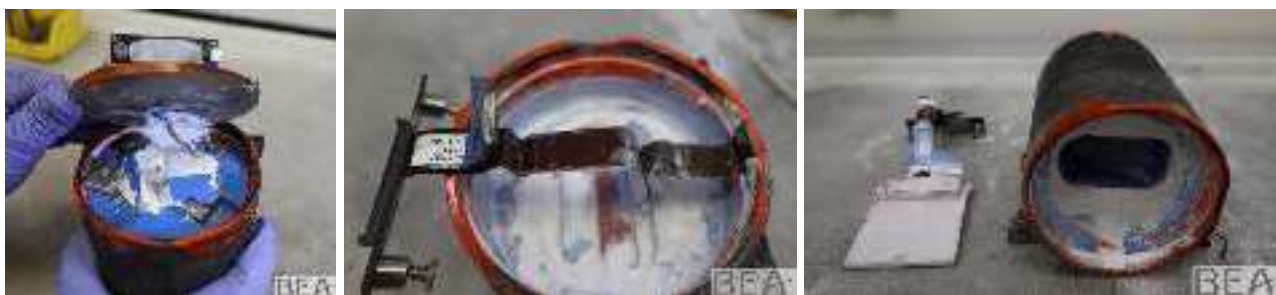
Figure 10: Extraction of the memory board from the protected module

The CSMU was opened by removing the screws and hold down latches to extract the memory board. One side of the flex cable was found torn off.

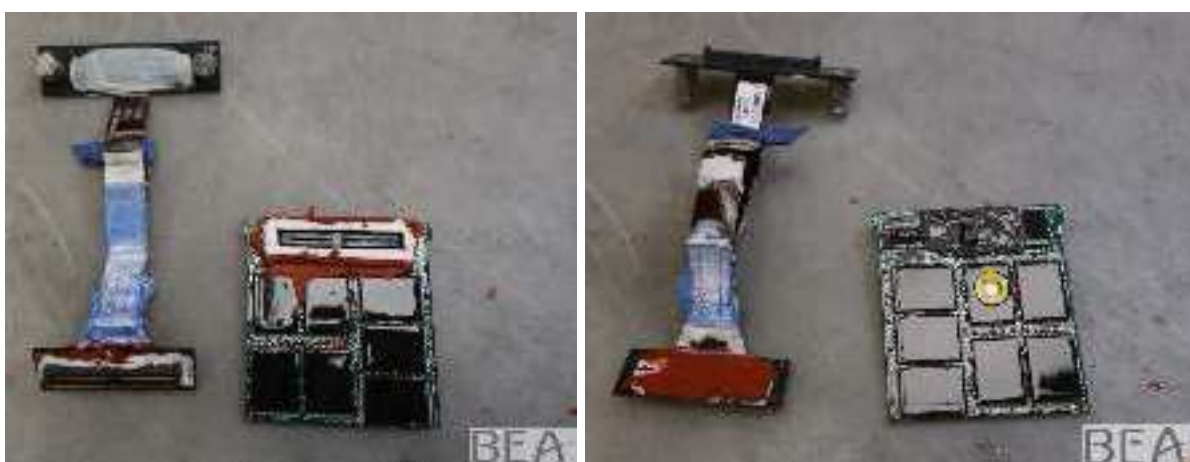
Figure 11: FDR memory board

The memory board was visually inspected under magnification. It was in good condition. The temperature indicator color showed that the memory board was not exposed to heat.

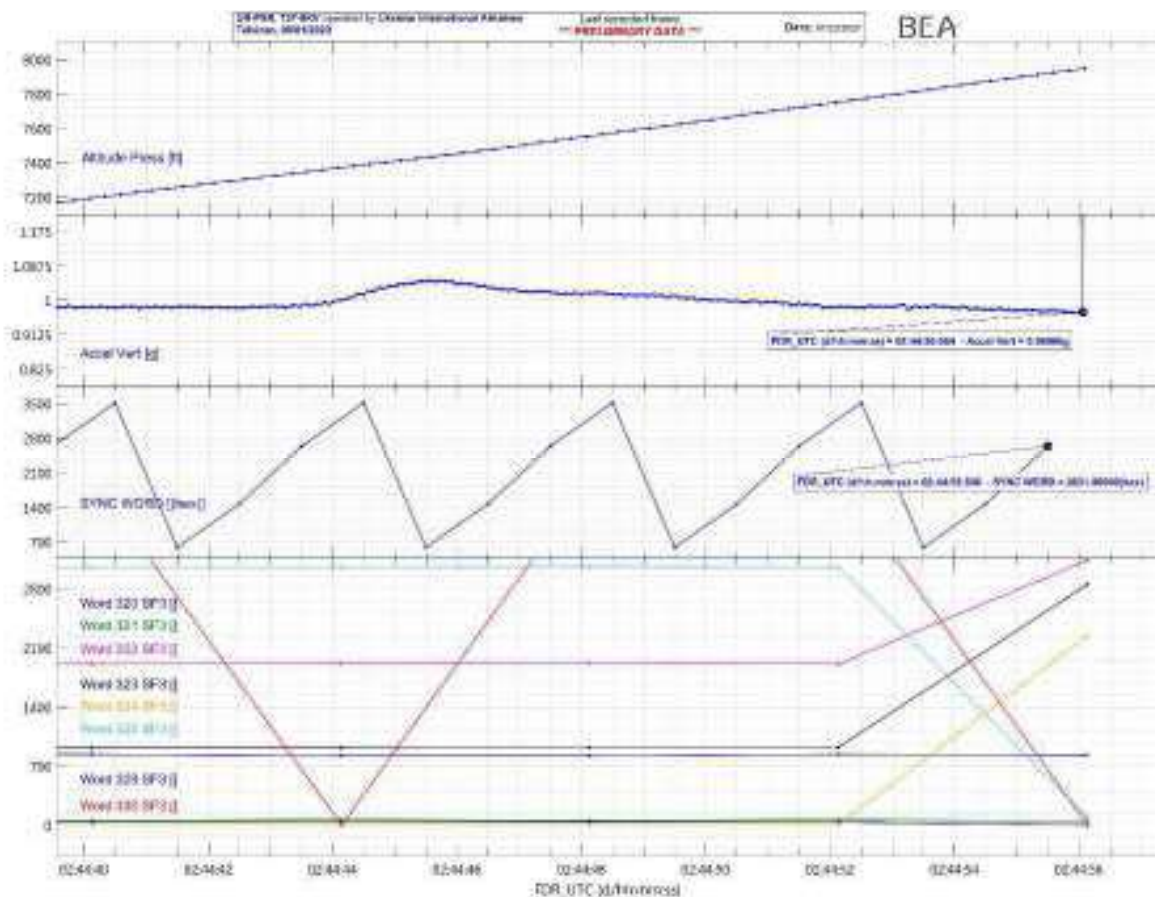
Figure 14: Plots of the last recorded words in the FDR file

All values recorded in the FDR raw file after word 321 of subframe 3, which is the last subframe (incomplete due to end of recording) recorded, are invalid and should not be considered.

In this document, the FDR analysis stops at the word 321, dated at 02:44:56.125 UTC.
