Accident
on 25 December 2003
at Cotonou Cadjèhoun
aerodrome (Benin)
to the Boeing 727-223
registered 3X-GDO
operated by UTA
(Union des Transports Africains)

REPORT TRANSLATION
3x-o031225a

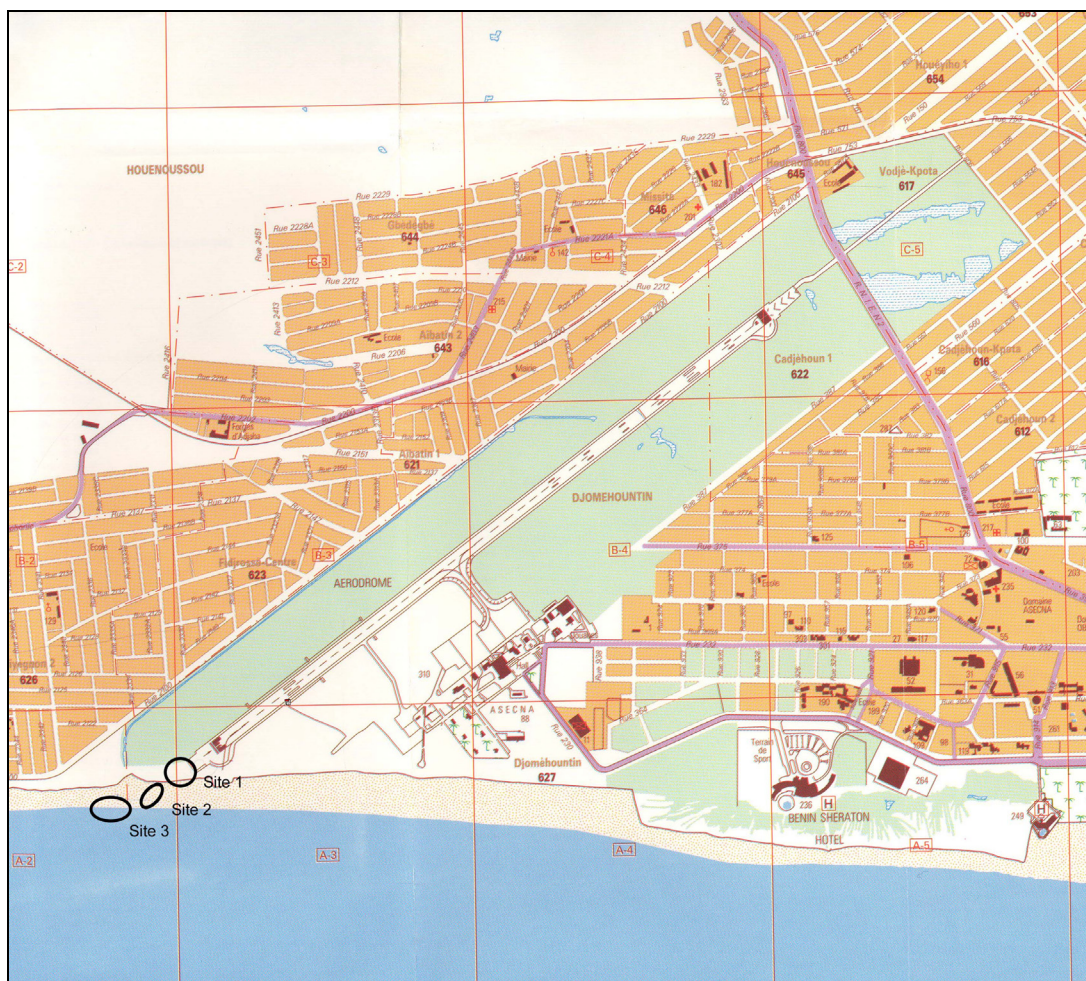
The airplane struck a technical building after the end of the runway (site 1), crashed onto the beach (site 2) and ended up in the ocean (site 3).

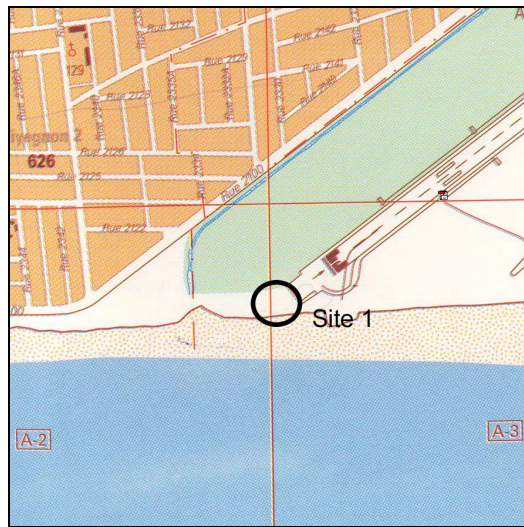
Site 1

The illustration of site 1 (below) shows the distribution of the airplane debris in three distinct zones, with a total area of about 1,550 m².

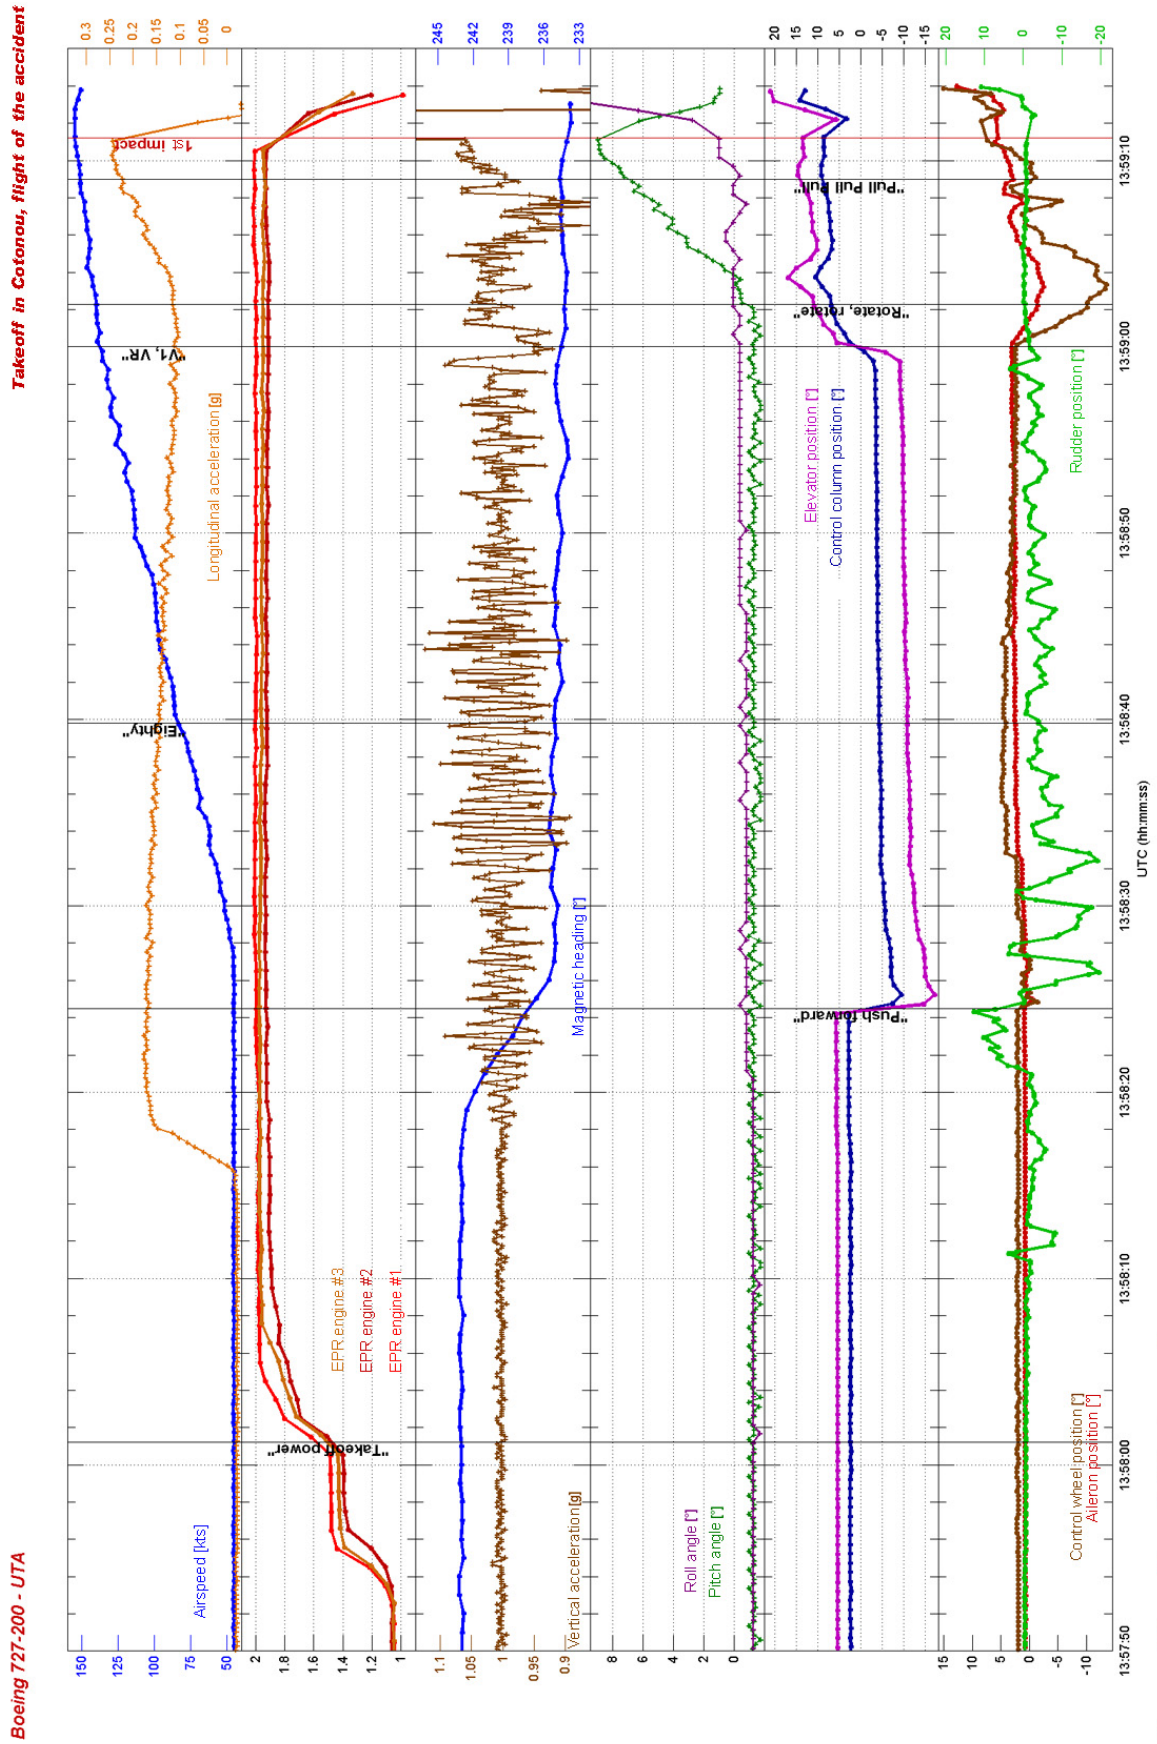
3X-GDO

The graphs obtained from the recorded parameters (see appendix) show that, when the stick was pulled back, the elevator was immediately set in pitch-up position, but that the airplane's response time was very slow compared to the usual time, the nose lifting off late while the acceleration was continuing. Such a situation at the beginning of the climb-out indicates either a limitation in the elevator's operation or an airplane with a center of gravity that is too far forward.
