REPORT

on the accident on 12 November 1999 North of Pristina (Kosovo) to the ATR 42-300 registered F-OHFV operated by SI FLY

F-FV991112A

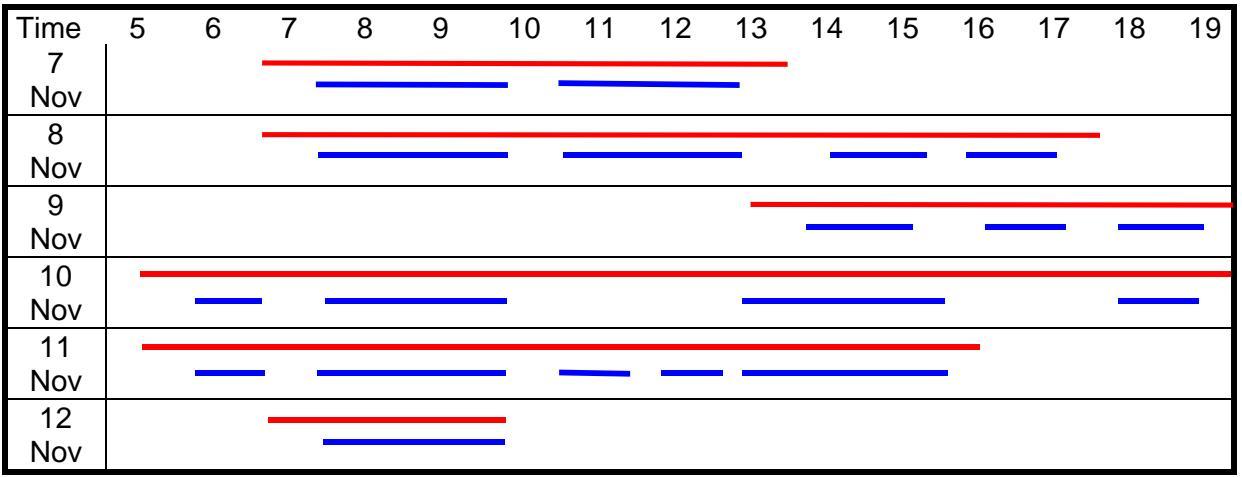
Since the 1st of November, the Captain had flown fifty-two hours. He had had two non-flying days, on the 4th when he was available for the Director of flight operations, and the 6th when he had a rest day. Between the 7th and the day of the accident, he had flown thirty-two hours. The day before the accident, he had ferried from Ancona to Rome beginning his duty period at 5 h 45. His day continued with the Rome-Pristina-Tirana-Pristina-Rome line.

Figure 2 : Captain's activity in the week preceding the accident service time flying hours

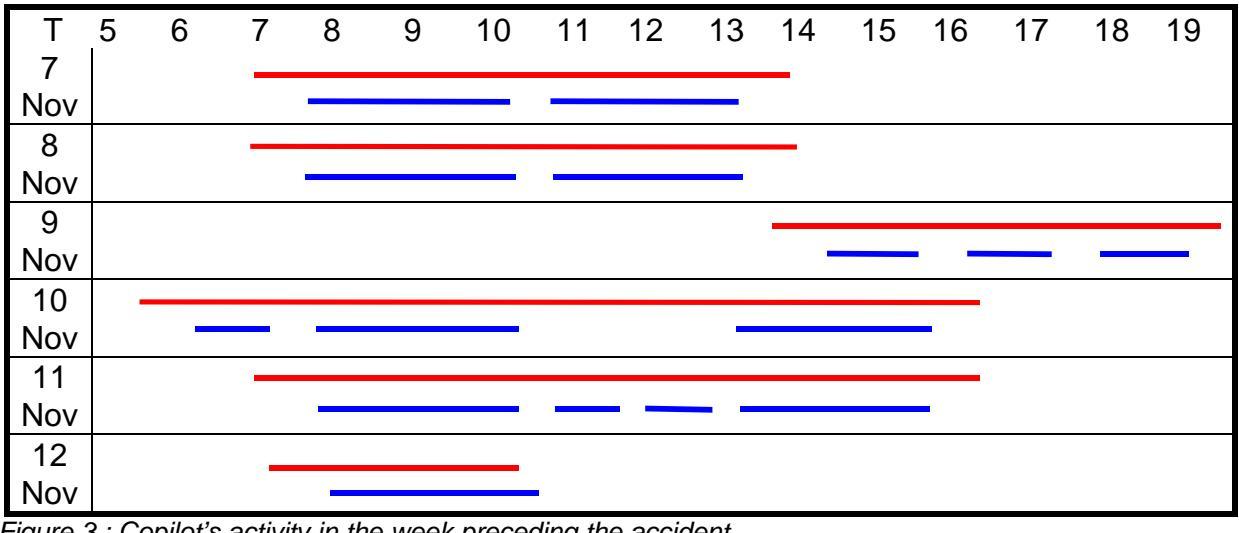
Since the beginning of November, he had flown forty-three hours. He had had two non-flying days, on the 4th when he was available for the Director of flight operations, and the 6th when he had a rest day. Between the 7th and the 12th, he had flown 27 h 30 min. The day before the accident, he had done the Rome-Pristina-Tirana-Pristina-Rome route with the same Captain.

Figure 3 : Copilot's activity in the week preceding the accident service time flying hours

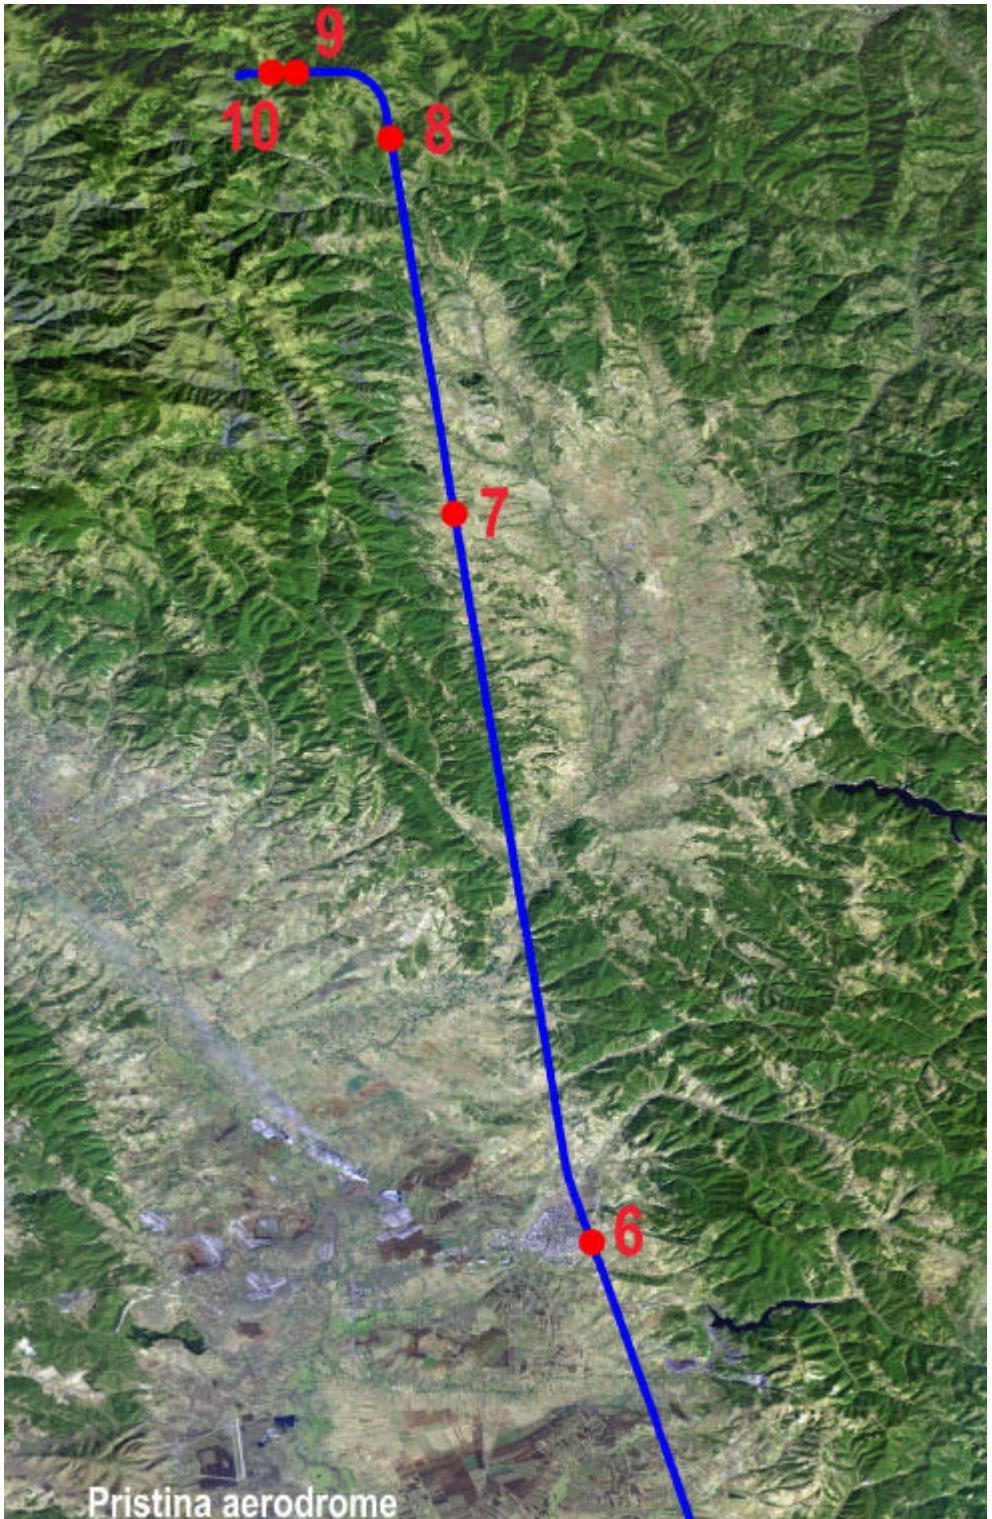
Figure 10 : Track of KSV 3275

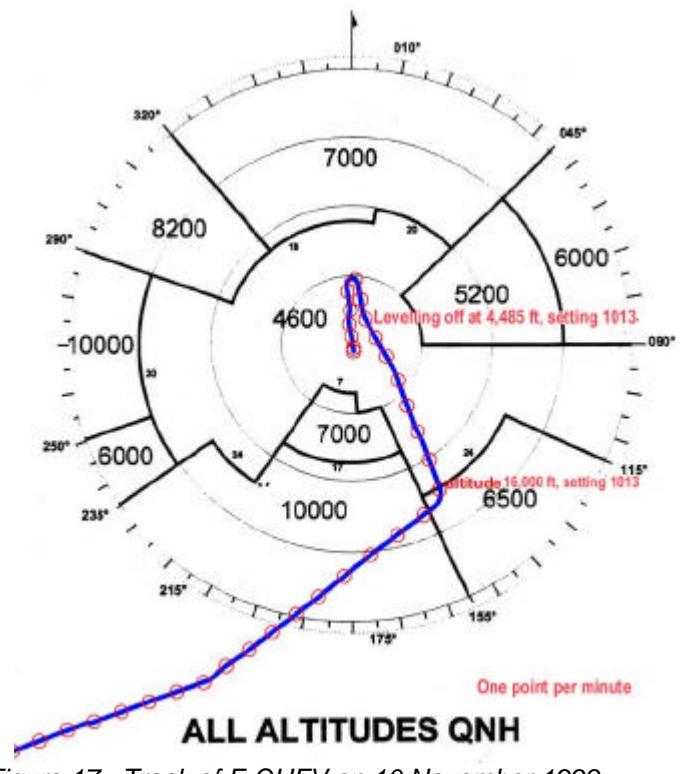
As we have seen, this lack of procedural discipline and the passivity of the crew may be explained in part by the daily routine of these flights, but fatigue also appears to be a contributory factor. The study undertaken did in fact show a high level of fatigue, in particular for the Captain. Moreover, note should also be made that this study did not take into account the concentration and workload, which the (recent) first flights, and difficult approaches to Pristina and Tirana had probably entailed. This state of fatigue promoted hypovigilance on the part of the crew, lulled by what appeared to be radar vectoring and made confident by the success of their previous approaches.

Figure 17 : Track of F-OHFV on 10 November 1999
