THE DUTCH
SAFETY BOARD

**CRASHED DURING APPROACH, BOEING 737-800,
NEAR AMSTERDAM SCHIPHOL AIRPORT,**
25 February 2009

The Hague, May 2010 (project number M2009LV0225_01)

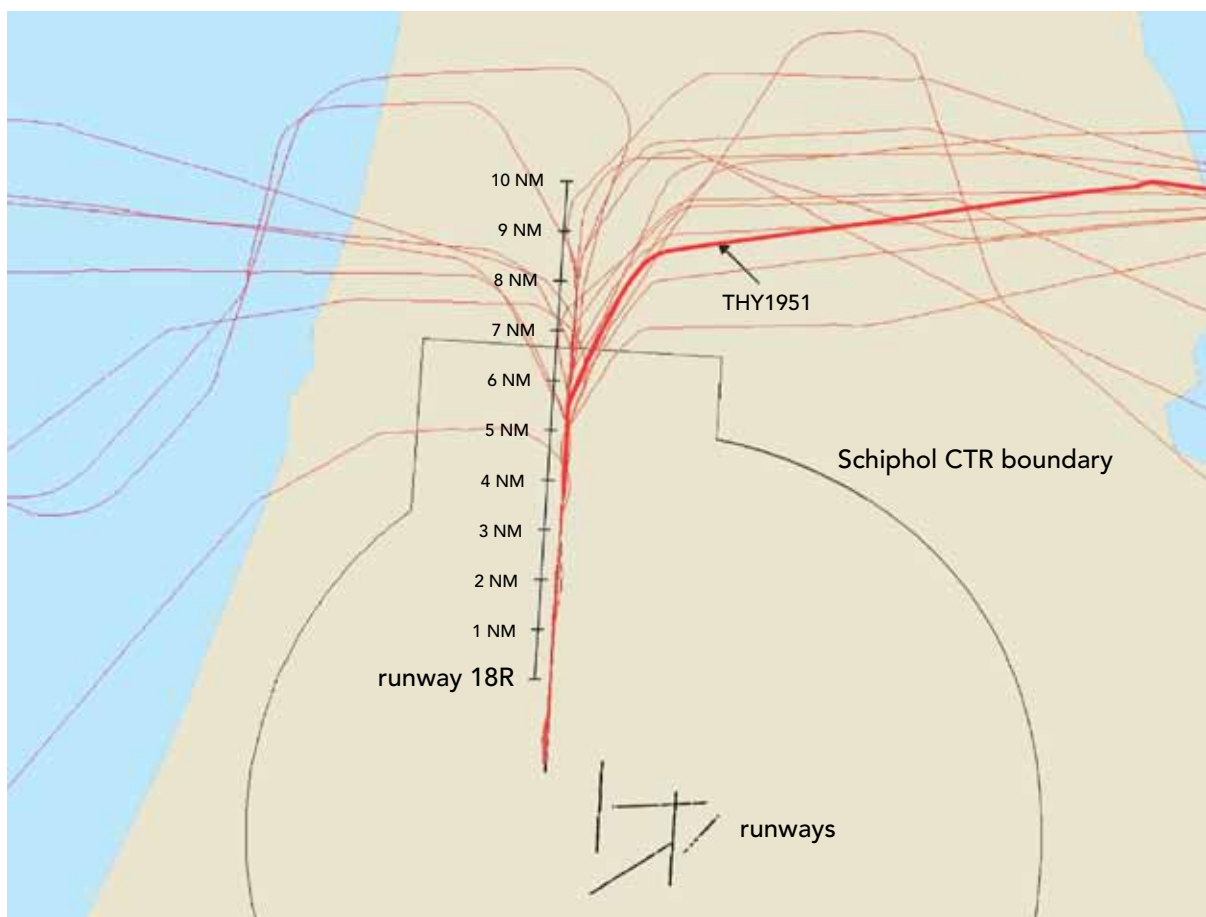
Illustration 7: radar data air approaching traffic runway 18R, between 09.20 and 10.30 hours on 25 February 2009 (source: ATC the Netherlands)

By giving instructions to approaching aircraft with which they are expected to intercept the localizer signal at 2000 feet just before 6.2 NM, there is no room for deviations. In this case an upper wind finally resulted in an interception of the localizer signal, approximately 1 NM more to the south than planned. When lining up at 8 NM such a deviation will not give problems.

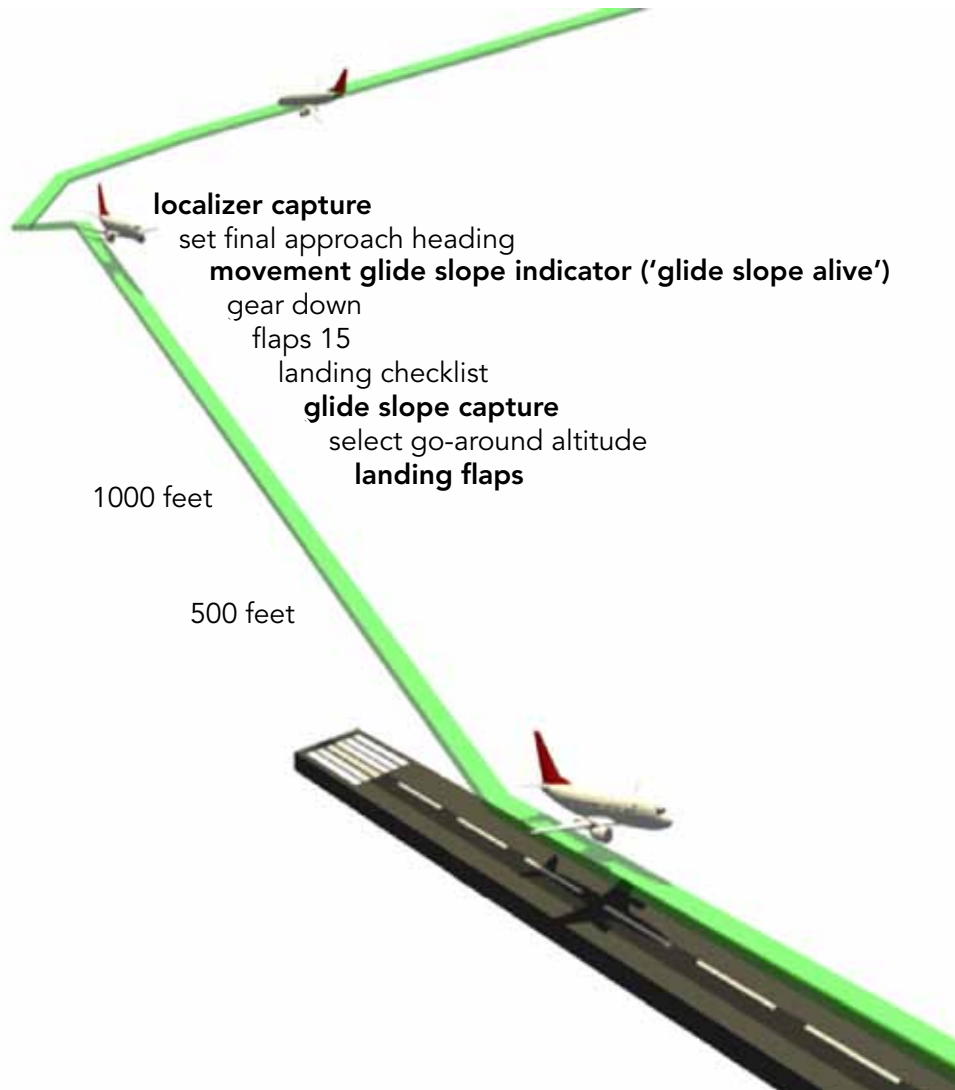
Illustration 9: schematic depiction of Turkish Airlines procedures for an ILS approach

The cockpit crew started configuring the aircraft for the approach before the localizer signal had been intercepted. The landing gear was lowered and flaps 15 was selected. Normally these actions are carried out after the localizer signal has been intercepted and the glide slope indicator on the primary flight display starts to move. From this it follows that the crew were aware that the course to the ILS would place the aircraft above the glide slope. At Turkish Airlines⁵¹ the landing checklist is completed for an ILS approach after the landing gear has been lowered and flaps 15 has been selected (see illustration 9 also). However, the landing checklist was completed at a later stage of the approach. The reason for this is not known. It is possible that the cockpit crew postponed it because they had to perform additional actions in connection with approaching the glide slope from above and having to monitor this constantly.

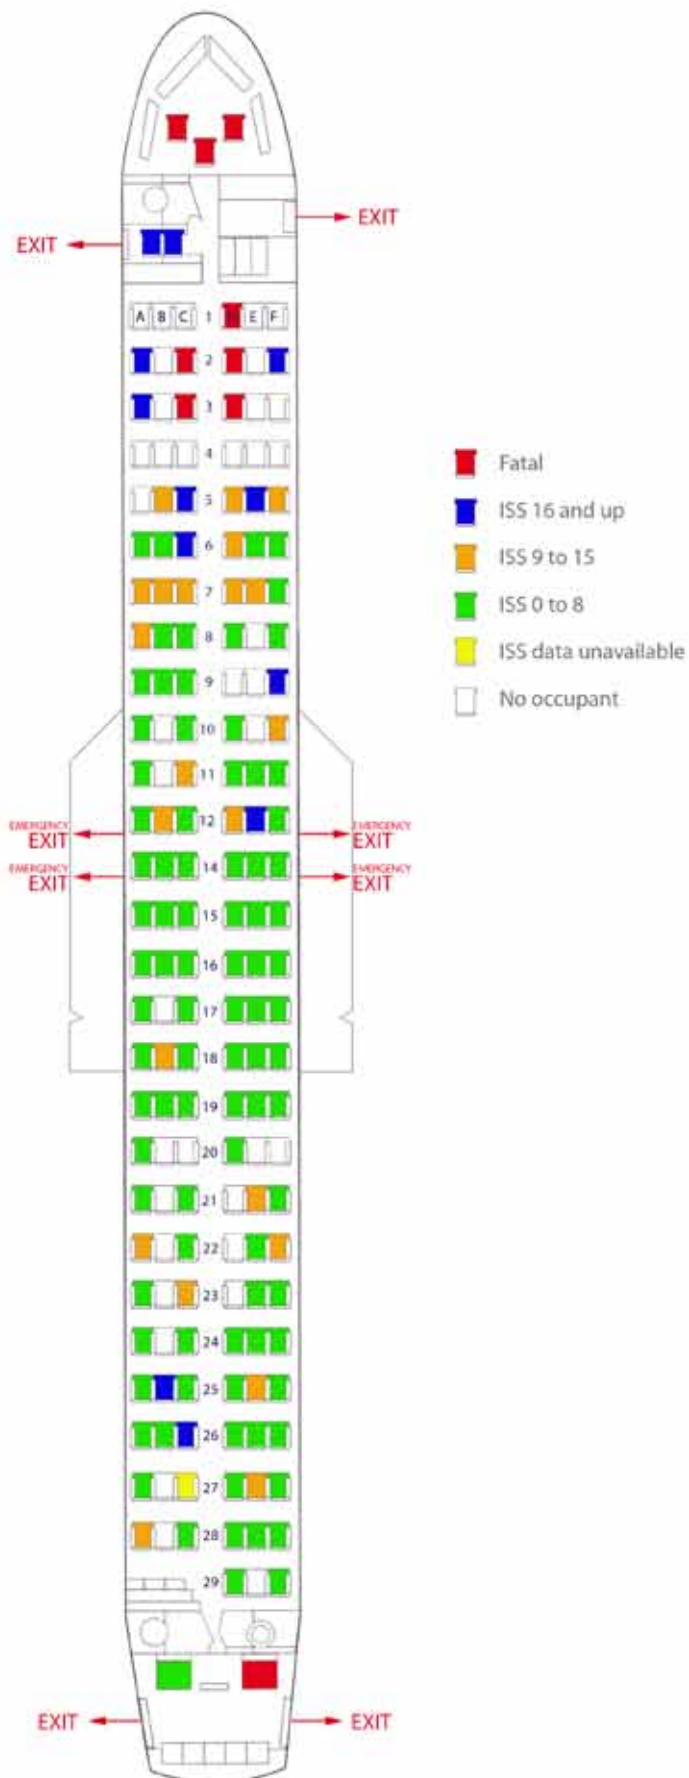
Illustration 11: gravity of injuries to occupants by seating position, according to ISS scale

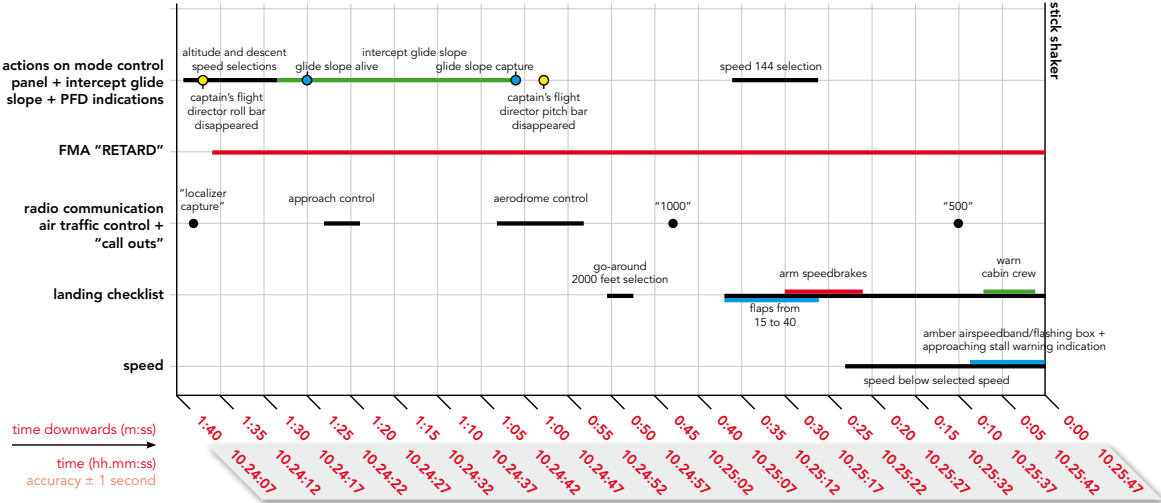
The crew must select a lower altitude¹¹⁸ and another mode for the autopilot to ensure the aircraft descends. The flight data recorder data and the simulator tests have shown that the following actions were performed consecutively for intercepting the glide slope from above, which in total took approximately 40 seconds to accomplish (also see the timeline):

Illustration 19: timeline of actions performed by the crew between the interception of the localizer signal and the activation of the stall warning

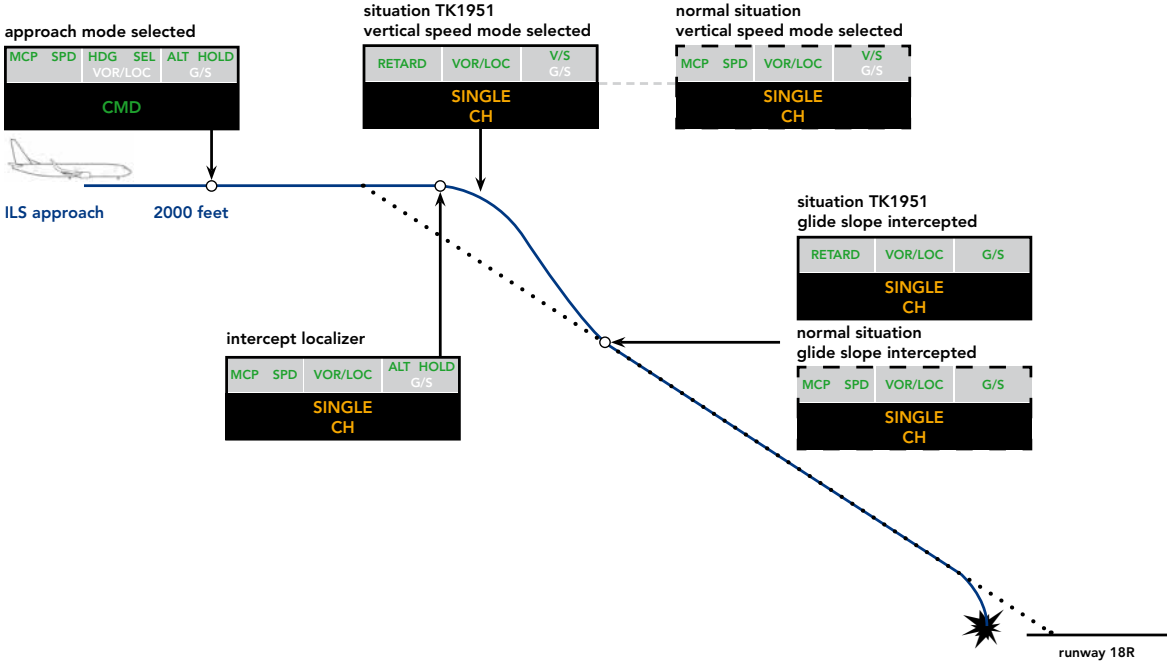
Illustration 20: flight mode annunciations during the approach of flight TK1951
